Nevada Division of Water Resources Memorandum

RE: Spanish Gulch Spring, Stock: V09759, Baumann; V04500, Bliss; V01423, Goicoechea; R04246, BLM, Eureka County, NV

Inspection

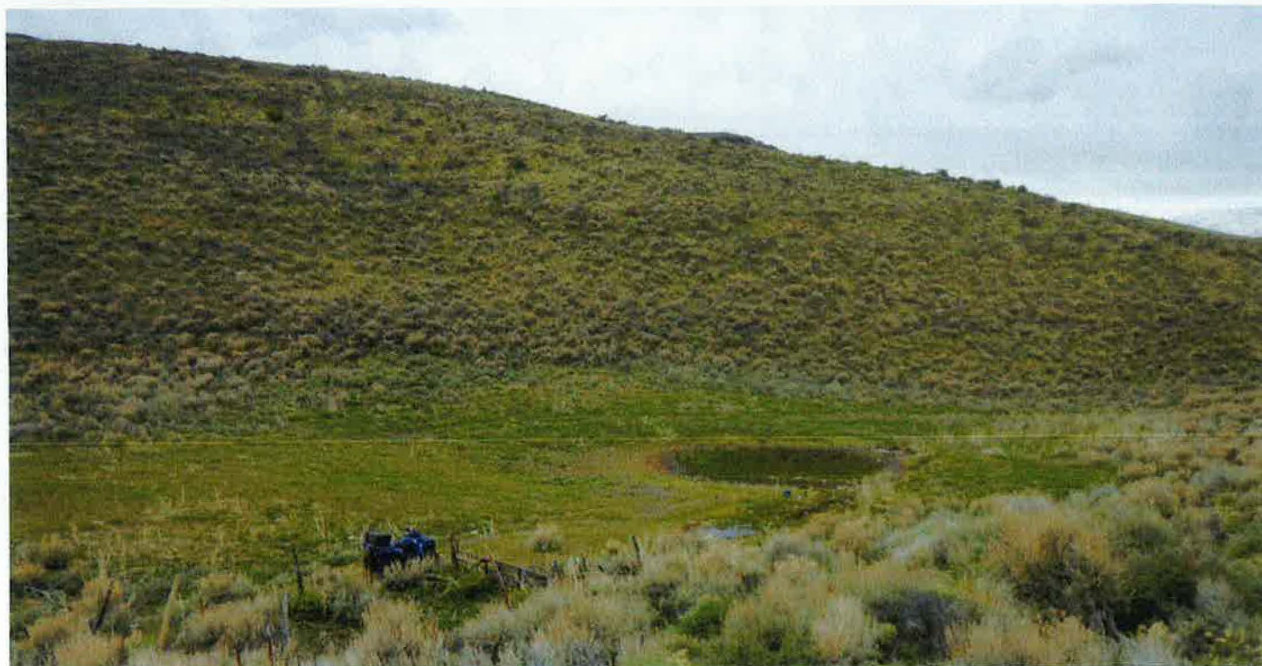
Upper Photo: Overview of Spanish Gulch Spring area, looking NW with fenced spring source next to ATV, draining northward into ~50 ft diameter shallow stock pond; Lower Photo: Close-up of spring source, looking north.

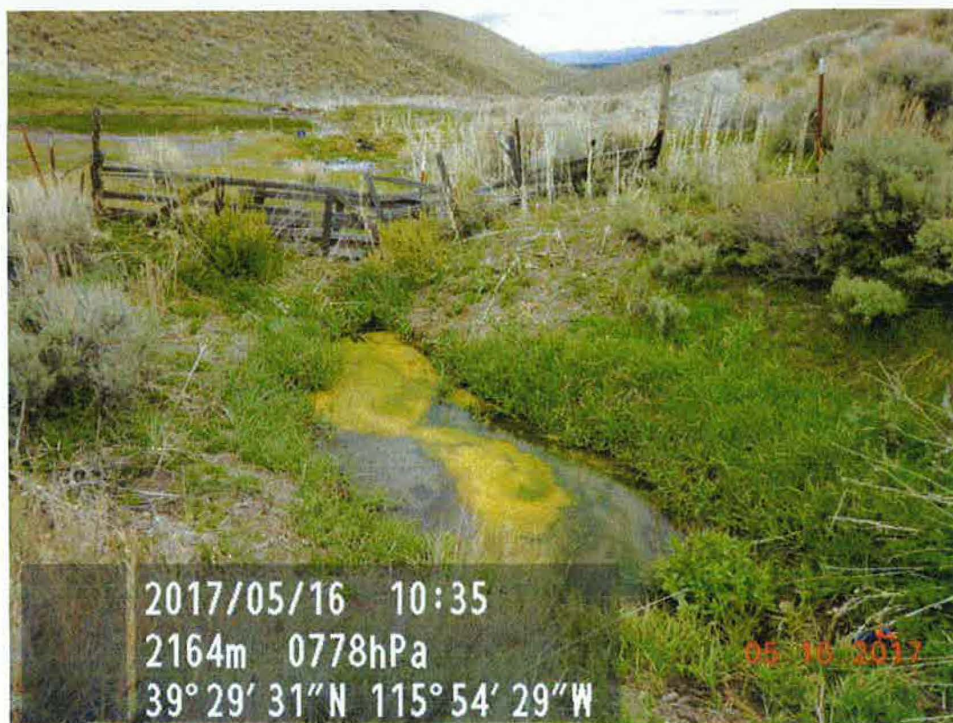
Fenced spring pool, ~10' by 3', & 4-6" deep, fed by 3" diameter distinct, bubbling point discharge at south end; drains northward into shallow 50 ft diameter stock pond; abandoned, old sheep trough below.

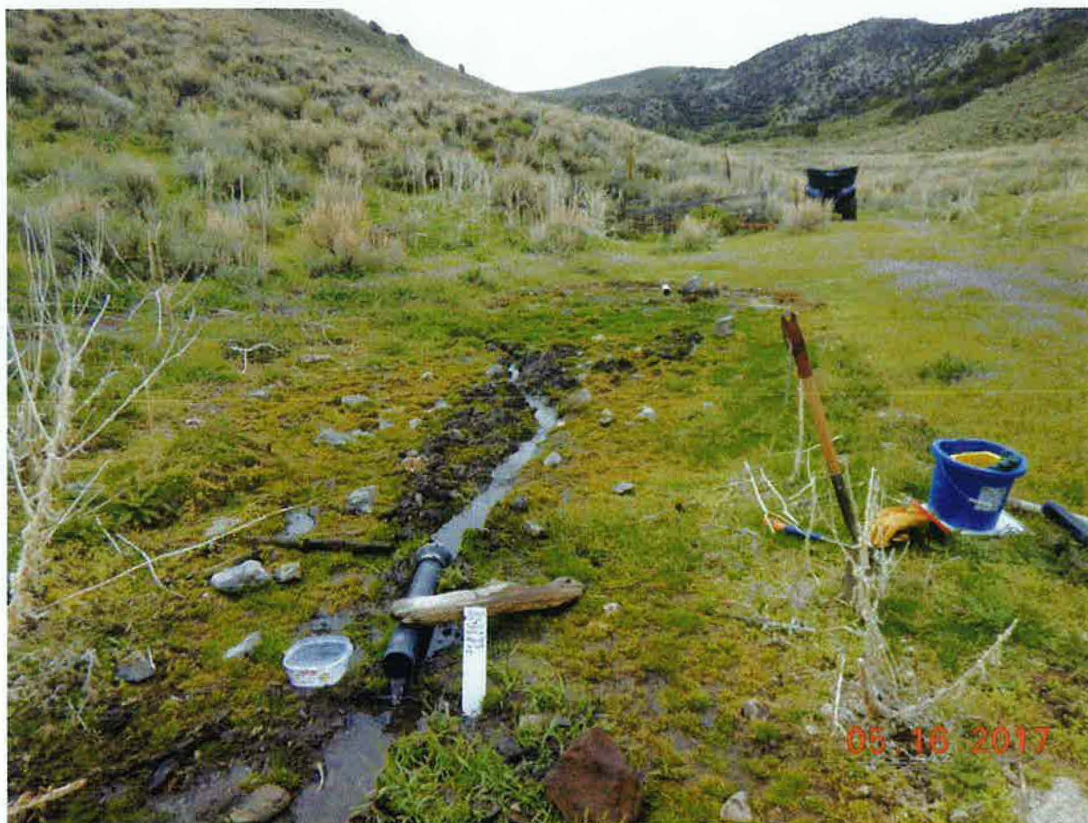
Upper Photo: Spanish Gulch Spring flow measurement site, looking south, with fenced spring source to left of ATV; Lower Photo: close-up of site with measured flow of 2.8 gpm (excellent).
