Nevada Division of Water Resources Memorandum

RE: V-04499, Milk Ranch Spring, Bliss Stock Claim; R-04247, BLM, Eureka County, NV

Inspection Date(s)
5/15-16/2017

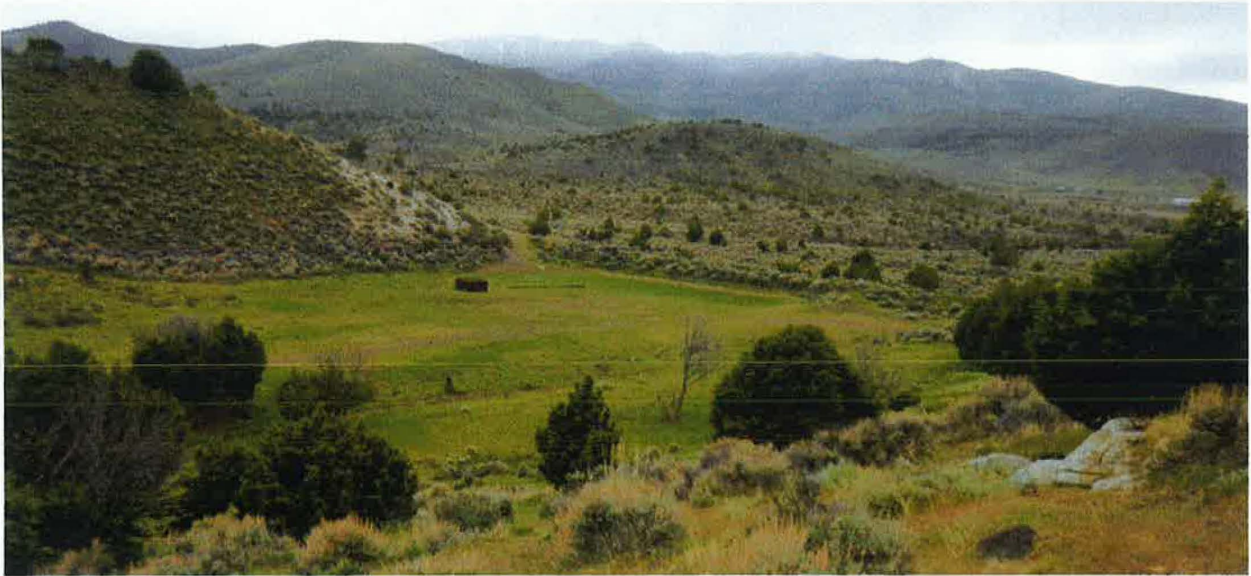
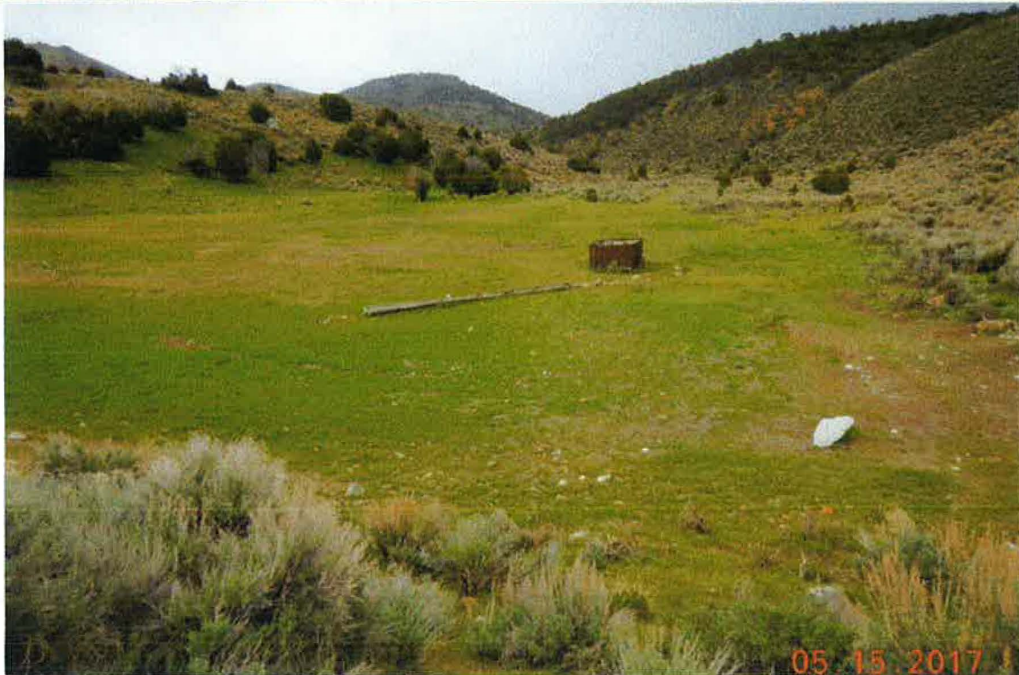
V-04499, Milk Ranch Spring, Bliss Stock; R04247, BLM

Upper Photo: overview of Milk Ranch Spring area, looking SW with Prospect Peak in far distance; there is a sub-irrigated ~1 acre area in center of photo which was the location of the historic Milk Ranch (dairy cows); the embankment to right is an old railroad grade which helps contain runoff in a $\frac{1}{2}$ acre depression; sheep trough is located to right of brown object. Lower Photo: same area looking NE; the actual source of the current minimal water is likely pipelines and springbrook from the spring filed under V09768, ~ $\frac{1}{2}$ mile to the NE and up drainage, although most maps do place a spring at this location.

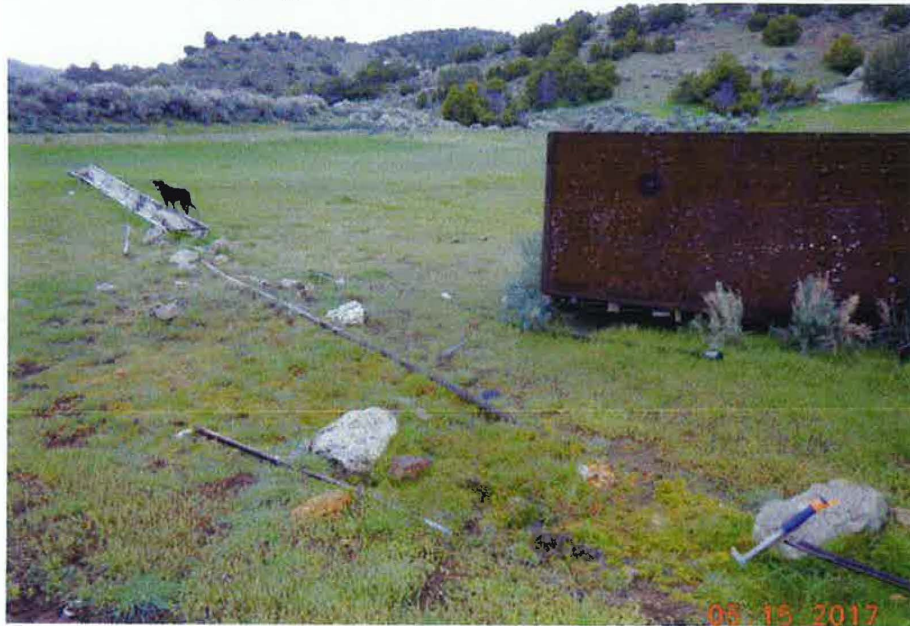
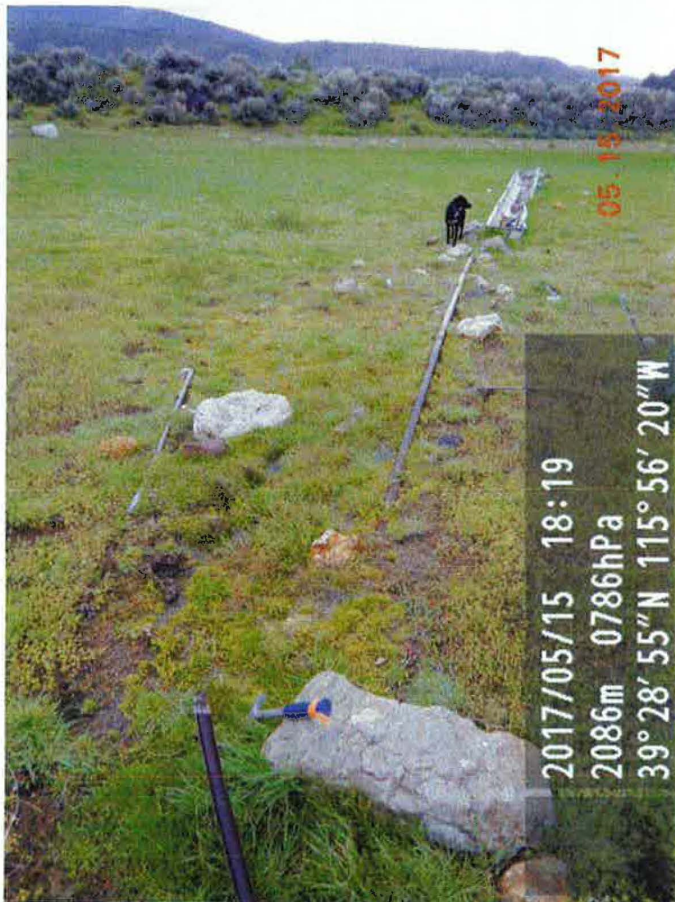
V-04499, Milk Ranch Spring, Bliss Stock; R04247, BLM

Upper Photo: various pipelines associated with Milk Ranch and sheep trough, looking NW; there is a very slow trickle of water ≤ 0.1 gpm) from one of the pipelines, most of which may be derived from a buried pipeline extending NE up the drainage; the brown metal object was likely used for storing water before being riddled with bullet holes; Lower Photo: close-up of pipeline discharge area, with railroad embankment in middle distance, looking WNW.
