**NEVADA DIVISION OF WATER RESOURCES
ADJUDICATION SECTION**

FIELD INVESTIGATION REPORT

DIAMOND VALLEY (BASIN 153) ADJUDICATION

THOMPSON RANCH AREA, EUREKA COUNTY, NV

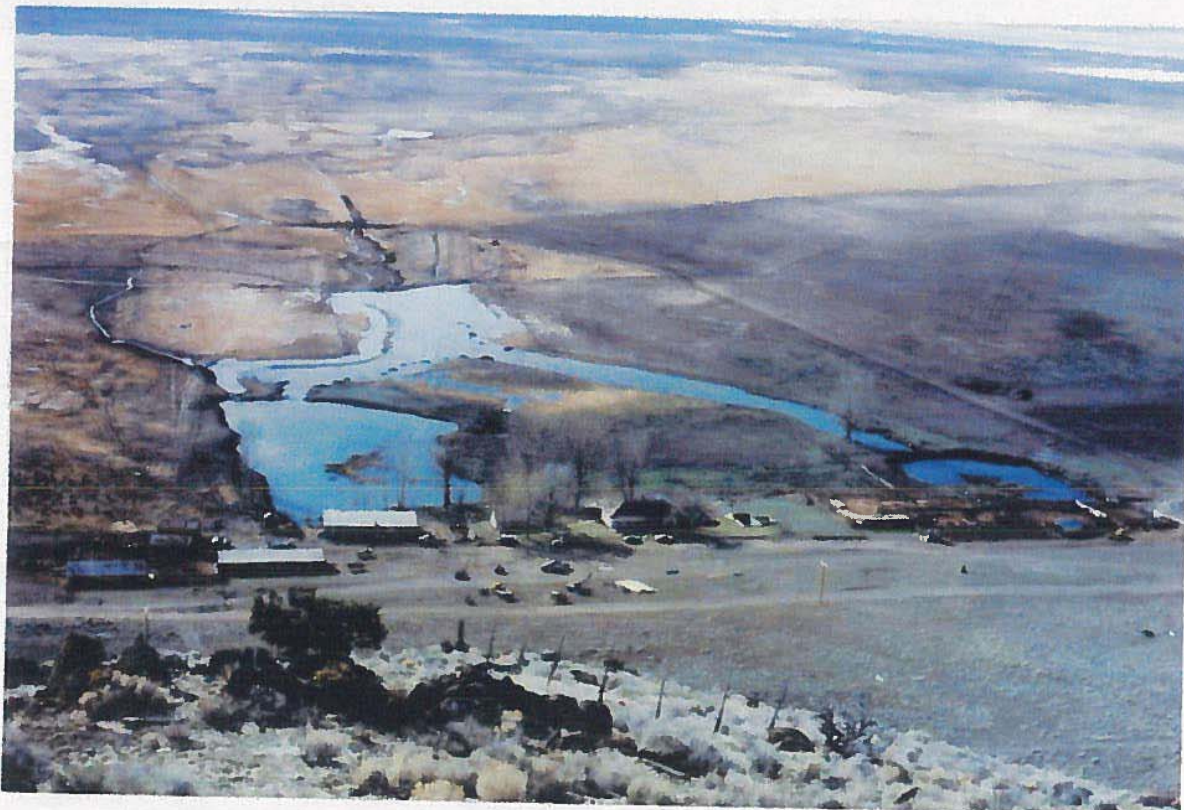
Figure 5a – Photograph of Thompson Springs (V-01115) and Ranch, taken about March 7, 1982, looking west. Shows larger, main south spring (V-01115.1) on left and associated reservoir, and smaller north spring (V-01115.2) and pond on right. The photograph highlights the challenges of obtaining an accurate flow measurement from the springs, due to the configuration of the reservoirs and flat gradient. J. Harrill of the USGS estimated the flow at 130 gpm (0.29 cfs) on March 10, 1982. Photo provided by M. Thompson.

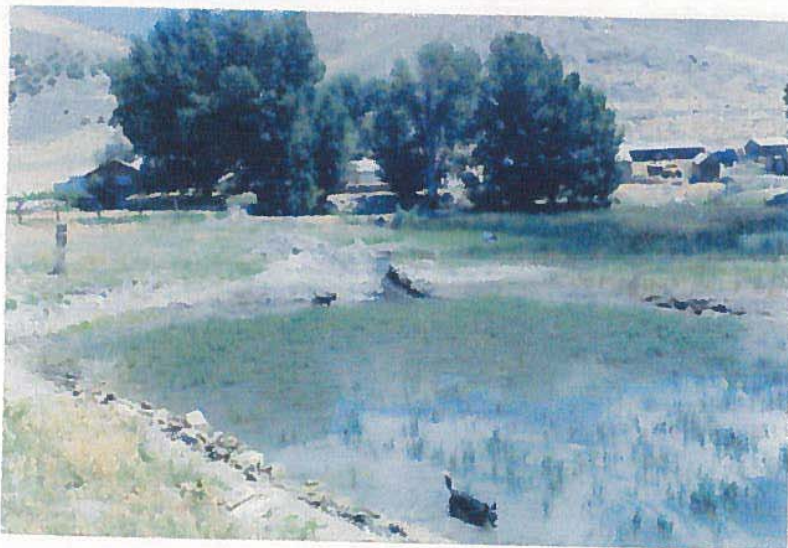
Figure 5b – Photograph of the south, main Thompson Spring (V-01115.1) summer 1982, looking east. Flow rate is likely much less than $\frac{1}{4}$ cfs, however, the average of five measurements from the same summer was 1.26 cfs. Photo by M. Thompson.

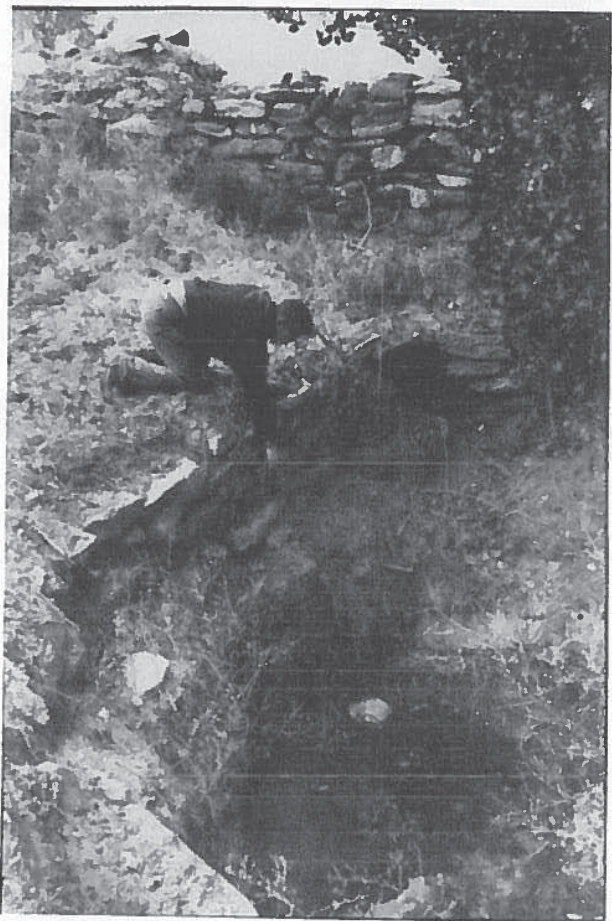
Figure 6 – Photograph of the south, main spring (V-01115.1) with rock lined wall and M. Thompson, taken in about 1993, around the time when the spring ceased flowing. This is the same area shown in Photo 1b in later part of report; the former spring is now mostly overgrown and obscured. Photo from HCN article, August 9, 1993.

V-01115, Thompson Springs PODs – The two PODs for this claim were investigated on September 7-8, 2016, and more briefly again on April 10, 2017 and were found to be totally dry. However, former works of diversion were observed in the vicinity of both of the claimed PODs. At the former south spring (V-01115.1, Figure 3), an apparatus for domestic water was found adjacent to an overgrown rock wall feature that enclosed the main spring source at one time, and validates the claimed domestic use on the 2013 amended proof (Figure 6, photo of main spring in 1993). An 18" steel casing was driven into the area

several decades ago (Photo 1b). The casing was bridged (blocked) at a shallow depth below the surface, so the depth to water could not be determined. Remnants of the former small irregular reservoir, which extended over an area of about 3 acres to the west, along with associated ditches draining from it could still be discerned (Photo 1a). The POD area for the north, smaller spring (V-01115.2, Figure 3) consists of a dry former pond about 1 acre in size (Photos 2-3). A recent backhoe excavation about 6-8 ft deep was made in 2013 (per Exhibit 237), and was reportedly pumped a slight amount for water at the time. No sign of near surface water was seen in this excavation during the recent field work. An older steel headgate on a 12" CMP was observed leading to one of the former ditches at the west end of this smaller former pond. An old wooden stock trough is present above the headgate, and the main natural channel or ditch from the pond was clearly obvious just to the south of the headgate, which conveyed water to the north-central portion of the former POU, and the 12 acres of harvest crop (alfalfa, garden, grain, etc.) claimed in both older proof maps.

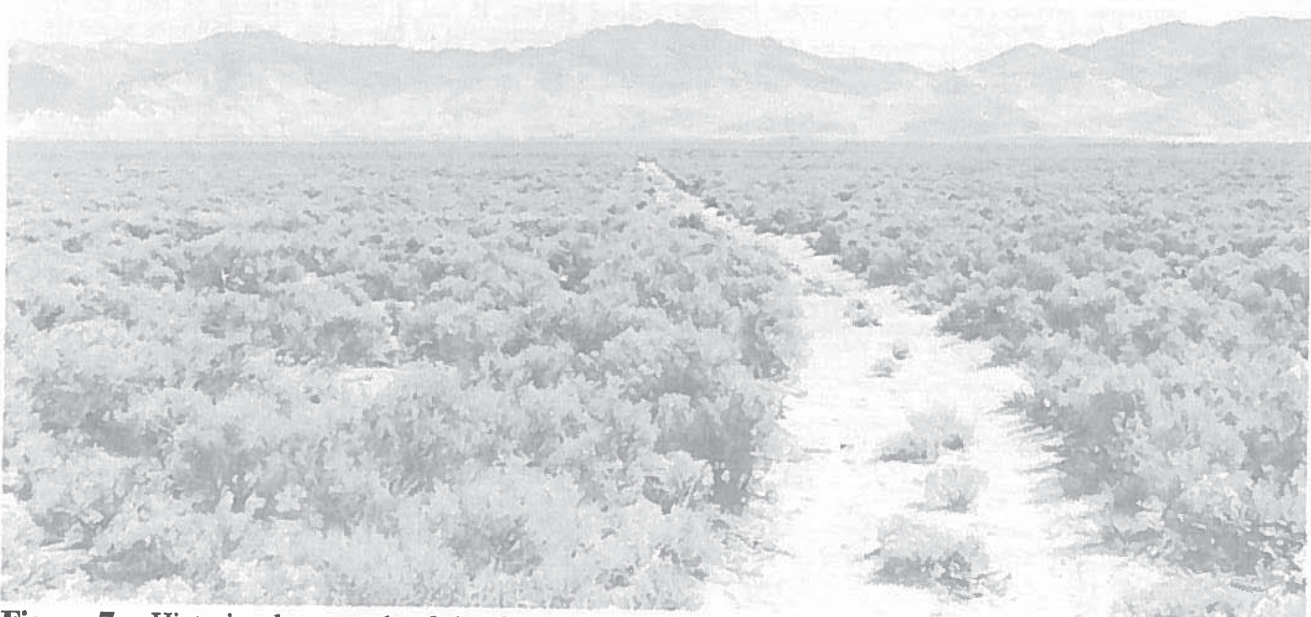
Figure 7 – Historic photograph of the Overland Trail and SW portion of Thompson Ranch, taken from about the west-central portion of Section 10, looking NE with Thompson Ranch in far distance and Overland Pass on skyline. Photo likely dates from the 1960s before intense underground pumping affected the ranch springs; no crops were claimed on the 1912 and 1975 proof maps in the foreground area, which is all sagebrush; the 2013 amended proof and map claimed hay throughout this general area, and cited the 1879 GLO map illustrating a large meadow expanse as support. Location of photo and view is similar to that of Photo 8 in later part of report. Taken from Soil Conservation Service Report for Diamond Valley Area, published in 1980.

trace to minor native grasses. A significant portion of this area is topographically even with, or slightly above the elevation of the former Thompson springs reservoir, and could not be flood irrigated from that source, and therefore the main water source would have to be the Horse Canyon ditch, which has been demonstrated to be an insufficient source, especially for a harvest crop. If the above area was ever irrigated from the Thompson springs and reservoir, water would have had to be pumped into topographically higher ditches, or by hand lines. It is noteworthy that neither the 1912 nor the 1975 maps show any type of crop or culture in this approximate 150 acre area of claimed harvest on the 2013 map, nor the approximate 300 acres to the south and west in the W½ Section 10 and NE¼ Section 9, even though the same land was owned by the 1975 claimants (Figure 7 historic photo; and Photos 8-9).

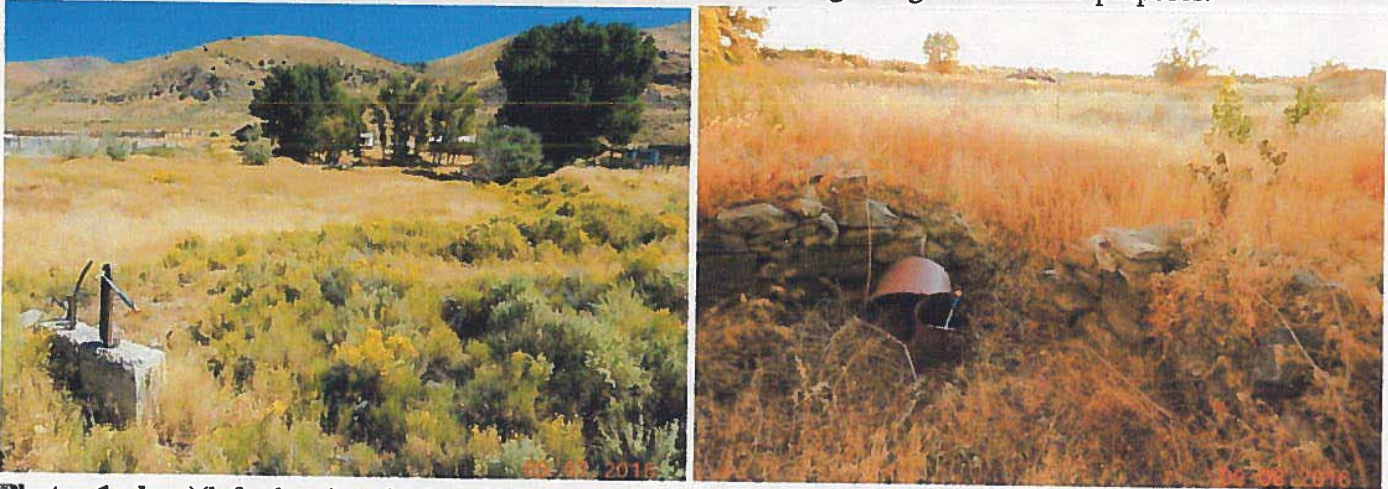
Photos 1a-b: a)(left photo) main (south) Thompson spring (V-01115.1) area and ranch, looking E with Diamond Mountains in distance; former south spring is located in center cluster of cottonwoods and has been dry since the 1990's; historic ranch buildings are behind trees; area in middle ground is former ~5 acre reservoir, with concrete dam/headgate structure in lower left corner; b)(right photo) rock lined main south spring, at east end of former reservoir, looking W; an 18" steel casing (left of center with hammer) was drilled into the spring several decades ago for domestic water, but is now bridged and dry.

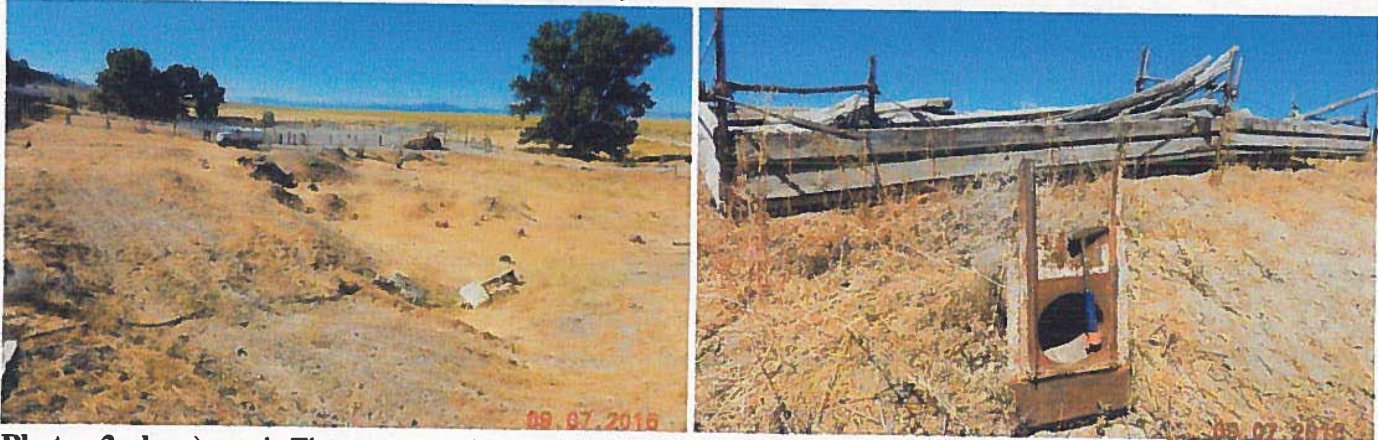
Photos 2a-b: a) north Thompson spring (V-01115.2) area and ranch, looking SSW; this smaller spring also has been dry for several decades; an 8-10 ft deep backhoe excavation near center of photo did reportedly encounter some water several years ago; the former ~1 acre pond is in the right portion of photo; b) headgate and wooden trough at west end of former 1 acre pond, looking W.

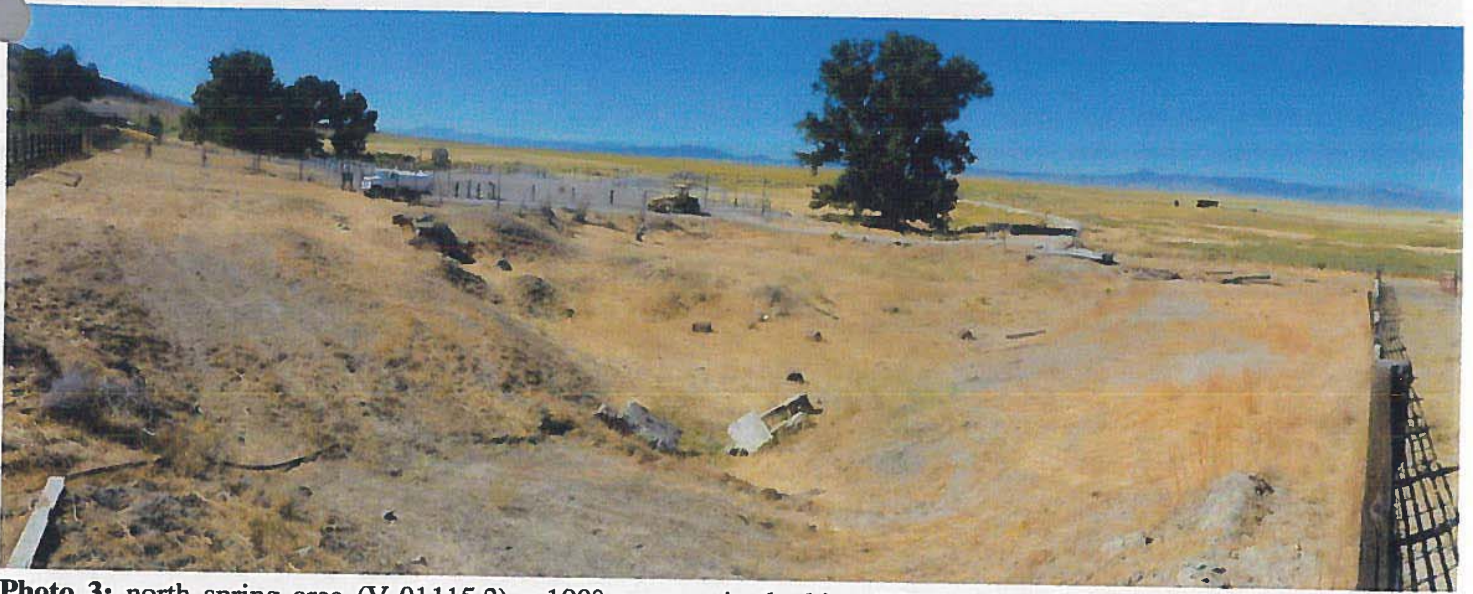
Photo 3: north spring area (V-01115.2), ~100° panoramic, looking SW; headgate and trough in Photo 2b are located in center, to right of large cottonwood; former ~12 acres of historic harvest crops and grain shown on the 1912 and 1975 proof maps would be located to right, in upper far right portion of photo; south spring area is located by larger cluster of cottonwood trees on left.

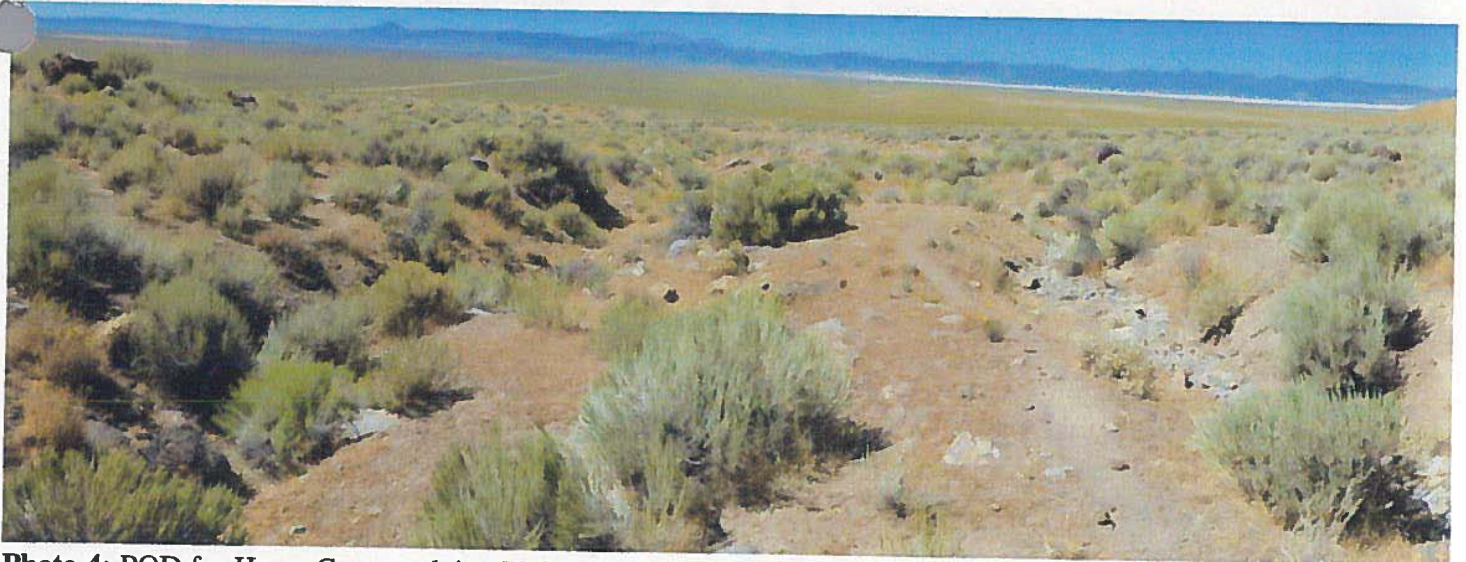
Photo 4: POD for Horse Canyon claim (V-01114), ~100° panoramic, looking W. The natural stream channel is on left, and the constructed ditch from the POD is on right; Thompson Ranch is just out to view in upper right; the distinct round peak to left on horizon is Mt. Hope with the Sulphur Spring Range to right; the Roberts Mountains are in the very far distance, left of center.

place and more or less as depicted as on the various proof maps (Photo 4). However, in more recent years Google imagery indicate that most of the Horse Creek water has been ditched from the POD for about ½ mile further northward, at a flatter gradient along the east side of the county road, rather than as shown on the various submitted proof maps. Ditching the water in this manner likely resulted in higher ditch losses due to the greater distance. In April 2017, portions of the lower ditch just east of the claimed POU on the 2013 map had been cleaned with a backhoe. The water was flood irrigating a portion of the POU without the benefit of secondary ditches, with the ditch water flowing WSW along an older dirt road, rather than a ¼ to ½ mile to the NW per the 1912 and 1975 maps, and down the ditch-channel (stream) depicted on the USGS topographic map (Photo 6).

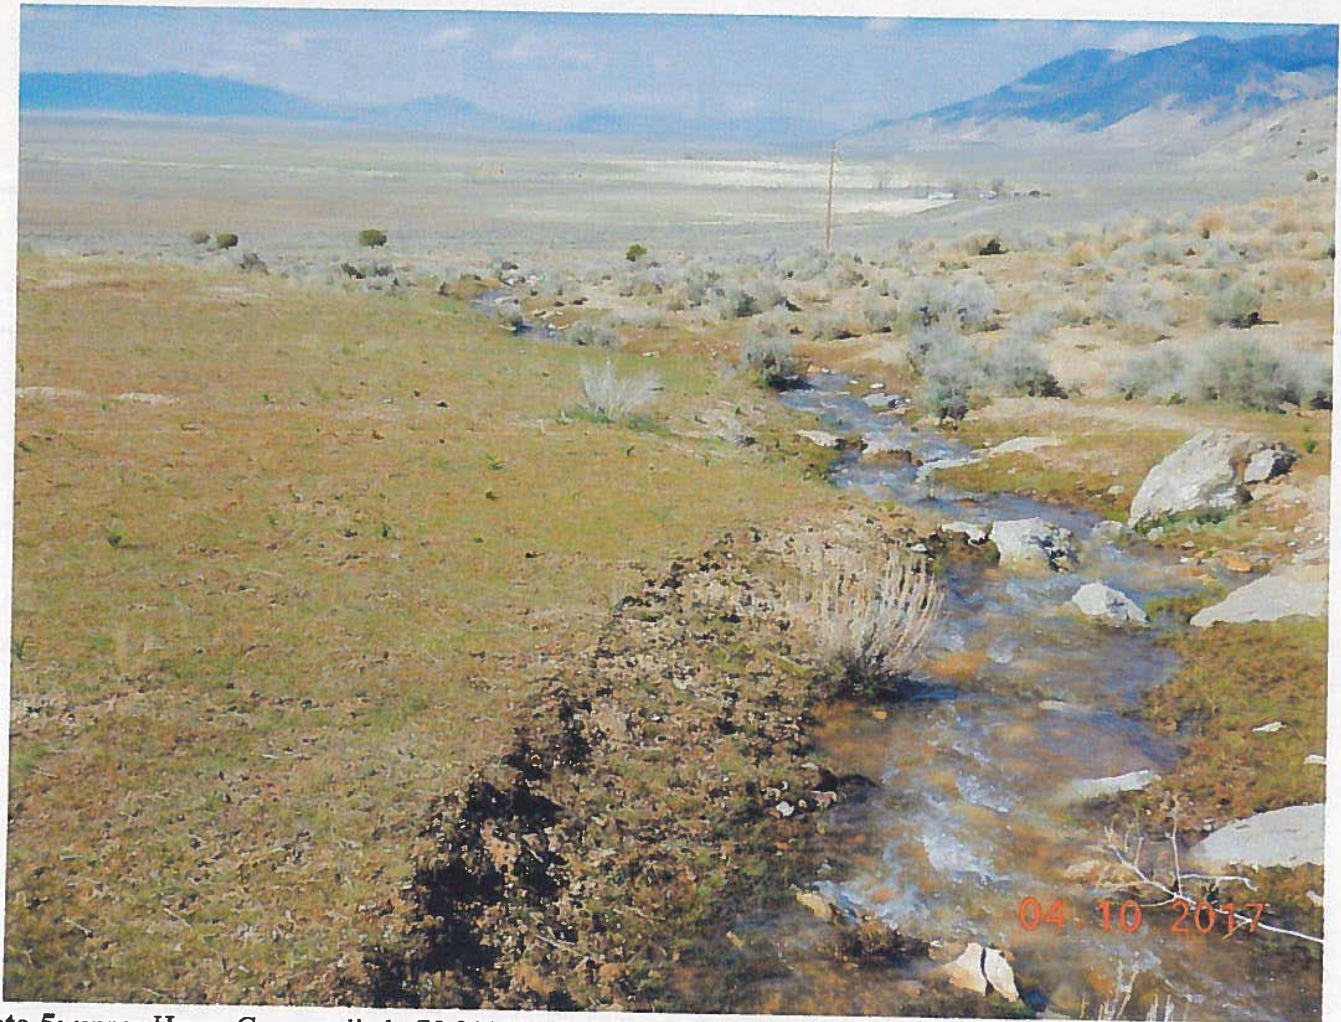
Photo 5: upper Horse Canyon ditch (V-01114), looking NNW; the 4/2017 flow measurement site is located ~300 yds NW of photo, just above the county road. Maximum flow recorded with a pygmy meter was 1.32 cfs, while flow measured with a large 90° V-notch weir was 1.03 cfs. There was no flow of water on 5/1/2017, nor on subsequent visits in later May and June despite wet late spring weather, indicating that flow is limited to the early freshet, and melting snow conditions. Thompson Ranch and former springs (V-01115) are marked by cottonwoods to right of power pole; former claimed irrigated lands extend from those trees, to left center and left distance. The light tan areas south of the ranch are mostly dry mustard weed, where a wheat crop was attempted in 2016; light tan-greenish area to left of mustard weed was brush-hogged in 2016 but not planted; brownish areas to left of that, were brush-hogged in early 2017; these entire areas were claimed as harvest or hay on the 2013 proof map

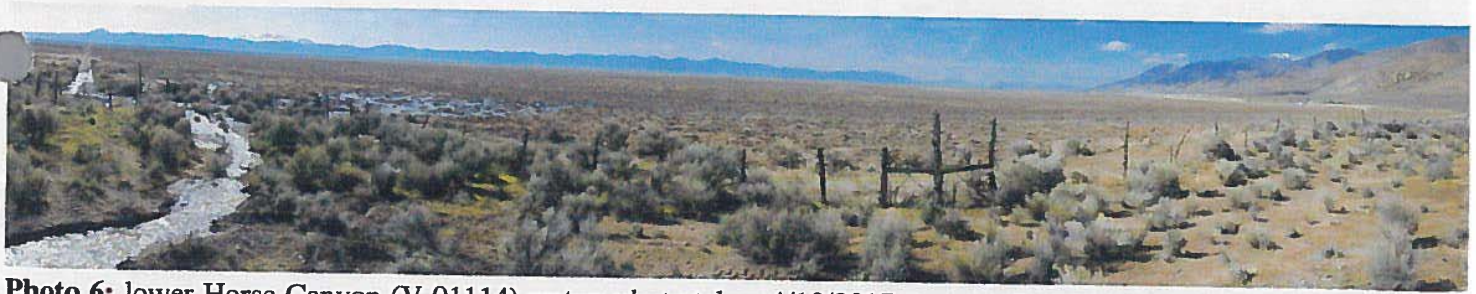
Photo 6: lower Horse Canyon (V-01114) water; photo taken 4/10/2017 at start of POU (claimed as hay) for 2013 map; 180° panoramic looking ~NW. Water was being conveyed here, instead of in the Horse Canyon ditch as claimed on all maps, and located several hundred yds to north (right portion of photo, middle distance). The 1912 and 1975 maps do not claim any crop-culture in the foreground area, nor from center of photo to left in middle distance. Much of area inside fence was brush-hogged in early spring, 2017.

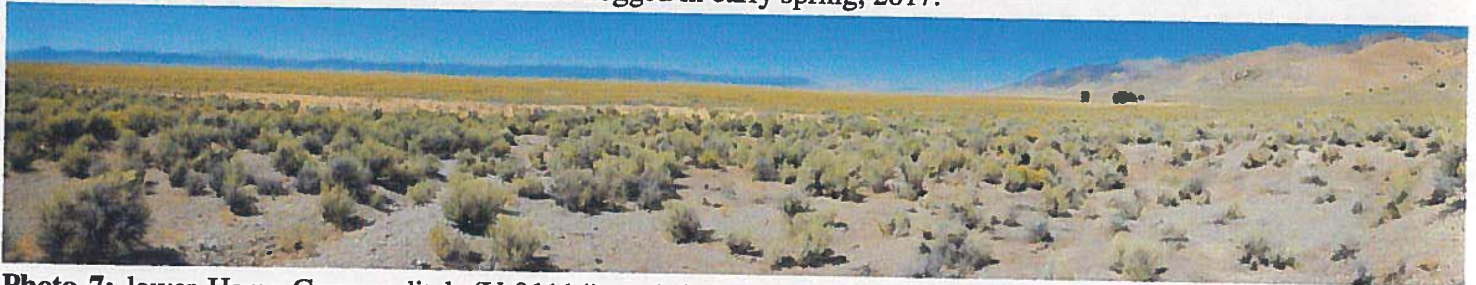
Photo 7: lower Horse Canyon ditch (V-01114) on left, at start of POU for 2013 map, 180° panoramic looking ~NW. Note alluvial-rich material in foreground with low sagebrush; according to the 2013 map, the right side of photo is claimed as harvest (grain/alfalfa), while the left side is hay; Thompson Ranch is in right distance; note that much of the claimed POU in foreground is topographically even with, or slightly upslope from the springs and could not be watered by them. The 1912 and 1975 maps do not claim any crop-culture in this general area. The light tan area in middle distance is mostly dry mustard weed, where a crop of wheat was attempted in 2016.

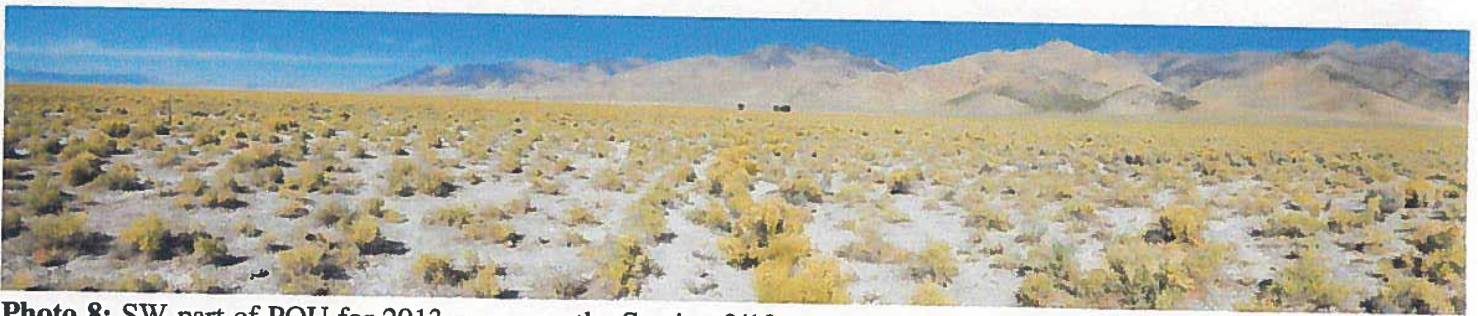
Photo 8: SW part of POU for 2013 map near the Section 9/10 quarter corner; 180° panoramic looking ~NE along former Overland/Pony Express Trail (marked by a linear narrow growth of rabbitbrush in foreground). Most vegetation is now low greasewood growing in alkali-rich soil; Thompson Ranch and former springs with cottonwood trees are in center distance. Entire area in foreground is claimed as hay on the 2013 map; no crop-culture is claimed in this area on either the 1912 or 1975 maps; see Figure 7 photo of same general area for comparison of dominant sagebrush vegetation in the 1960s.

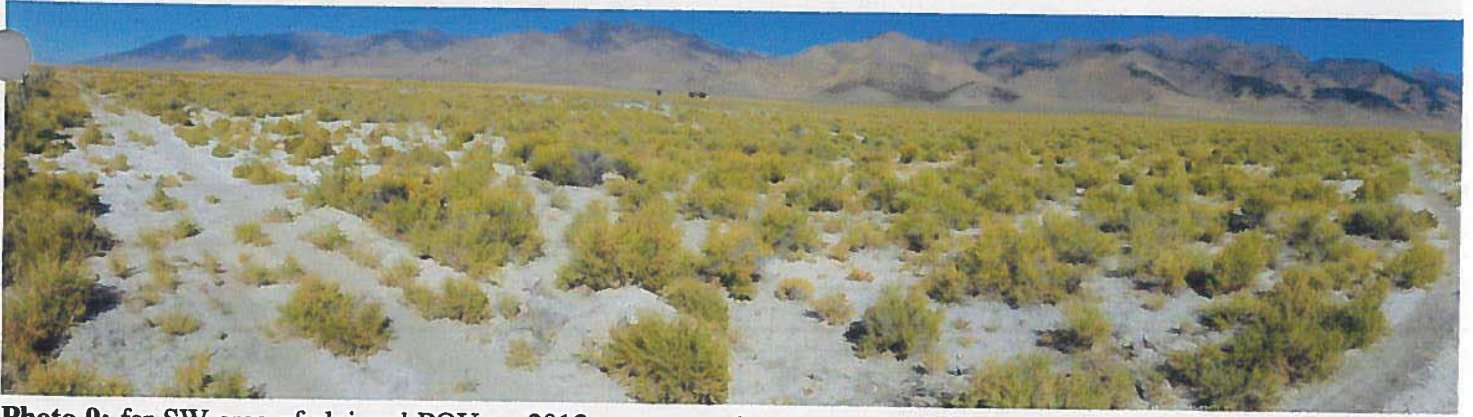
Photo 9: far SW area of claimed POU on 2013 map, near the center of Section 9; ~140° panoramic looking ~NE, Thompson Ranch in center far distance. Vegetation in foreground is mostly 2 ft high greasewood; no crop-culture is claimed in this area on the 1912 and 1975 maps; the right 1/3 of photo is outside of the POU on all claim maps, and shows no difference to the left 2/3's of photo which is claimed as hay on 2013 map; note alkali-rich soil in most of foreground area. North-south fence line and trail at far left edge of photo mark, west boundary of 2013 claimed POU.

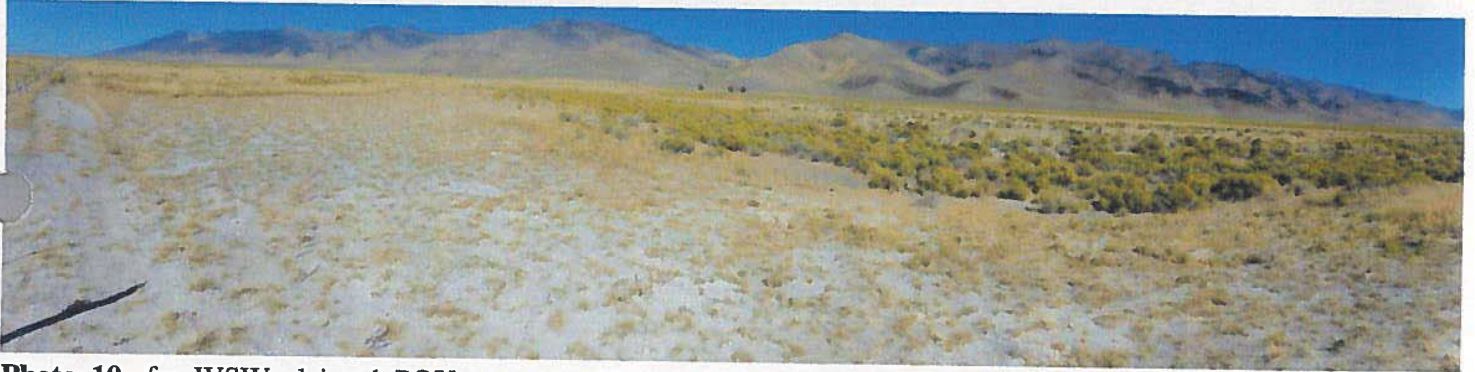
Photo 10: far WSW claimed POU, near the ¼ corner of Sections 4 and 9; ~140° panoramic looking ~NE, Thompson Ranch in center far distance. On 1975 map, area is claimed as diversified pasture ("DP"); on 2013 map, right side of photo is claimed as hay, left side as DP, while no crop-culture is claimed on the 1912 map. Vegetation is moderately dense, 2 ft high rabbitbrush on right in gully area with ~3 ft of relief, and more sparse alkali grasses and other vegetation on left side of photo on slightly higher, elevated ground.

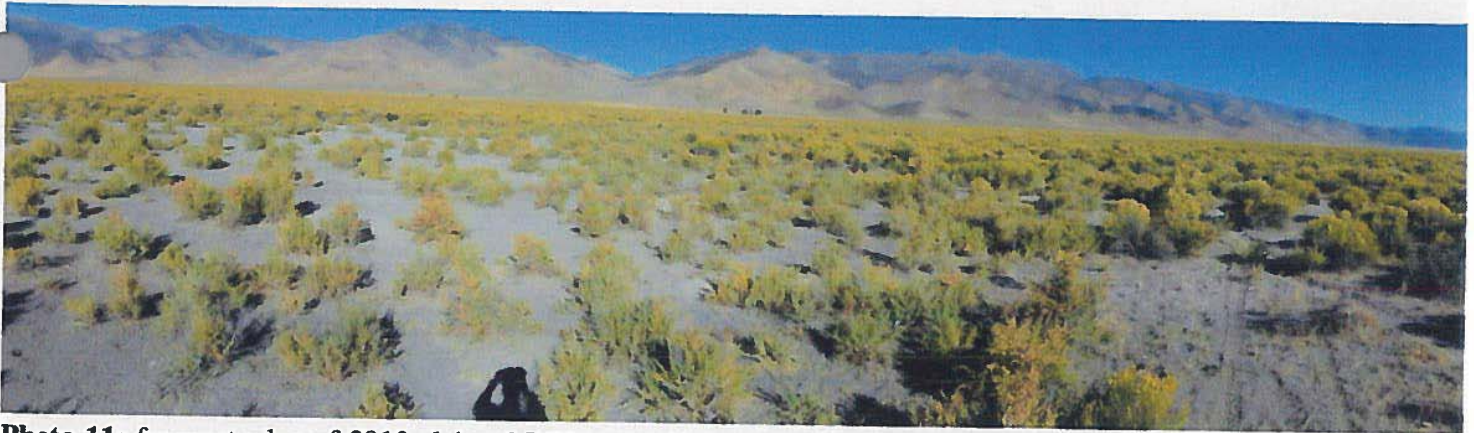
Photo 11: far west edge of 2013 claimed POU, near $\frac{1}{4}$ corner of Sections 4 and 5; $\sim 140^\circ$ panoramic looking $\sim E$, Thompson Ranch in center far distance. Most of 1 square mile to east of photo is claimed as diversified pasture on the 2013 map; no crop-culture is claimed on the 1912 and 1975 maps. Vegetation is sparse greasewood with lesser rabbitbrush; the entire outer west boundary of the Venturacci property along the north-south section line is unfenced in this area.

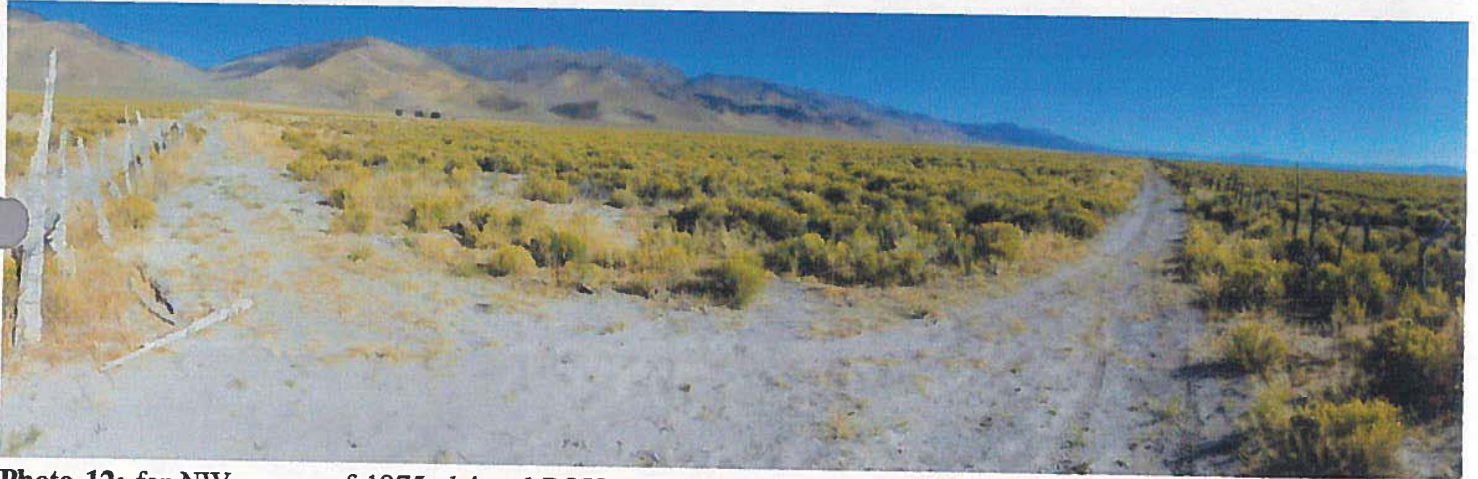
Photo 12: far NW corner of 1975 claimed POU, $\sim 120^\circ$ panoramic looking $\sim SE$, Thompson Ranch left of center. Area is also claimed as DP on 2013 map, while no crop-culture is claimed on the 1912 map. Vegetation is mostly rabbitbrush. Left fence is E/W, right fence is N/S and correspond to the mapped fence lines on USGS topo map in the north center of Section 4.

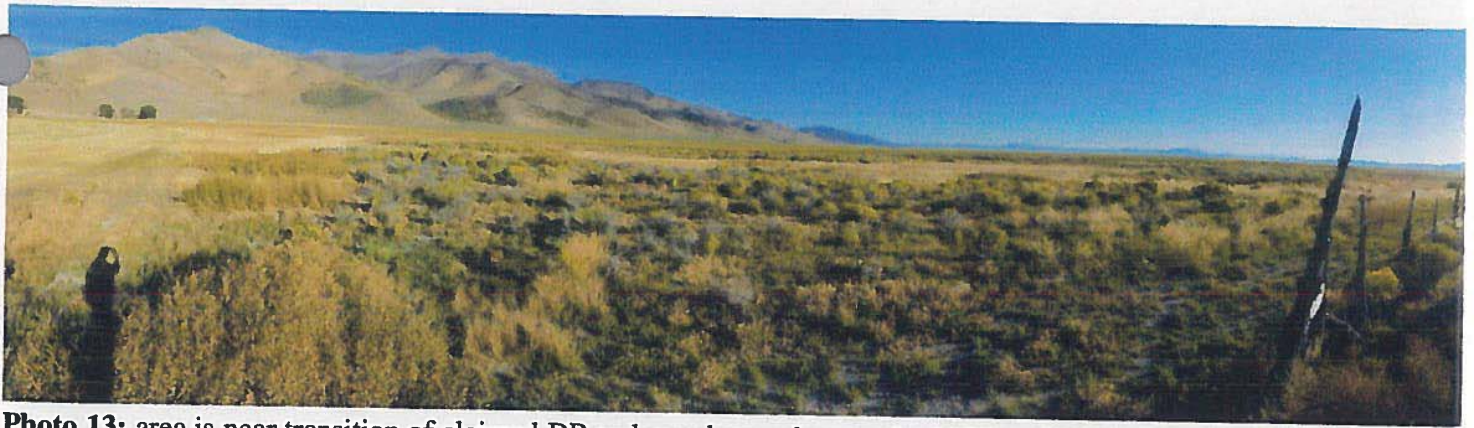
Photo 13: area is near transition of claimed DP and meadow or hay on the 1975 and 2013 maps; ~130° panoramic looking ~SSE, Thompson Ranch on far left side behind edge of new pivot. Most of area in fore- and middle ground is claimed as former meadow on all maps, and lies along the former channel of Taft/Thompson creek, which here per the topo map drains westerly through central portion of photo, and then NW behind photo. Vegetation is mostly mixed grasses and rabbitbrush; cut crop on pivot is triticale.

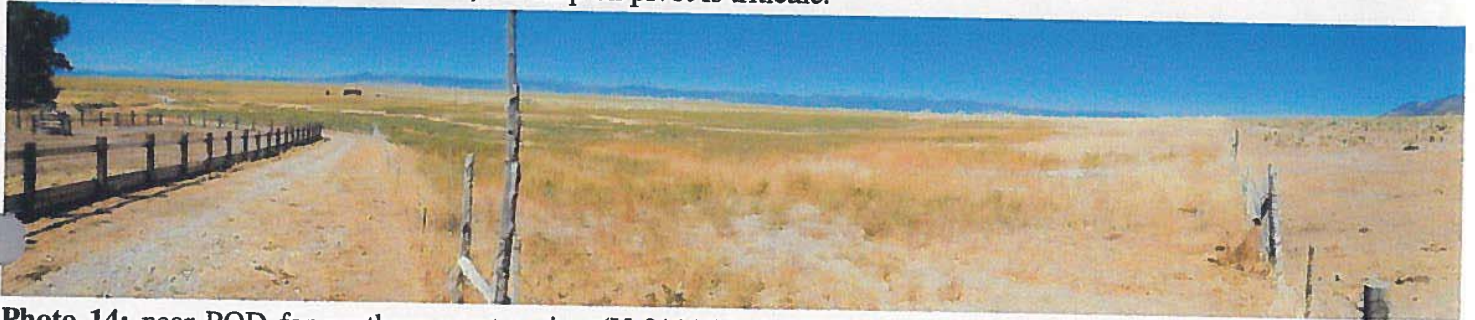
Photo 14: near POD for northern-most spring (V-01115.2, left of photo) at Thompson Ranch, 180° panoramic looking ~WNW; most of area in photo is claimed as harvest (grain/alfalfa) on 2013 map. Much of the claimed POU in immediate foreground and to right is topographically even with, or upslope from the spring source; there is evidence that crops were grown here but water was pumped from the pond, after the Thompsens acquired the property in the late 1940's. The 1912 and 1975 maps do not claim any crop-culture in this area, except for ~12 acres of harvest (grain, garden, alfalfa) in the low-lying area in middle left distance, to right of cottonwood.

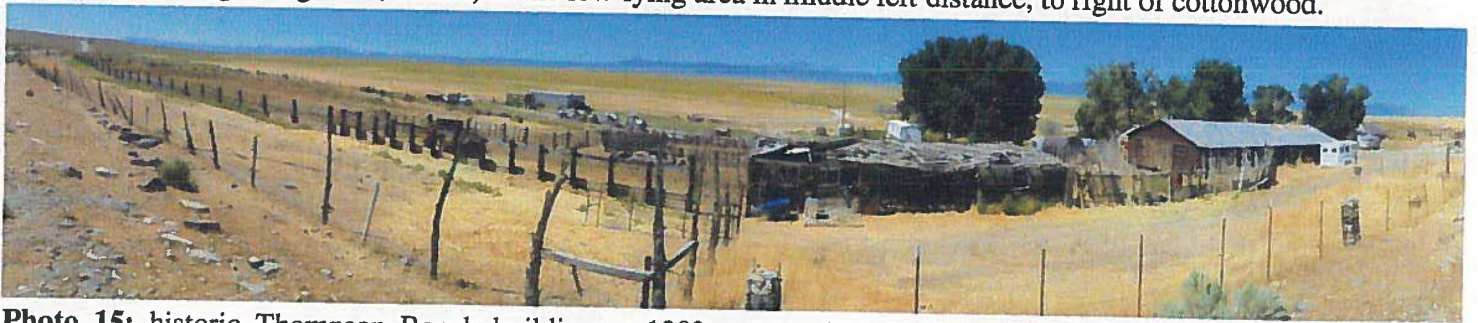
Photo 15: historic Thompson Ranch buildings, ~130° panoramic looking ~WSW; cottonwoods mark former spring area (V-01115.1). Most of area in left foreground and left middle distance is claimed as harvest (grain/alfalfa) on the 2013 map; no crop-culture is claimed in the corresponding areas on the 1912 and 1975 maps; main area of formerly irrigated meadow and hay claimed on all maps is in the central middle and far distance, to left and behind cottonwoods.

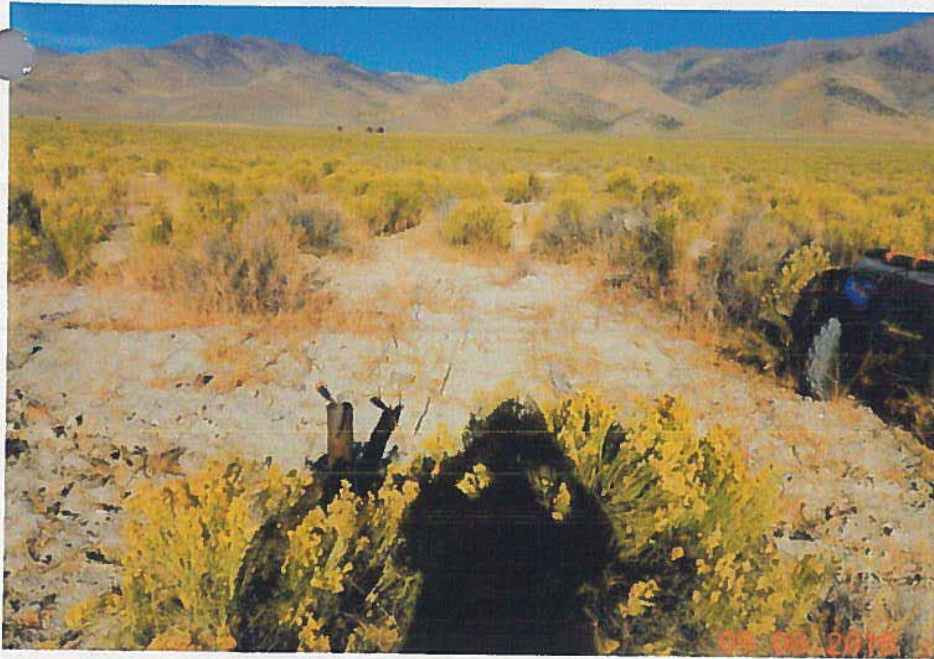
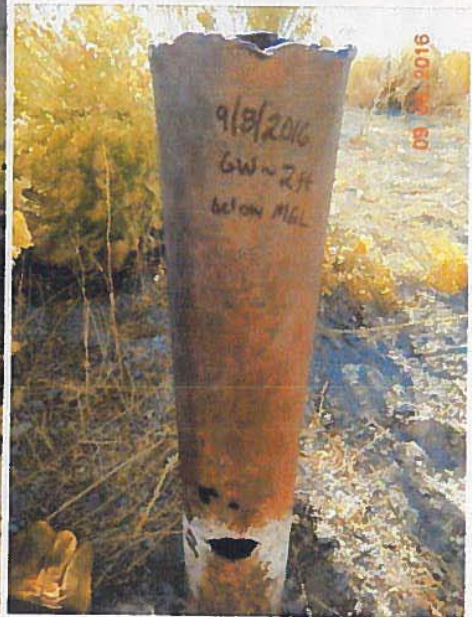
Photo 16: V-10974 (spring, stockwatering), ~2 miles SW of Thompson Ranch buildings; a) 4" steel casing (to left of shadow), with Thompson Ranch cottonwoods in far distance, looking ENE; b) close-up of well casing; depth to ground water was measured at 6.84 ft BMGL (5,778.16 ft) on 6/16/2017; looking SW; note battered nature of top of casing and absence of any trough, excavation or appurtenances.

The claimed point of diversion was visited on September 8, 2016 and again on June 16, 2017, and is located about 2 miles southwest of the Thompson Ranch, approximately 200 yds north of the former Overland and Pony Express trail (Photo 16, Figure 8). No flowing spring or trough were found. However, a 2 ft high, 4” diameter steel well casing with a 1½” diameter hole about 6” above ground level was found. Static ground water in the casing was measured at a depth of 7.84 ft BMGL (5,778.16 ft) on June 16, 2017. The approximate 2 ft high steel casing was uncemented and appeared to be hand-driven based on the battered top of the casing; the steel looked to be many decades old. No excavation near the casing was seen, and it appeared that when there was artesian water flowing in previous years, it merely flowed

through the hole in the side of the casing directly onto the ground surface, without the benefit of an excavation or trough. There is a mapped spring on the 7½ minute USGS topographic map at this location. It is possible that there was a spring at one time, but it has since ceased flowing for similar reasons as the Thompson springs, and the steel casing may have been driven into the spring to enhance its flow and to use the water. However, it is more likely that it is an older, pre-1970s seismic survey shot hole that the 4" casing was driven into for stockwatering, in a similar manner as for Application 44780 ("Bend Well"), which was cased by the Thompson family in the 1950s. (The well under 44780 is a similar looking, hand driven steel casing into a "spring" mapped on the USGS topographic map, but which originated as a seismic shot hole.) It is troubling that the information filed with the proof in regards to the description of both the works and water source, could not be verified by the field investigation. This site is suitable for groundwater monitoring purposes and should be added to the Diamond Valley well net.

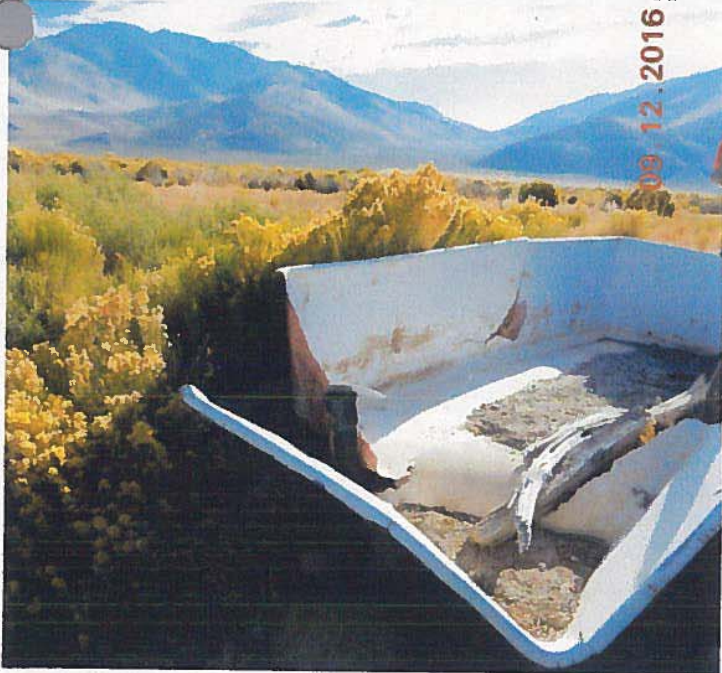
Photo 17: former artesian well (4" black PVC casing with hammer head, left center) and tub stock trough, looking east. Water was measured at 9.87 ft below the top of the casing on 9/12/2016, or a corrected water level elevation of 5,787.63 ft; the well last reportedly flowed ~2008. Telegraph Canyon and Overland Pass are in the center distance.

Unnamed Artesian Well, Thompson Ranch - A former artesian well was visited with Mr. Venturacci on September 12, 2016, and is located about 1 mile WNW of the Thompson Ranch in the SE¼NE¼ Section 4, T23N, R54E (N39.90635°, W115.88476°). The casing consists of a 4" diameter, thick walled uncemented black PVC pipe, with an adjacent small bathtub, which served as a stock watering trough at one time (Photo 17). A static water level measurement with an E-tape, measured water 9.87 ft below the top of the casing, for a corrected groundwater elevation of 5,787.63 ft. A similar depth to possible groundwater was measured on 4/12/2017, but the casing appeared bridged more or less at that depth and could not be sounded deeper.
