NEVADA DIVISION OF WATER RESOURCES

FIELD INVESTIGATION REPORT

DIAMOND VALLEY (BASIN 153) ADJUDICATION

ROCK & BOX SPRINGS CANYONS, EUREKA COUNTY, NV

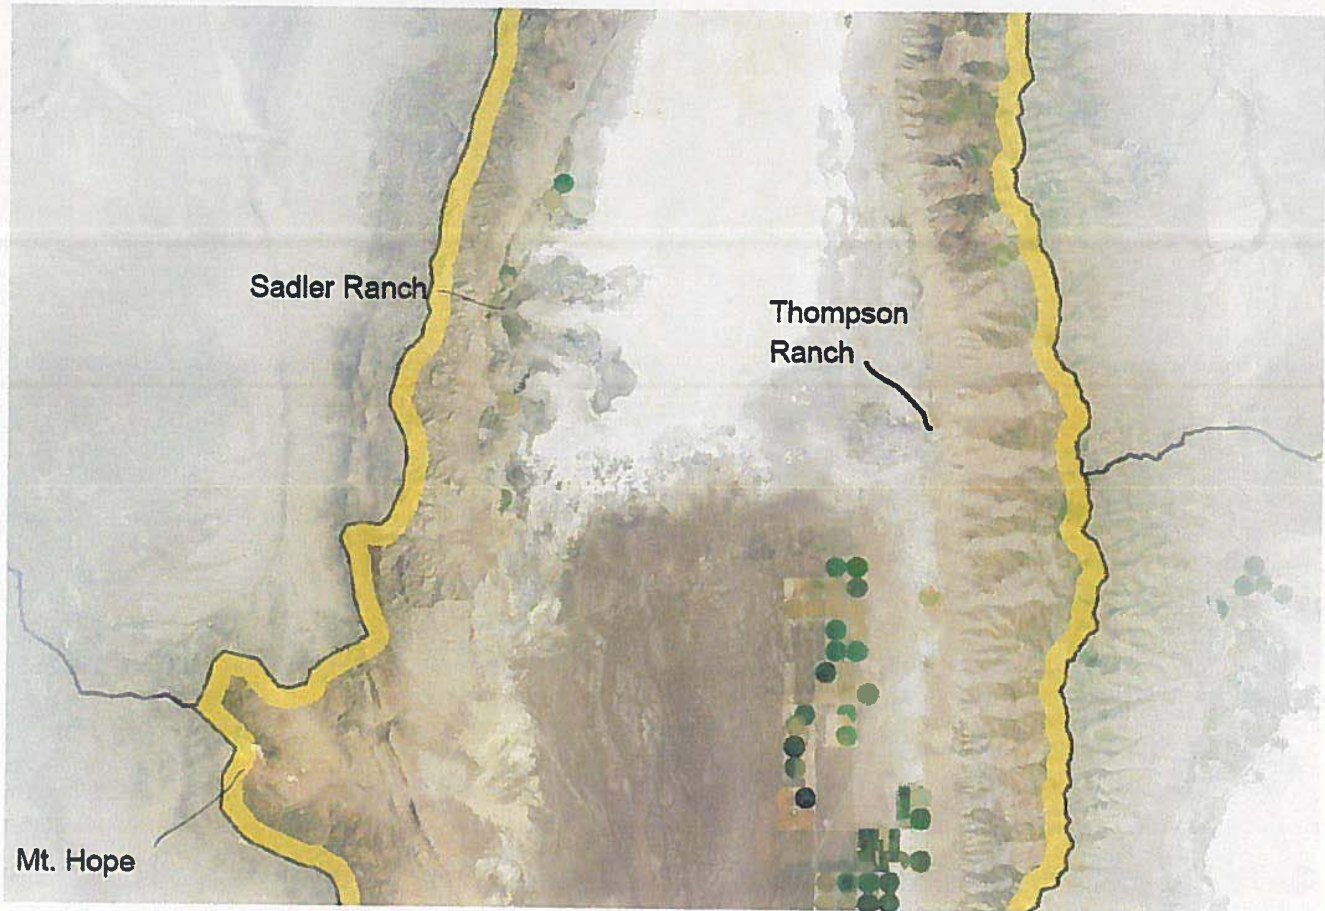
Figure 2 – Enlargement of 2015 NAIP image, north-central portion of Diamond Valley. Mau Ranch and Box Springs Canyon are located 6 miles north of Thompson Ranch; scale is two center pivots equal approximately 1 mile.

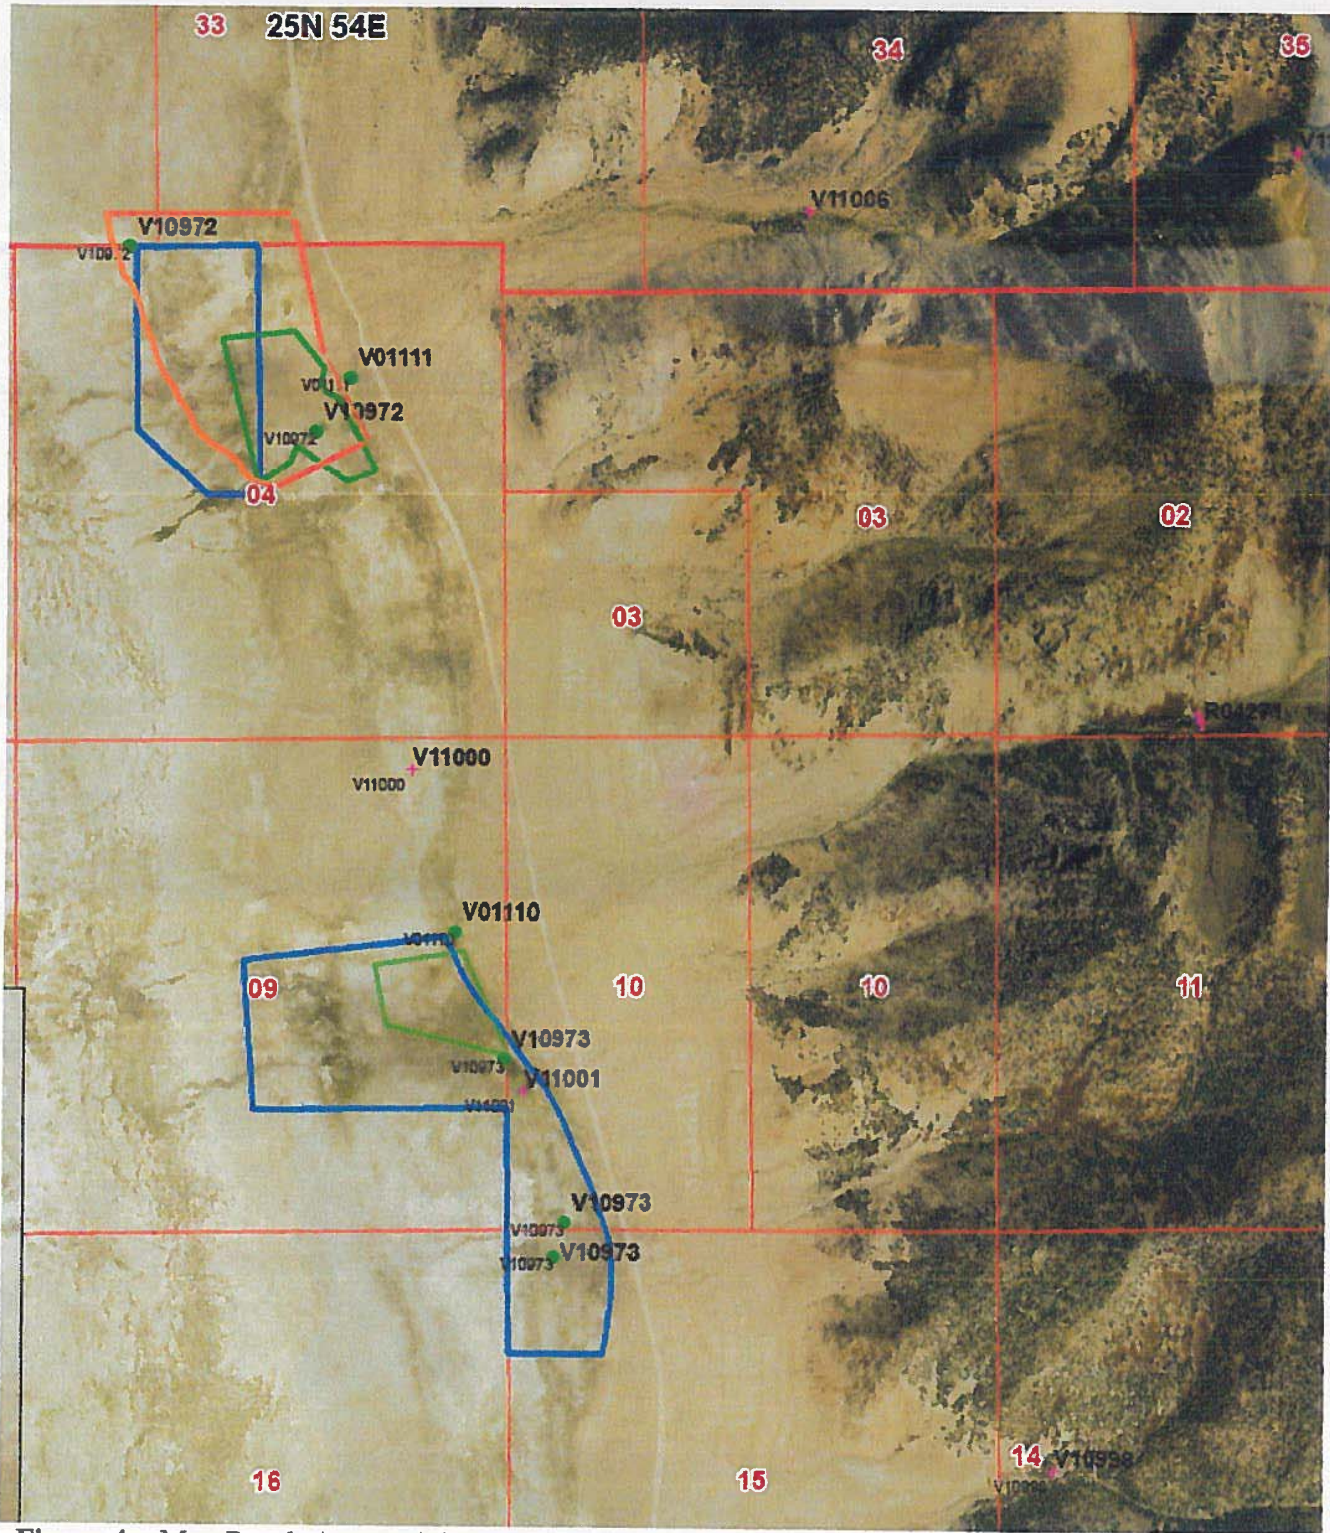
Figure 4 – Mau Ranch Area aerial map, showing locations of PODs & POU. Rock Canyon field in east center of Section 9 and POU of V-01110 (green outline), with POD near NE corner of POU, is enclosed by V-10973 POU (blue outline). One mile to the north is main Mau Ranch; POU of V-01111 (green outline) in NE portion of Section 4, is mostly enclosed by POU of V-10972 (orange outline); blue outline is certificated POU of Permit 2441 from Davis Canyon Creek.

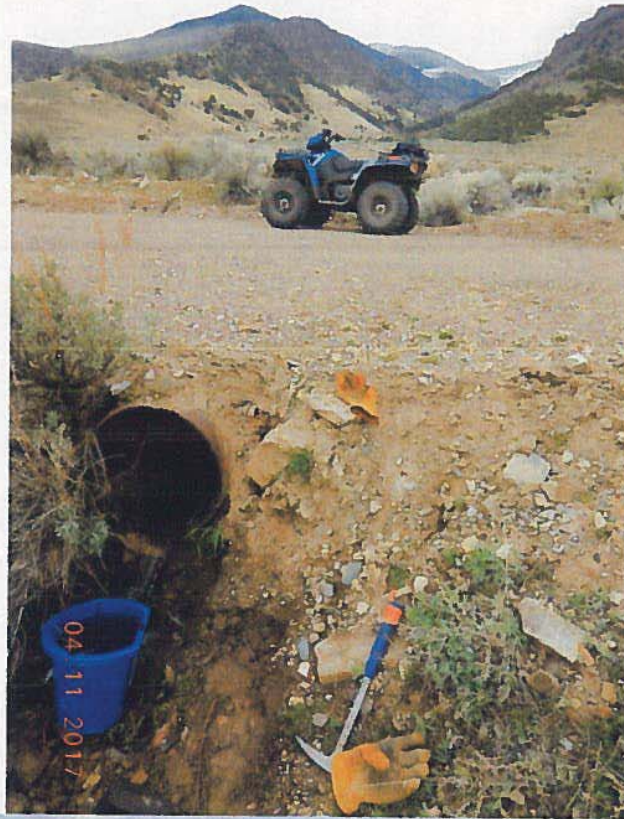
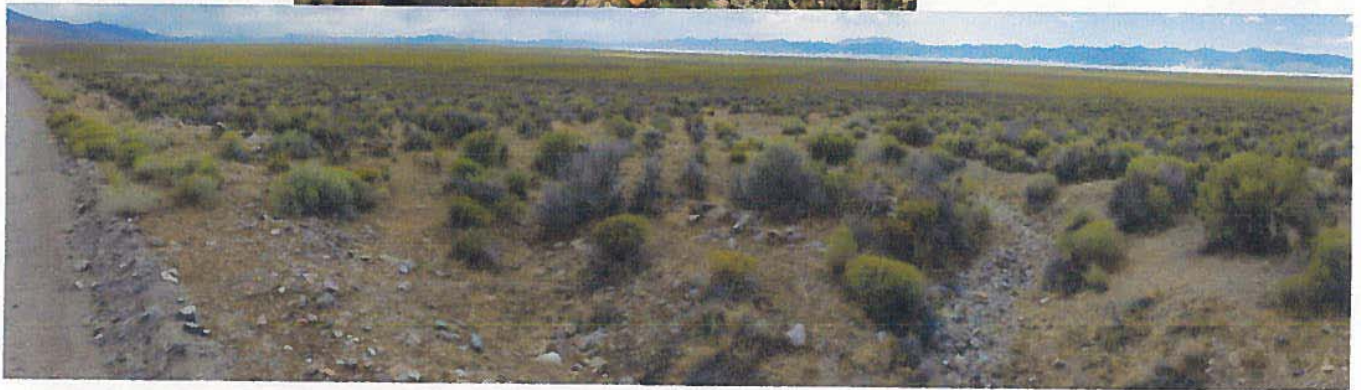
Several flow measurements are available for the sources of interest, and are summarized in Table 1. A flow measurement on Rock Canyon was made on April 11, 2017, at the culvert along the county road, about 300 yards above (east) of the claimed POD for V-01110 (Photo 1a). A flow rate of 22.5 gpm was measured by direct methods (3 gallon bucket and stop watch). On May 1, 2017 flow was estimated at approximately 5 gpm. On several other visits in May and June, as well as on September 11, 2016 there was no flow and the channel was dry (Photo 1b). It is apparent that flows in Rock Canyon to the POU are mainly limited to the freshet period from melting snow, and it may be classed as a smaller intermittent drainage. The spring areas claimed under V-10973 were visited in September 2016, and April 2017, and were not flowing at either time and there was no evidence of any recent flow (Photo 3).

Recent examination of the POD and POU for the Rock Canyon field area (V-01110) shows a fairly well defined natural channel, and a 50-100 ft wide zone of gravel and smaller cobbles near the lower portion of the alluvial fan, west of and below the county road (Photo 1b), indicating considerable water flow. Near the claimed POD, there is a NW-SE fence line where the east highline ditch would be located. A few signs of a former unmaintained ditch could be surmised, along with pieces of historic (pre-WW II) farm implements (steel tire from hay crane). The north-bounding ditch per the claim map coincides with the main drainage channel, rather than a well-maintained ditch. There is approximately 20-25 acres of unmanaged, mostly cleared land near the claimed POU for V-01110, which in September 2016 had been heavily grazed by cattle; some remnants of alfalfa were seen in the grazed forage. Rabbitbrush and lesser amounts of sagebrush occur outward from the main portion of the claimed POU, as well as some smaller clusters and other scattered plants within the POU (Photos 2a-b).

Photos 1a & 1b – 1a (upper) Rock Canyon flow measurement site at county road, looking ENE; site is several hundred yards east of the claimed POD for V-01110. Flow measured at 22.5 gpm on 4/11/2017 using a 3 gallon bucket and stopwatch; flow estimated at 5 gpm on 5/11/2017. There was no flow and the channel was dry on later visits, and in September 2016. **1b** (lower) Rock Canyon channel and POU from county road and flow measurement site, ~120° panoramic looking SSW on 9/11/2016. The POU of V-01110 is in middle distance in right portion of photo below darker vegetation and break-in slope. The PODs and southern portion POU for V-10973 is in left portion of photo in middle distance below break-in-slope; main north portion of its POU encompasses the area claimed under V-0110, as well as ~¼ west in distance. The only flowing surface water throughout this area is from Rock Canyon during the spring freshet.

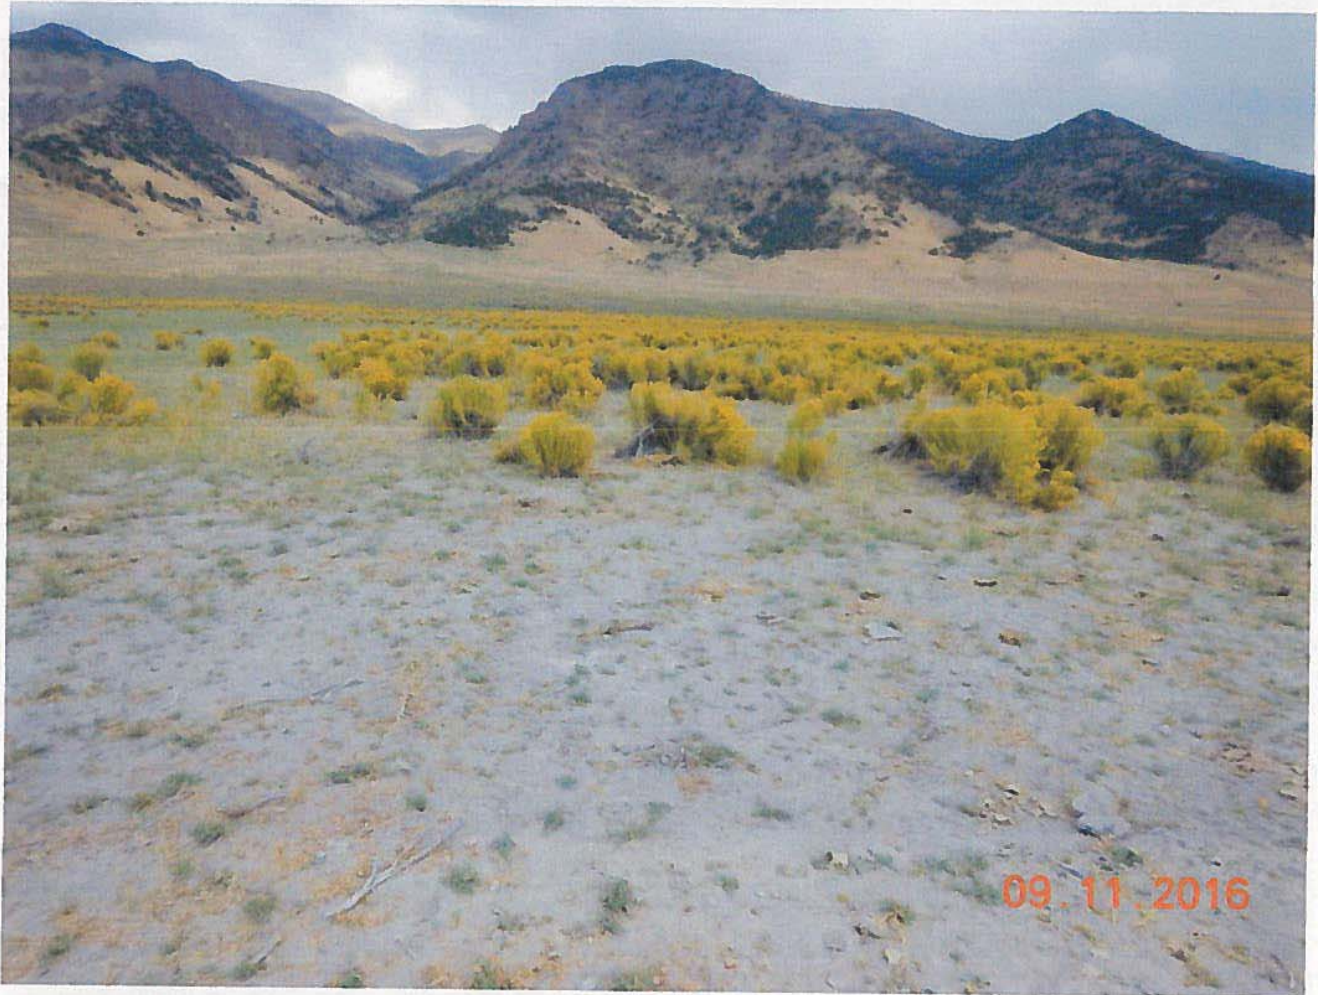
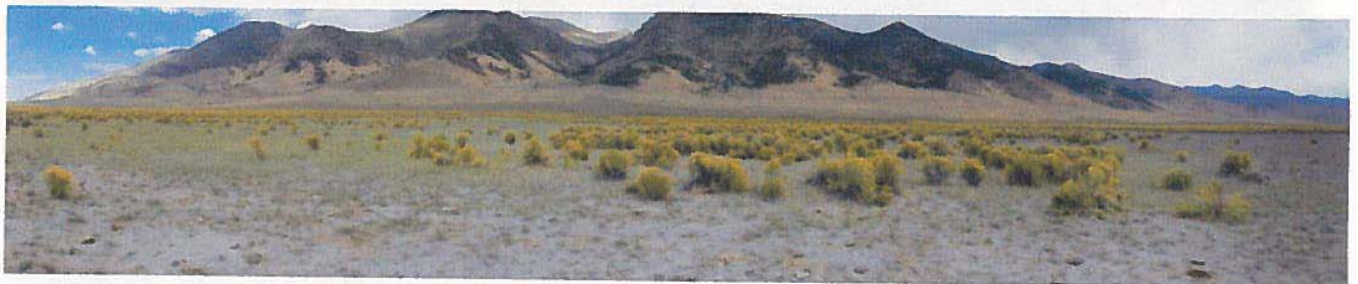
Photos 2a & 2b – 2a (upper) Photo from NW corner of claimed POU of V-01110, looking east, showing typical heavily grazed land with rabbitbrush, and lesser sagebrush and grasses. Rock Canyon is the largest canyon, left of center. **2b** (lower) ~160° panoramic looking east from same location as 2a, of main portion of POU in center of photo taken on 9/11/2016; central and southern portion of POU of V-10973 and PODs are in right ~1/3 of photo, with the three claimed springs located along the base of the alluvial fan in middle to far distance.

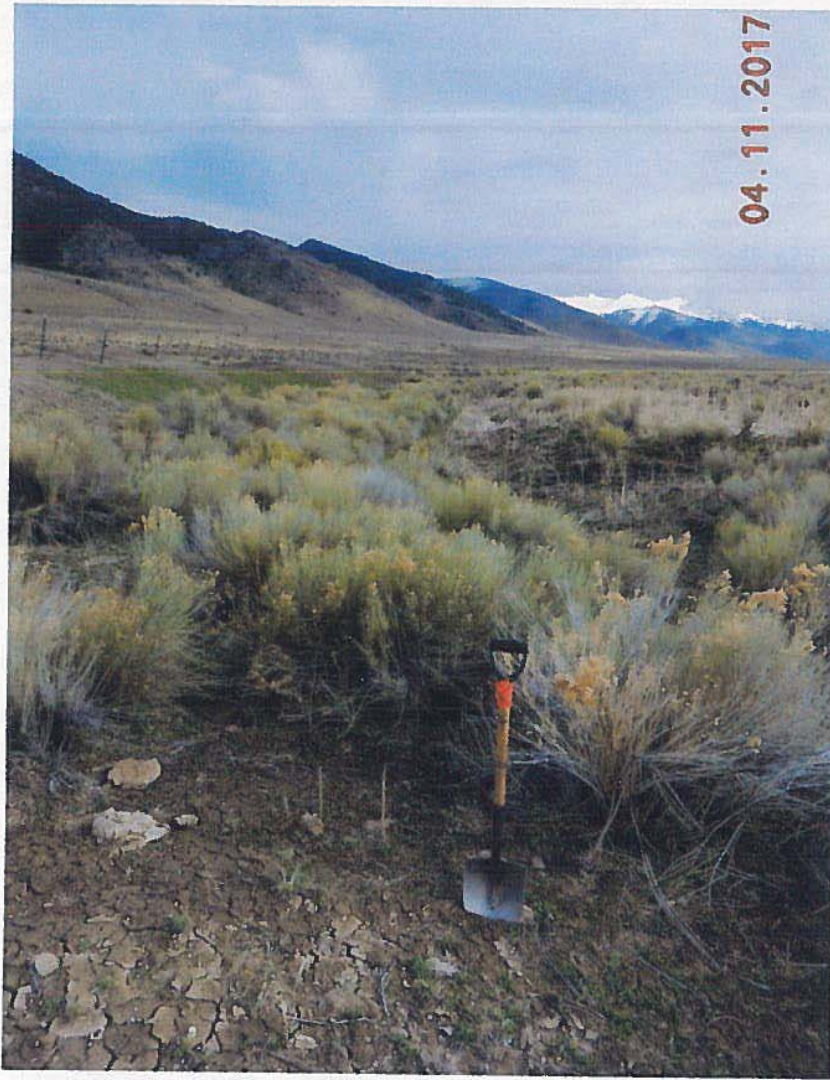
The three spring PODs for **V-10973** roughly correspond with springs mapped on the USGS 7½' topographic map. The northern, lower spring occurs near the SE corner of the claimed POU of V-01110. There is a circular depression approximately 50 ft in diameter associated with it, along with about 1 acre of grassland; a probable excavated trench several hundred feet long extends to the SSE to a former spring claimed for stock under V-11001 (Photo 3). It is difficult to determine to what extent these northern spring areas have been modified by human excavation versus natural events, but regardless none appear to have been developed for irrigation and were more

Photo 3 – Area around north claimed spring POD for V-10973, looking SSE. Former spring is located near the southeast corner of the POU of V-01110. South portion of claimed POU for V-10973 extends from this photo for ~3,000 ft to right of break-in-slope, in right lower portion of photo. There is ~100 yard trench-like feature above shovel, and a fenced linear spring-like, dry depression to the left.

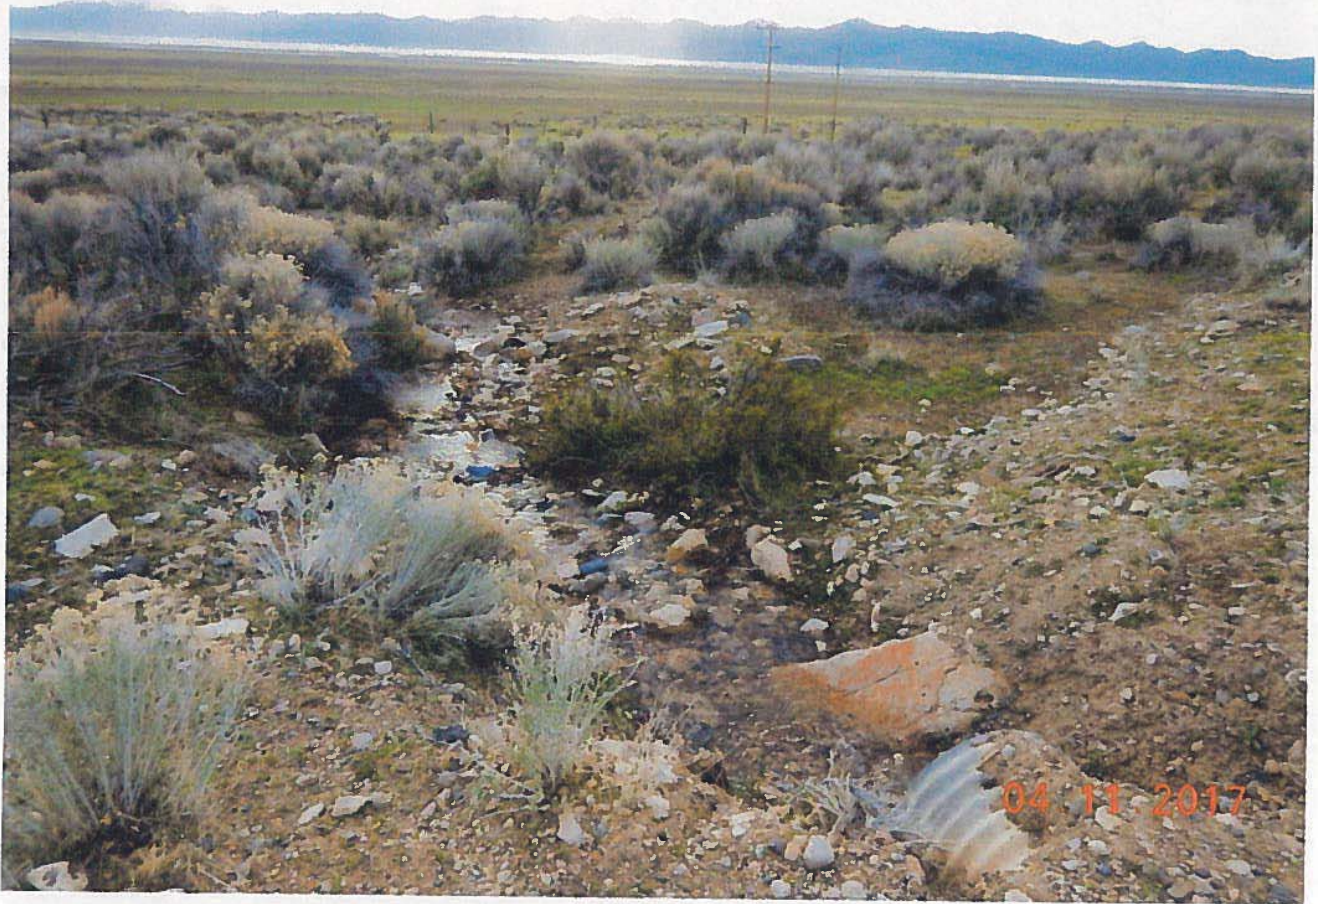
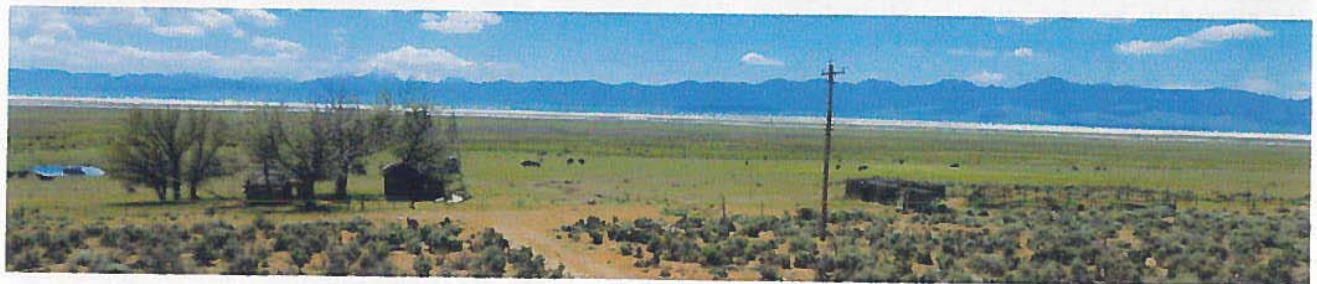
Flow in Box Springs Canyon was measured in the main channel near the Mau Ranch buildings and claimed POD for V-01111, just below (west) of the county road. On April 11, 2017 the flow was measured at 48 gpm using a 90° V-notch weir (Photo 4a). On May 1, there was no flow at the county road crossing, but portions of the channel were moist and likely flowed earlier in the day. Subsequent visits in May and June, as well as in September 2016 the channel was dry and there was no evidence of any recent flow. Box Springs Canyon may be classed as a moderate-size intermittent drainage, similar to the Telegraph Canyon drainage near the Cox Ranch. The upper (south) spring claimed under V-10972 is an oblong depression, approximately 40 ft wide by 150 ft long, with 10-15 ft of relief. On September 11, 2016 the depression was mostly dry, with some partially muddy areas, as well as several small clusters of 2-3 ft high tules. On April

Several buildings and other structures are still standing at the Mau Ranch (Photo 4b). Along the immediate east side of one of the historic wooden dwellings is a possible former hand dug well, which is rock lined and approximately 6 ft by 6 ft in size. This structure is now mostly filled in by dirt to within 2 ft of ground level, and several modest-size silver poplar or similar trees are growing within it.

Photo 4a & 4b – 4a (upper) Box Springs Canyon drainage at county road, looking west. POD for V-01111 is just west of culvert; a flow rate of 48 gpm was determined using a 90° V-notch weir on 4/11/2017. Northern portion of POU for V-01111 is in middle distance; POUs of V-10972 and Permit 2441 from Davis Creek are further west and in upper right. **4b** (lower) Cropped photo looking west, of main Mau Ranch area and most of POU of V-01111, taken 5/25/2017; Box Springs Canyon flow measurement site (Photo 4a) is ~100 yards to right of photo. South (upper) spring for V-10972 (Photos 5a-b) is just left of trees. POU for V-10972 encloses most of that of V-01111, and includes areas ¼ mile or more to the west and north. The possible former hand dug well is located on the east side of the building on the far left.

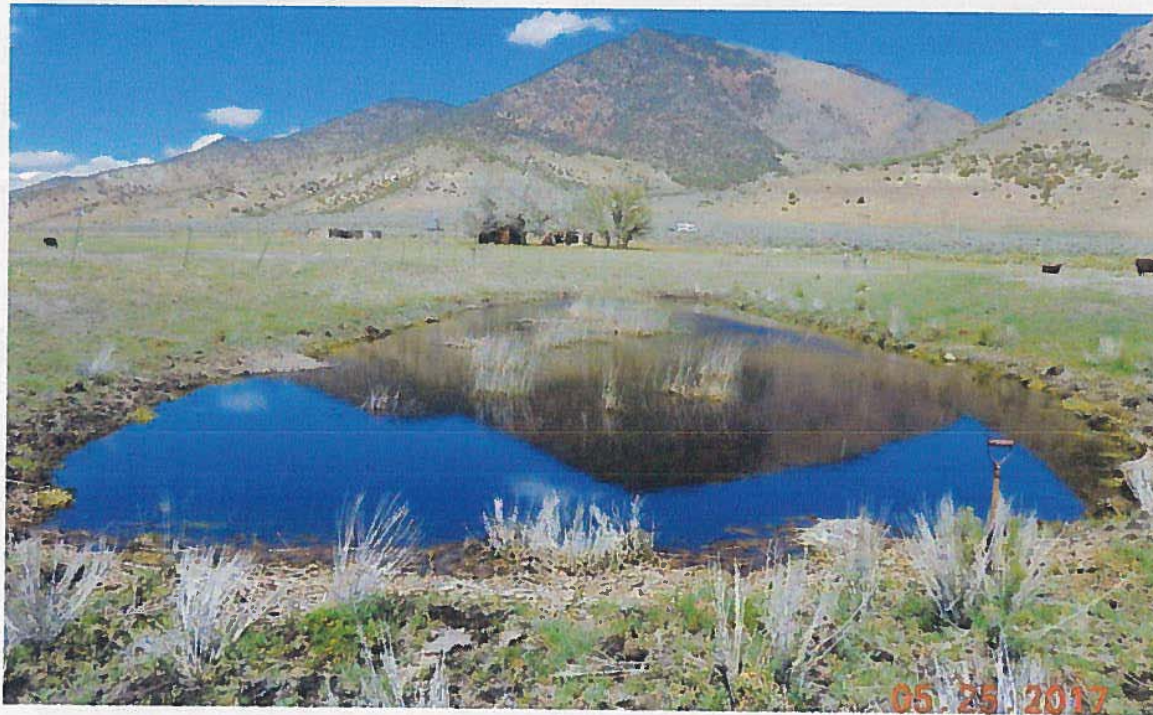
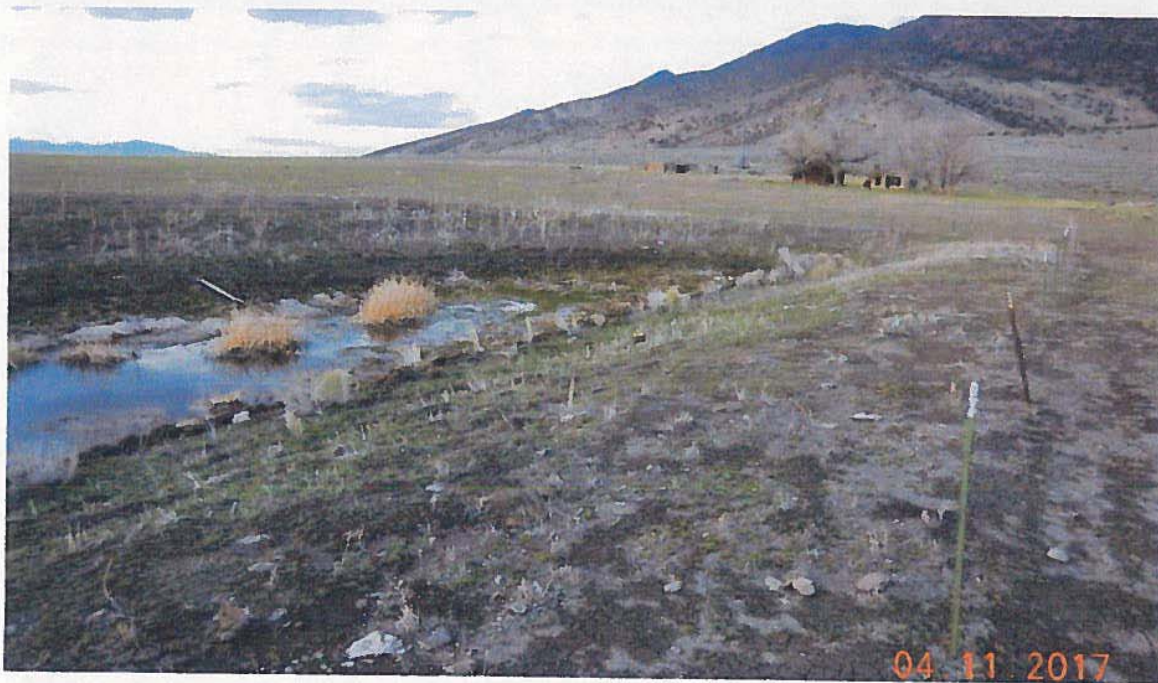
11, 2017 there was some standing water several inches deep and mud in the lower part of the depression (Photo 5b). On May 25, 2017 much of the depression was filled with water 6" to 1 ft deep (Photo 5a); there was likely some flow ($\leq 1-2$ gpm), but it could not be measured due to the low gradient and lack of an outlet. Based on these visits and conversations with Mr. Venturacci, it is apparent that much of the water recently observed in the spring is from subsurface flow from the Box Canyon ditch and natural channel, which drains SW toward the depression. There was likely a greater groundwater component to the spring flow before intense underground pumping of Diamond Valley, as a photograph by M. Thompson from April 1961 shows that water filled most of the depression, and was likely 3-5 ft or more deep then.

For the upper (south) spring POD claimed under V-10972 (Photos 5a-b), no evidence of any works of diversion, outlet or ditches were found extending from the oblong depression to the claimed POU, a significant portion of which would be uphill of the POD. Before intense underground pumping of the basin, the spring may have subirrigated a small area in its vicinity, in a similar manner as was postulated for the former springs on the Cox Ranch (V-02546). The south spring could also have been used for stock watering at one time, though the depression is

Photo 5a & 5b – 5a (upper) Shallow spring pool for south (upper) spring claimed under V-10972, looking NE. Flow is unmeasurable, but on this date was likely $\leq 1\text{-}2$ gpm, and is mostly due to recharge from Box Springs Canyon. POU of V-01111 encompasses all of foreground area and middle distance to abandoned ranch buildings. Note lack of outlet or ditch from the spring. **5b** (lower) same location as Photo 5a, looking NNE; flow is likely < 1 gpm and the spring was not yet recharged by Box Springs Canyon.

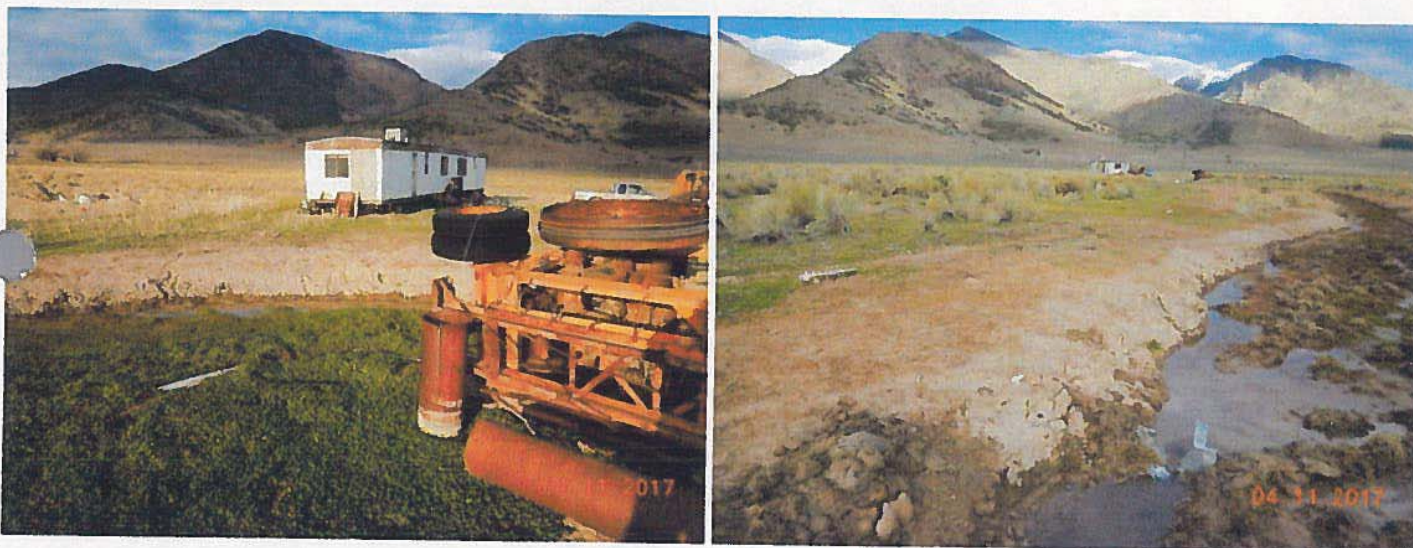
Unpermitted Well & Permit 29862 – An unpermitted 16” cased artesian well is located in the NW¼SE¼ Section 4, approximately 700 ft SSW of the south spring claimed under V-10972, and about 400 yards SSW of the abandoned Mau Ranch buildings. A recently occupied single-wide trailer is located immediately northeast of the well, and a drill rig is tipped over at the wellhead (Photo 6a). According to Milt Thompson, the well was drilled in 1979. The well likely corresponds to abrogated irrigation Permit 29862, and well log 20517; recent use has been for domestic and stock watering. Static water level was measured at 3.39 ft below the top of the casing, or at 1.89 ft below mean ground level, equating to an elevation of 5,792.11 ft on April 11, 2017; water temperature was 57°F. Water quality is likely good based on abundant watercress in the immediate discharge area. A flow measurement site was established 85 yards WNW of the wellhead, and a flow rate of 10.6 gpm was determined using a small 60° V-notch weir on the same date (Photo 6b). The well should be added to the Diamond Valley wellnet and flow rates monitored.

Photos 6a & 6b – 6a (left photo) Unpermitted artesian well likely drilled under abrogated Permit 29862², looking NE; 6b (right photo) nearby downstream flow measurement weir site, looking ESE.
