Walker River Basin Assessment

Prepared For
U.S. Fish and Wildlife
Service
Lahontan National Fish
Hatcheries Complex
1340 Financial Blvd. #234
Reno, NV 89502

January 6, 2009

Prepared By
Otis Bay
Ecological Consultants
PO Box 929
Verdi, NV 89439
www.otisbay.com

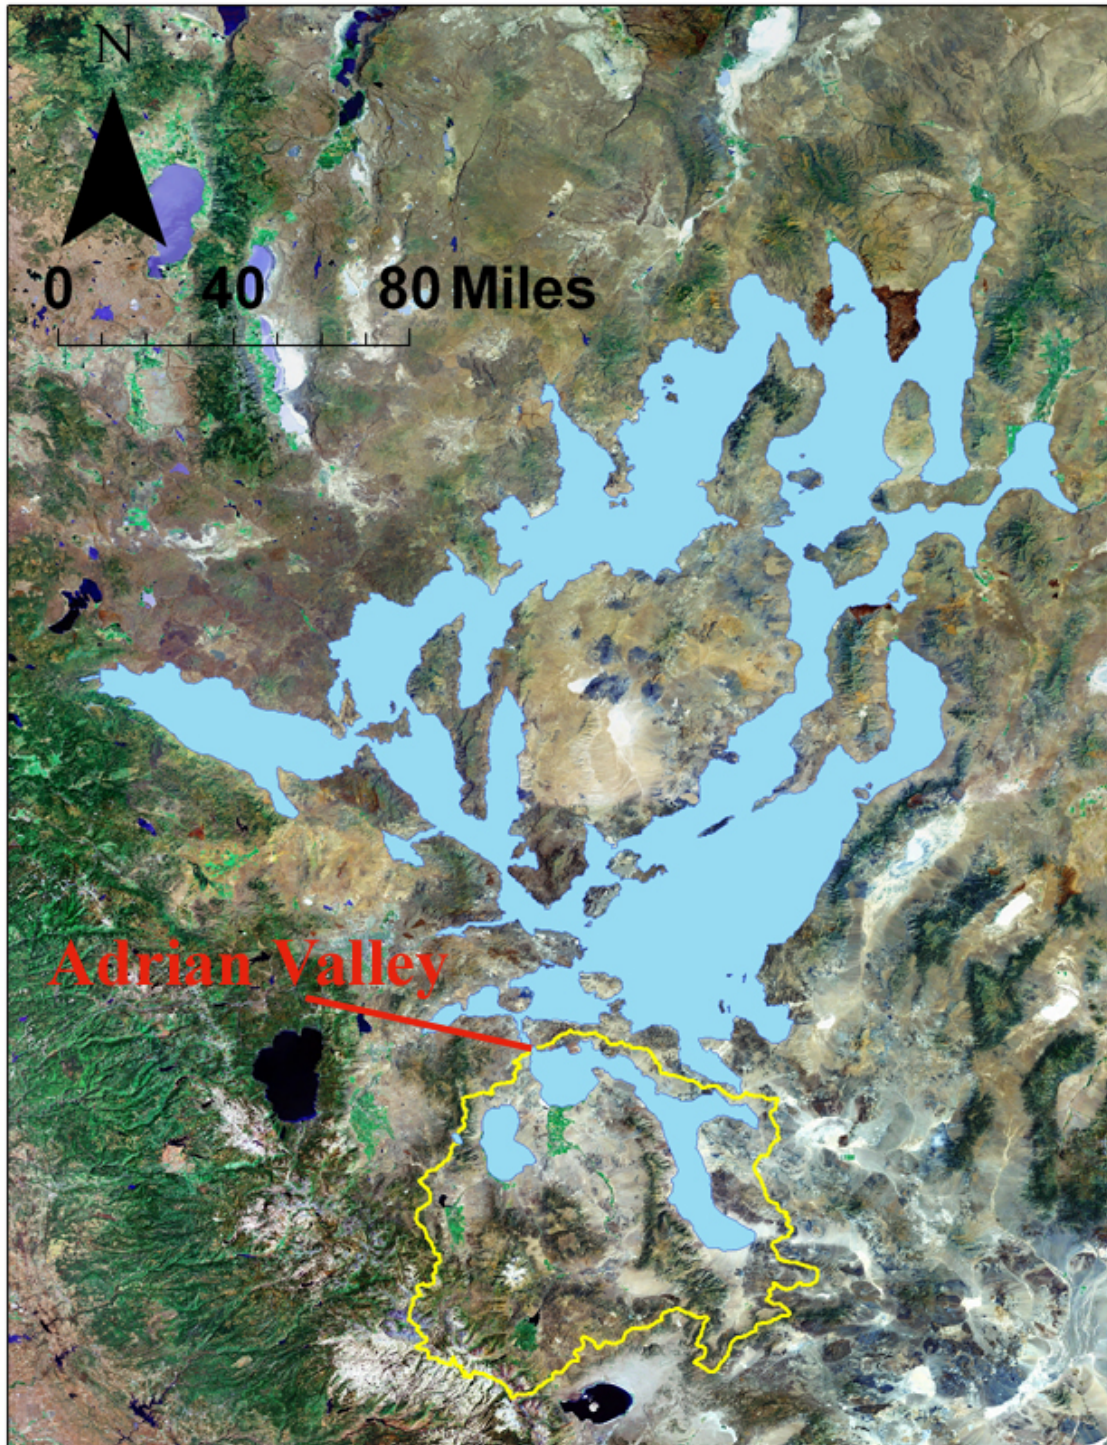
Figure 2.1-6. Geographical extent of the high-stand of the Lake Lahontan system. The Walker River Basin is outlined in yellow. The point of connection of Walker Lake to Lake Lahontan, as well as the potential point of diversion of the Walker River into the Carson Basin at Adrian Valley is noted. (Adapted from the Keck Library website of the University of Nevada Reno, <ftp://nas.library.unr.edu/keck/31301GBGEOS/gbgeoscience/pluvialutm.zip>)

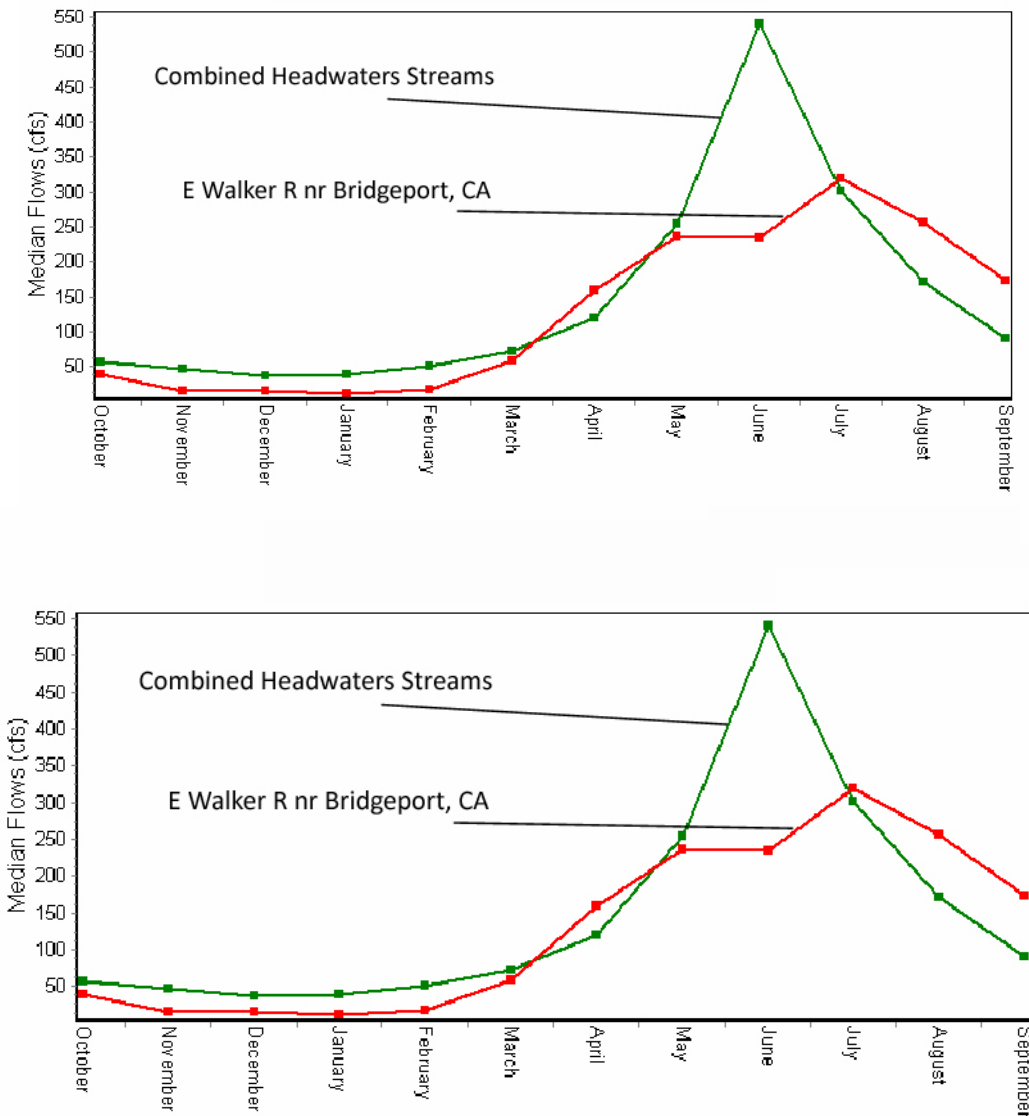
Figure 2.1-28. Comparison of monthly mean discharge values for the combined headwaters streams against the Bridgeport gage and against the gage above Strosnider ditch on the East Walker River. Note the reduction in peak discharge, and the increase in flows on the declining limb, and the reduction in winter base flows with similar patterns for both gages downstream of the reservoir.

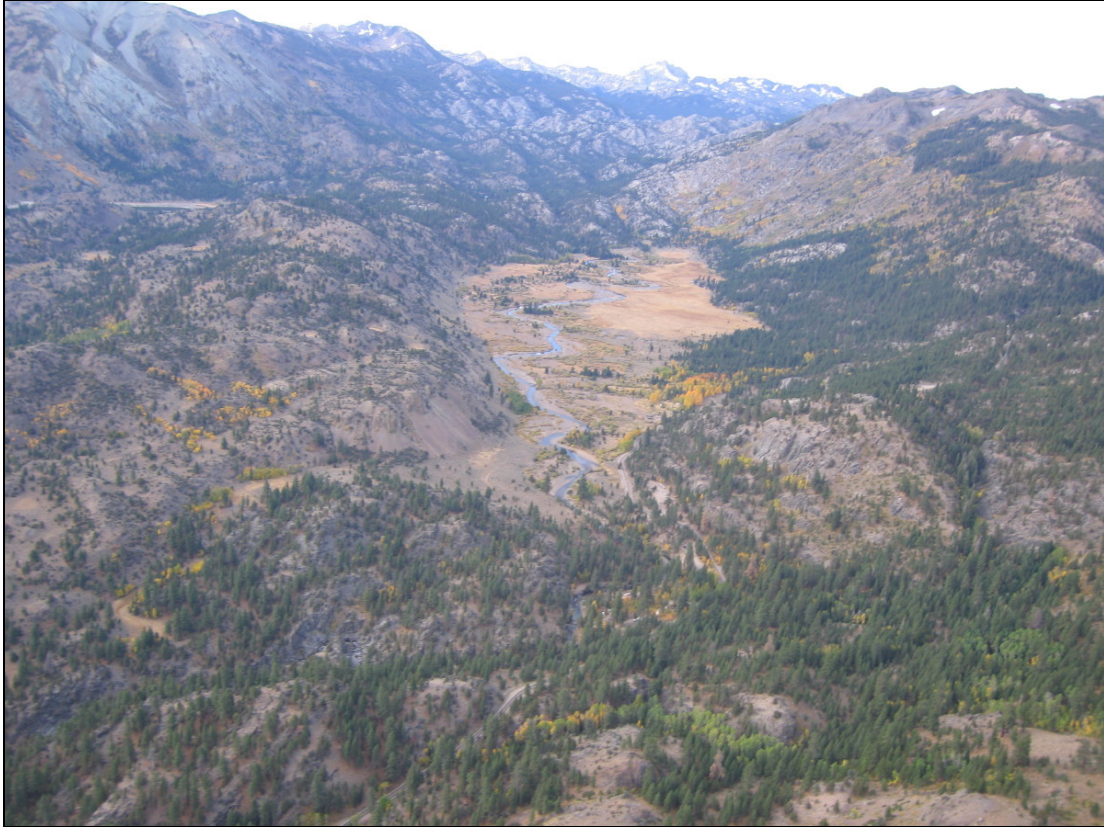
Figure 2.1-36. Oblique aerial photo of Leavitt Meadow on the West Walker River with a view looking upstream toward the crest of the Sierra Nevada. The photograph illustrates the alternate valley-canyon morphology typical of segment WW2.

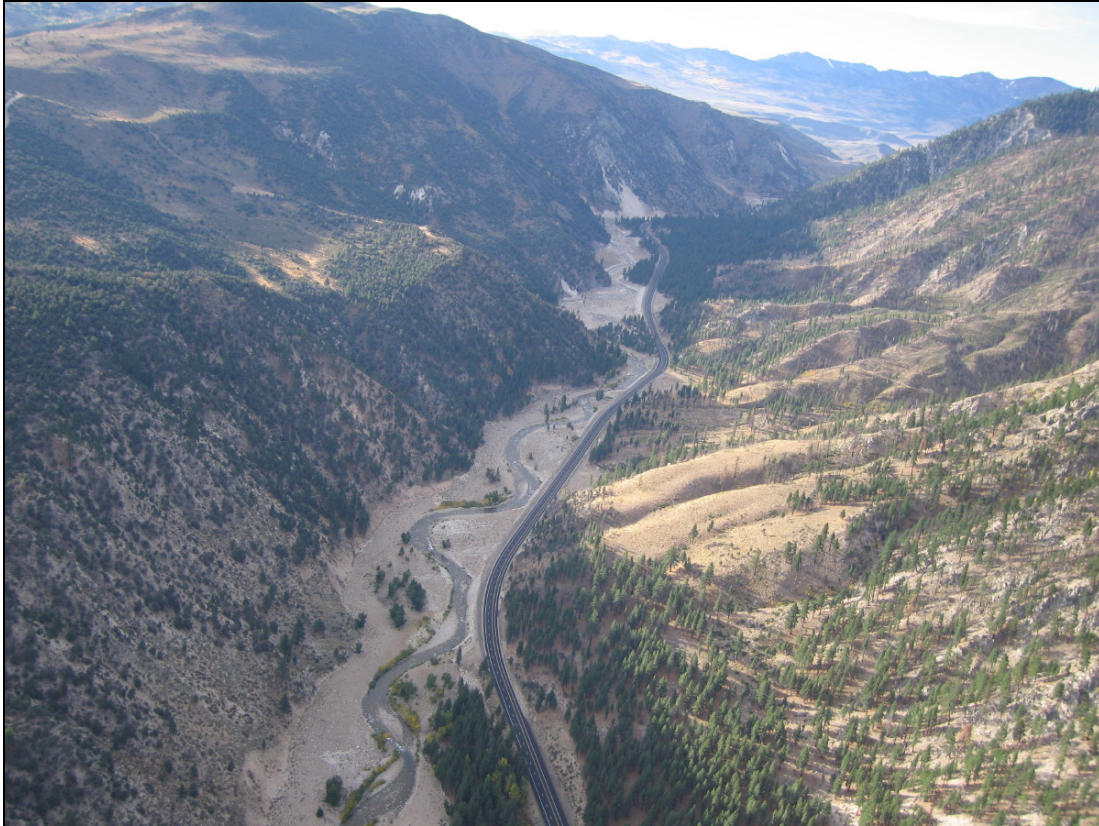
Figure 2.1-37. Low elevation oblique aerial photograph of the West Walker River in segment WW3. The view is looking upstream toward the crest of the Sierra. The photo captures the narrow valley confinement and direct hillslope connection to the channel in many locations.

WW3 begins just downstream of the West Walker's confluence with the Little Walker River. Here, the river enters a high gradient canyon with the Sierra Nevada to the west, and the Sweetwater Range to the east (Figure 2.1-37). The canyon is structurally controlled by the West Walker River fault zone (Sawyer, 1995). This fault zone is a region of down-to-the-east normal faults with recent (< 20 ka) movement. The canyon width and the Highway 395 roadway laterally confine the river in this segment. The bed substrate within this segment is composed mainly of coarse material ranging from gravel to boulder. This material is organized into reaches that are dominated by gravel and cobble and have pool-riffle morphology, and reaches that are dominated by coarser cobbles and boulders and have step-pool or boulder cascade morphology. Lower gradient reaches within the segment are accumulation zones for gravel and contain some large gravel bars. Hillslope material is often deposited directly into or very near the stream in this reach creating potential sediment sources. Following the flooding of 1997, significant channel and bank modification took place within the segment. In some areas stream banks were rip-rapped, and grouted.

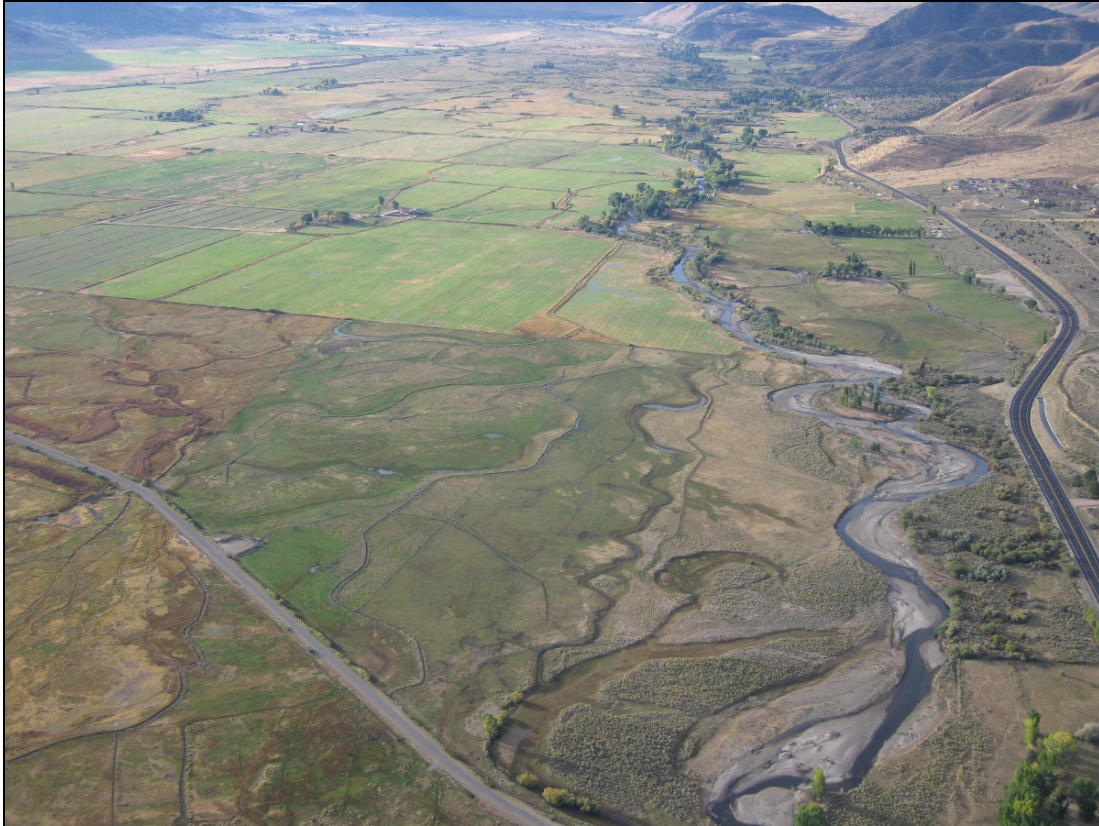
Figure 2.1-38. Low elevation oblique aerial photo of the West Walker River in WW4 in the Antelope Valley. The view is looking upstream. Note the geomorphic features in the foreground such as channel scars on the floodplain, and the large point bars in the active channel.

At the upstream end of WW4, the West Walker River flows into Antelope Valley (Figure 2.1-38). Antelope Valley is an extensional graben controlled by faults on the west and east sides of the valley (Sawyer et. al., 1998). The faults on the west edge are down-to-the-east normal faults that form high range-front escarpments. To the east, the geomorphic expression of fault traces is less pronounced, and the type of movement less well known. Entering the valley, the river flows along the steep front of the Sierra Nevada on the west side of the valley at the edge of Holocene age alluvial fan deposits (Dohrenwend, 1982). Aerial photos suggest historic east to west channel migration. Long, coalescing alluvial fans of Holocene and Pleistocene age, border the valley to the east. They originate from the foothills of the Sweetwater Range, and the Wellington Hills. Much of historic alluvial valley is now utilized for agricultural activity. Near the river and above the active floodplain, there is a broad, sagebrush flat composed of poorly sorted cobbles to silt that Dohrenwend (1982) suggests is undifferentiated Holocene basin fill. Nearer the channel there is a well developed inset floodplain composed of sand and covered by riparian vegetation including willow and Russian olive. Active bars within the channel are composed of sand and gravel. The banks in this segment include both fine and gravelly material and are vertical and eroding in places. Bank erosion is not widespread and occurs mainly on meander bends and may be more or less balanced by floodplain deposition.

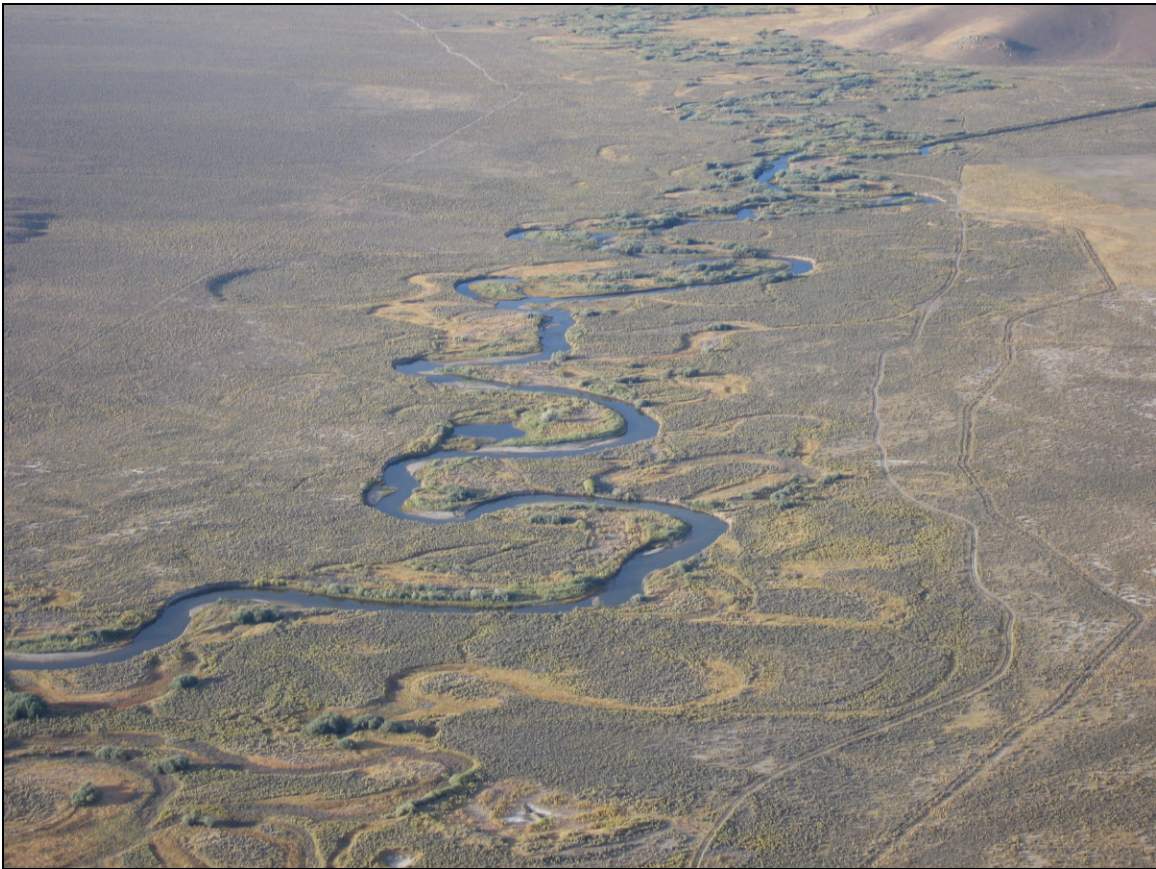
Figure 2.1-39. Low elevation oblique aerial photograph of the West Walker River in WW5. The view is looking upstream. The return flow canal of Topaz Reservoir can be seen in the upper right-hand corner of the image.

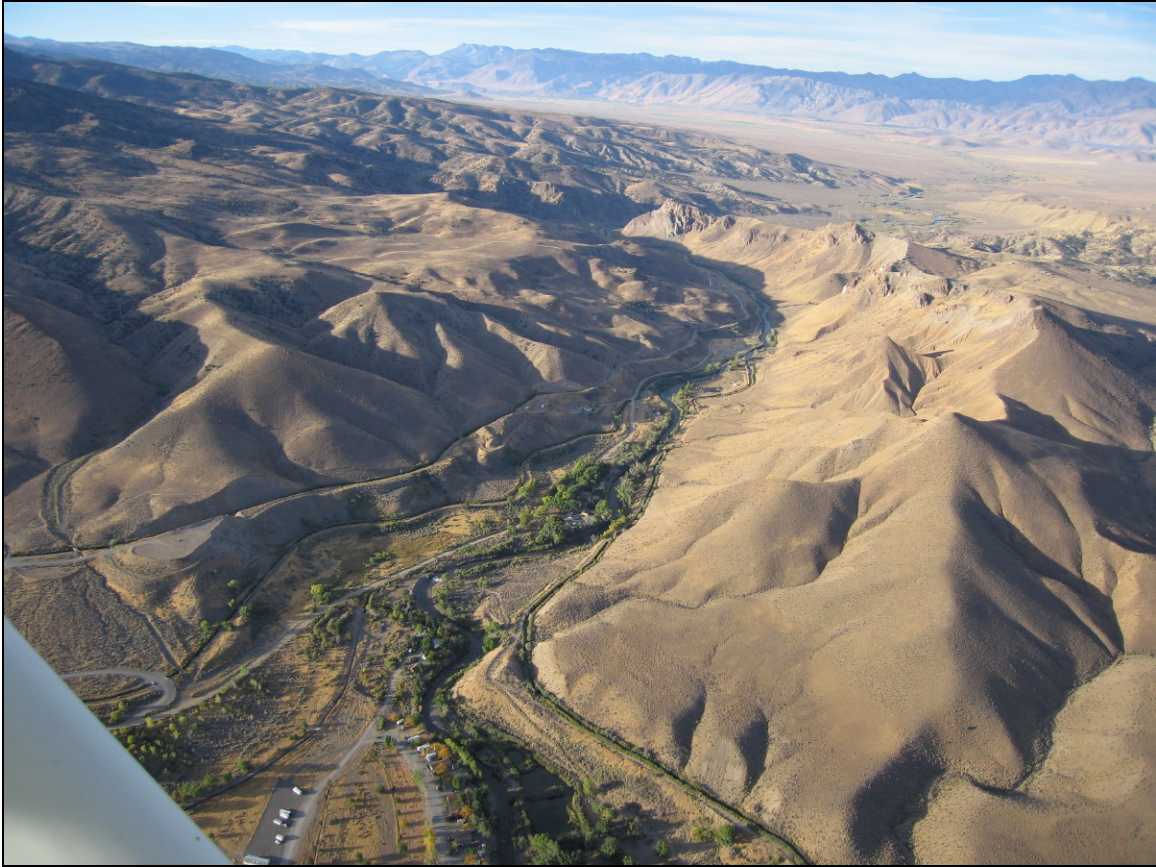
Figure 2.1-40. This aerial photograph was taken looking upstream at Hoyo Canyon, and WW6. The view is looking upstream. Antelope Valley is visible in the upper background.

Segment WW6 flows through Hoye Canyon (Figure 2.1-40), forming a gap at the northwest extent of the Wellington Hills, and southeast extent of the Pine Nut Mountains. These mountain ranges compose a west-tilted structural block controlled by small discontinuous normal faults to the west, and a long continuous zone of normal faults to the east called the Smith Valley fault zone (Adams and Sawyer, 1998b, 1999b). Within the canyon, the river is narrowly confined, and high-gradient. Hillslope deposits frequently reach the valley floor delivering coarse material to the stream. This material creates localized constrictions which cause upstream backwaters, and downstream riffles. The river meanders within the narrow curvature of the canyon, and there is deposition of narrow gravel point bars. Some of these point bars are capped by, or contain inset sand deposits. In the wider portions of the canyon, a narrow, heavily vegetated depositional surface has developed about 8 ft above the current elevation of the channel. An irrigation ditch parallels the river through the canyon and a large diversion dam at the downstream end of the canyon provides additional irrigation to the Smith Valley.

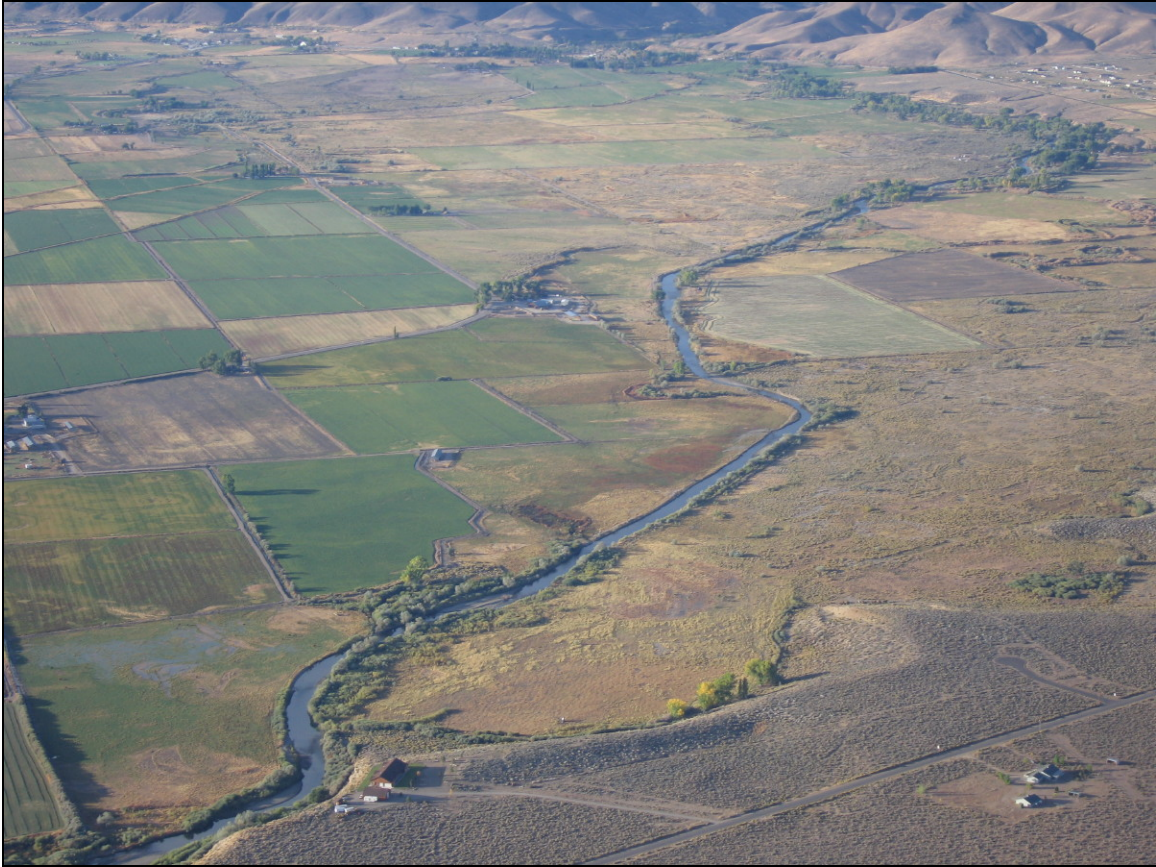
Figure 2.1-41. The aerial photograph was taken over the Smith Valley, and depicts the West Walker River in WW7. The view is looking upstream. Notice the artificially straightened channel. This section of channel was sinuous in 1938.

At the upstream end of WW7, the West Walker River exits Hoyer canyon and flows into Smith Valley (Figure 2.1-41). In this segment, the West Walker is wholly within the Basin and Range physiographic province. The geology and geomorphology of the Smith Valley is typical of this region. The valley is a graben bound by normal faults to the east and west. Pronounced range front escarpments are formed on the up-thrown range, and alluvial fans deliver sediment to the downthrown basin. Initially the river flows north along the western edge of the valley at the foot of the Pine Nut Mountains. The river then turns, flowing northeast across the width of the valley towards the Singatse Range. Within the valley, the river is low-gradient, and relatively low sinuosity. Oxbows and meander scars suggest evidence of a historically sinuous channel, particularly at the upstream end of the segment. Agricultural development has obscured much of the historic floodplain. In many locations, agricultural fields encroach onto the river, particularly to the east.

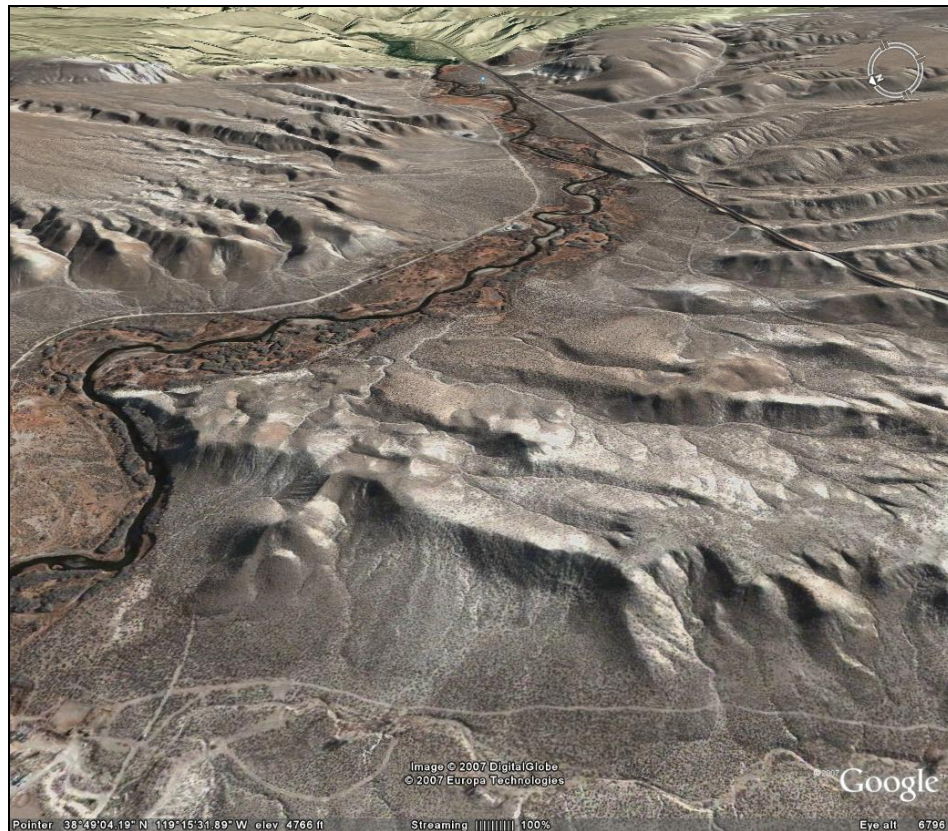
Figure 2.1-42. Aerial photograph depicting the West Walker River flowing through the downstream end of the Smith Valley in WW8. The view is looking downstream. Despite increasing valley confinement as the river incises alluvial fan deposits, the channel is more sinuous than in other parts of the valley. (Google Earth, 2008).

As the river flows northeast across the Smith Valley, it begins to incise alluvial fan deposits generated from the Singatse Range to the east. The width of the alluvial valley becomes increasingly confined downstream. Channel sinuosity in WW8 increases relative to WW7, meandering across a narrow floodplain exhibiting some riparian vegetation, which can be dense near the stream. Agricultural activity is minor in this portion of the valley. The channel in this segment appears to be broad and shallow with deposition of sand and small gravel in longitudinal and point bars (Figure 2.1-42).

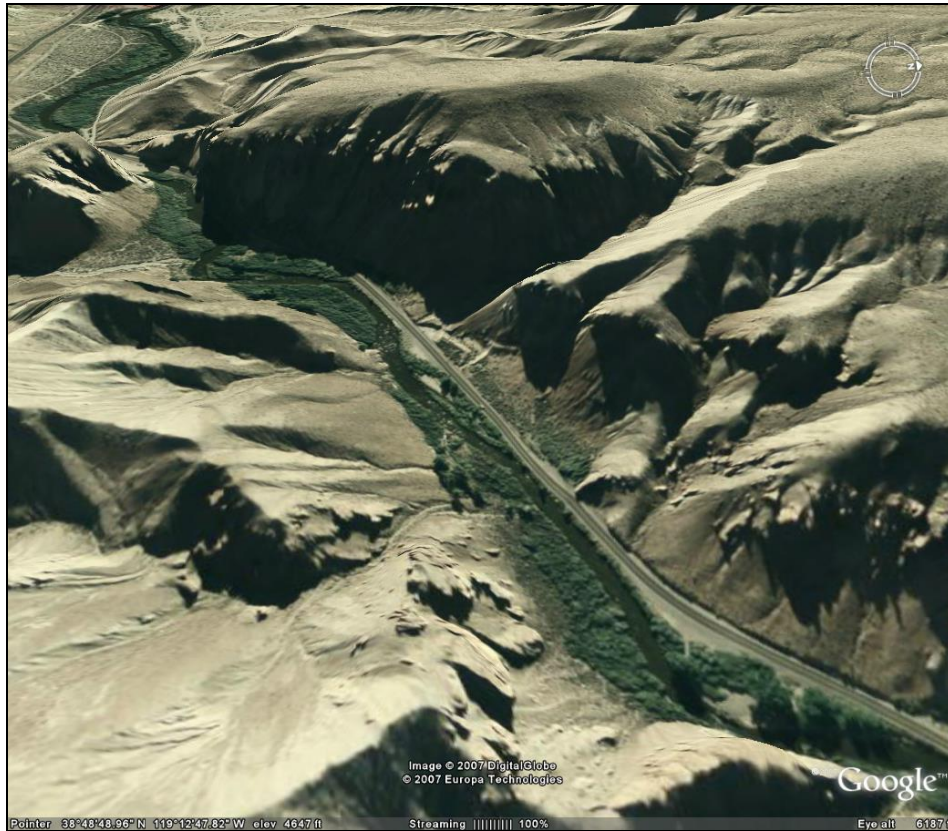
Figure 2.1-43. Aerial photograph of the West Walker River flowing through Wilson Canyon in WW9. Flow is from the top left corner to the bottom right corner of the image. Here the narrow valley and roadway confine the channel planform and link hillslope processes directly to the channel. (Google Earth, 2008).

The West Walker River flows through Wilson Canyon in WW9 (Figure 2.1-43). This canyon bisects the Singatse Range, the structural footwall of normal faults in the Singatse Range fault zone that runs along the eastern edge of the range (Adams and Sawyer, 1999a). Within the canyon, the river is narrowly confined, being directly constrained by bedrock outcrops in some locations, and by the road corridor. The gradient is steep, and the stream bed is composed of cobble/boulder size material organized in riffle-pool sequences. Adjacent hillslopes and side-canyons deliver colluvium directly to, or very near, the channel in many locations. Sand to cobble size material is deposited on the insides of bends, and longitudinal bars. A narrow, well vegetated riparian zone and floodplain is set within the confines of the road and canyon walls.

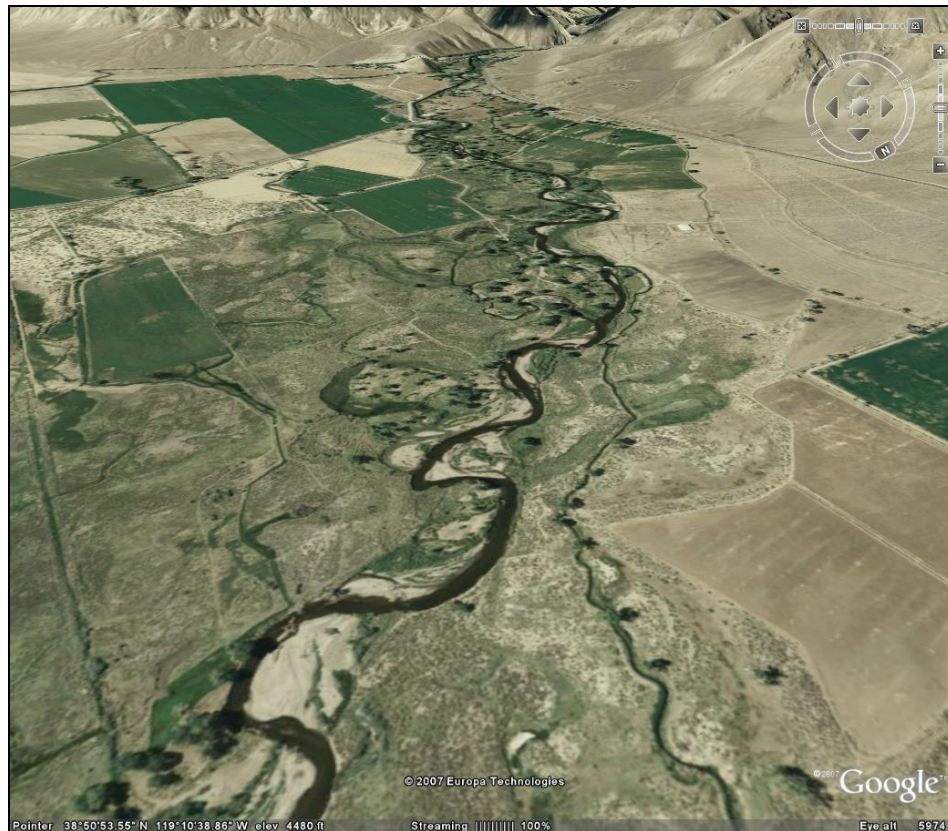
Figure 2.1-44. Aerial photograph of the West Walker River exiting Wilson Canyon and flowing north into the Mason Valley toward its confluence with the East Walker River. The view is looking upstream. As the river flows into the valley, sinuosity increases, and has been relatively unimpeded by agricultural development. (Google Earth, 2008).

Upon exiting Wilson Canyon, the West Walker River flows north into Mason Valley and WW10 (Figure 2.1-44). Its position along the extreme western edge of its modern floodplain is likely the result of down-to-the-east movement along normal faults in the Singatse Range fault zone. The river is low-gradient and sinuous in this segment. Abundant oxbows and meander scars are visible on the floodplain, indicating active channel migration in the past. Much of the potential historic floodplain has been developed for agricultural purposes. Some fairly wide floodplain areas are still present, with relatively extensive riparian vegetation. Aerial photos suggest the presence of some significant side-channel or sloughs in this segment.

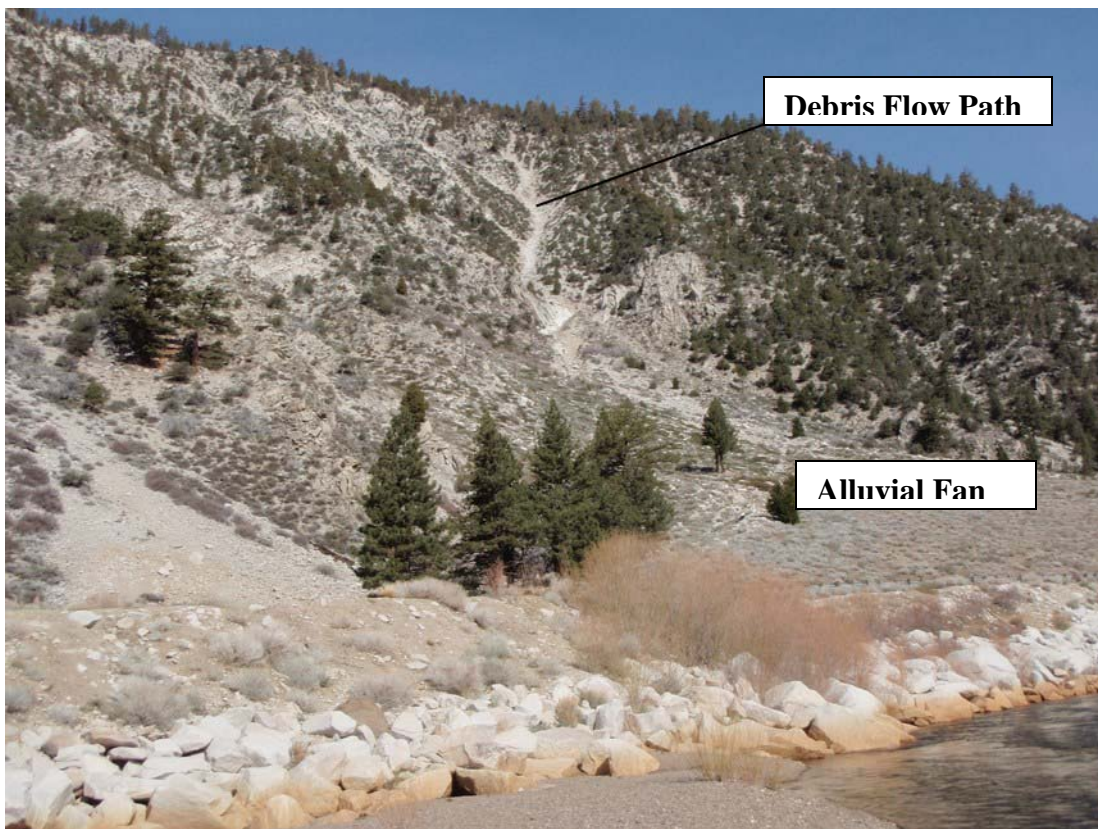
Figure 2.1-47. Debris flow paths above West Walker River near Chris Flat. Material delivered along this path drives channel adjustment at this location.

Despite its dynamic nature, this canyon has been found to be the easiest roadway through the mountains in this area. Therefore, the channel has had to be altered and armored to accommodate roads in this rugged environment (Figure 2.1-47 through Figure 2.1-50). Streambank armoring, and highway maintenance serve to limit the tolerable lateral adjustment of the channel in WW3, another factor contributing to small overall change in planform characteristics since 1938.

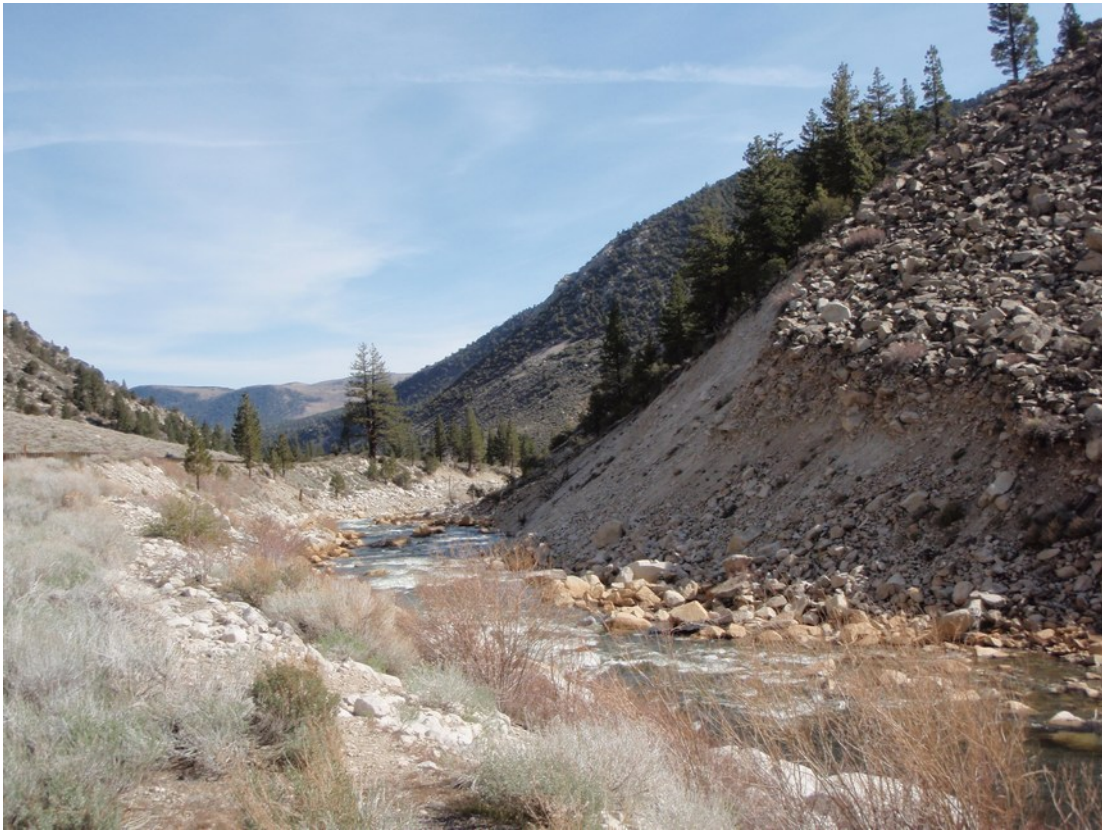
Figure 2.1-48. Active erosion at toe of slope contributes sediment to the West Walker River downstream of Chris Flat, with fine material being carried away, and coarse material being added to the bed. The view is looking downstream.

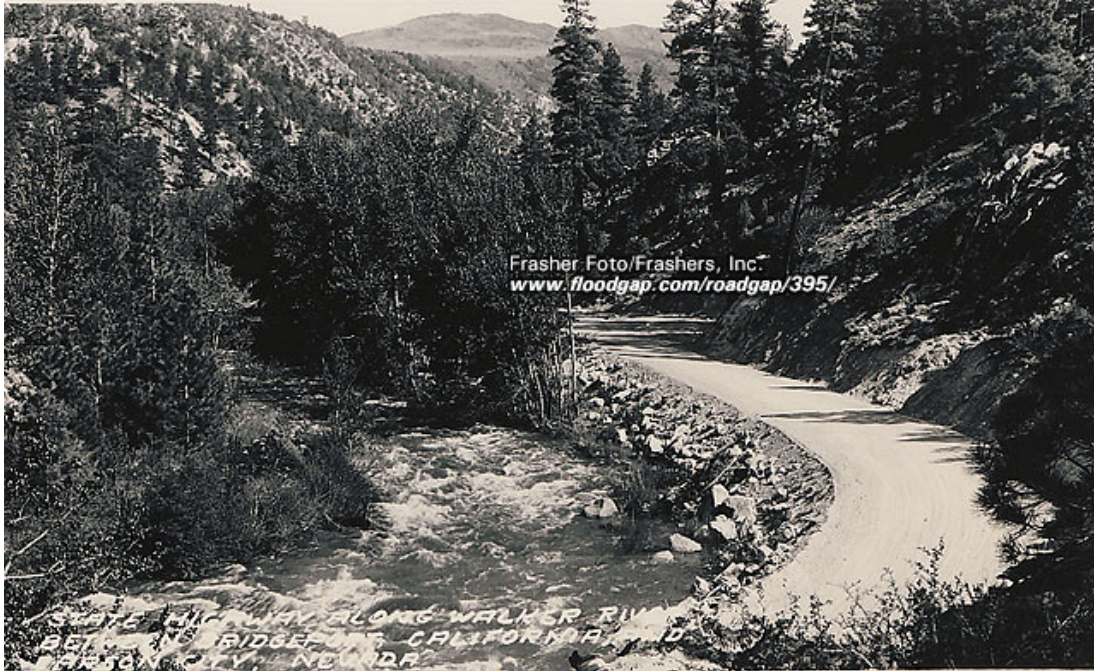
Figure 2.1-49. A postcard of the Walker Canyon from the 1930s, note the riprap and lack of riparian vegetation on the corner (from <http://www.floodgap.com/roadgap/395/u9/>). The view is looking upstream.

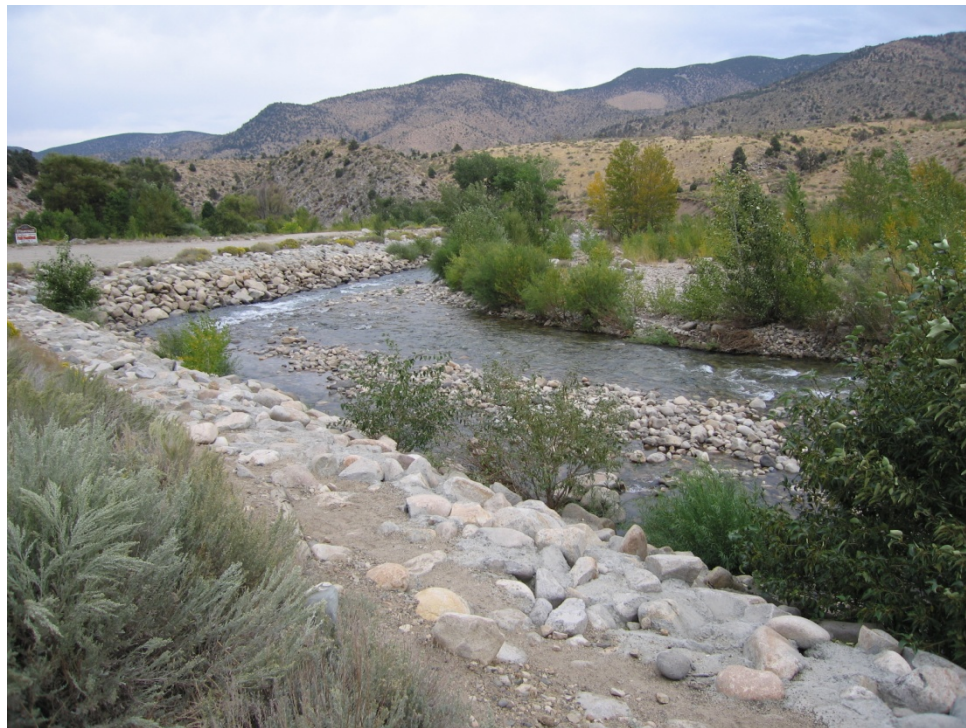
Figure 2.1-50. Riprap protecting highway and structures in modern times near the downstream end of WW3. The view is looking downstream.

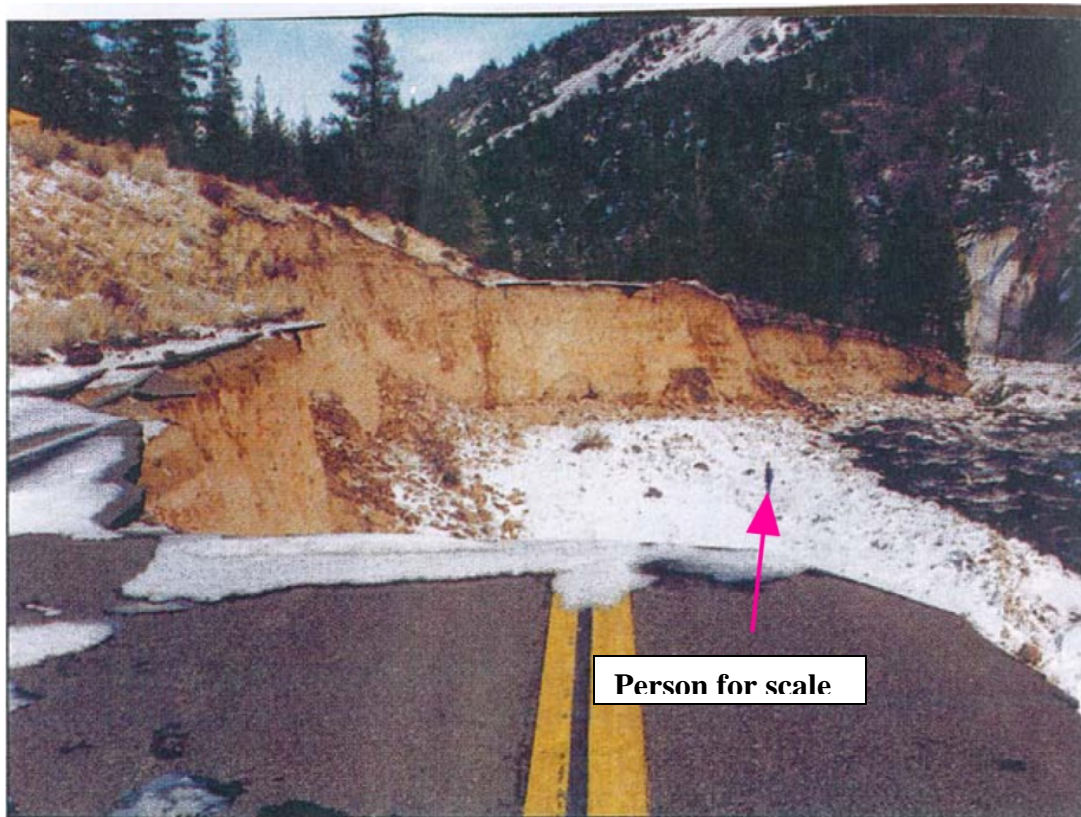
Figure 2.1-51. The photo illustrates the magnitude of erosion of the highway by the flood of 1997. Note the person for scale (from Schmidt, 1997).

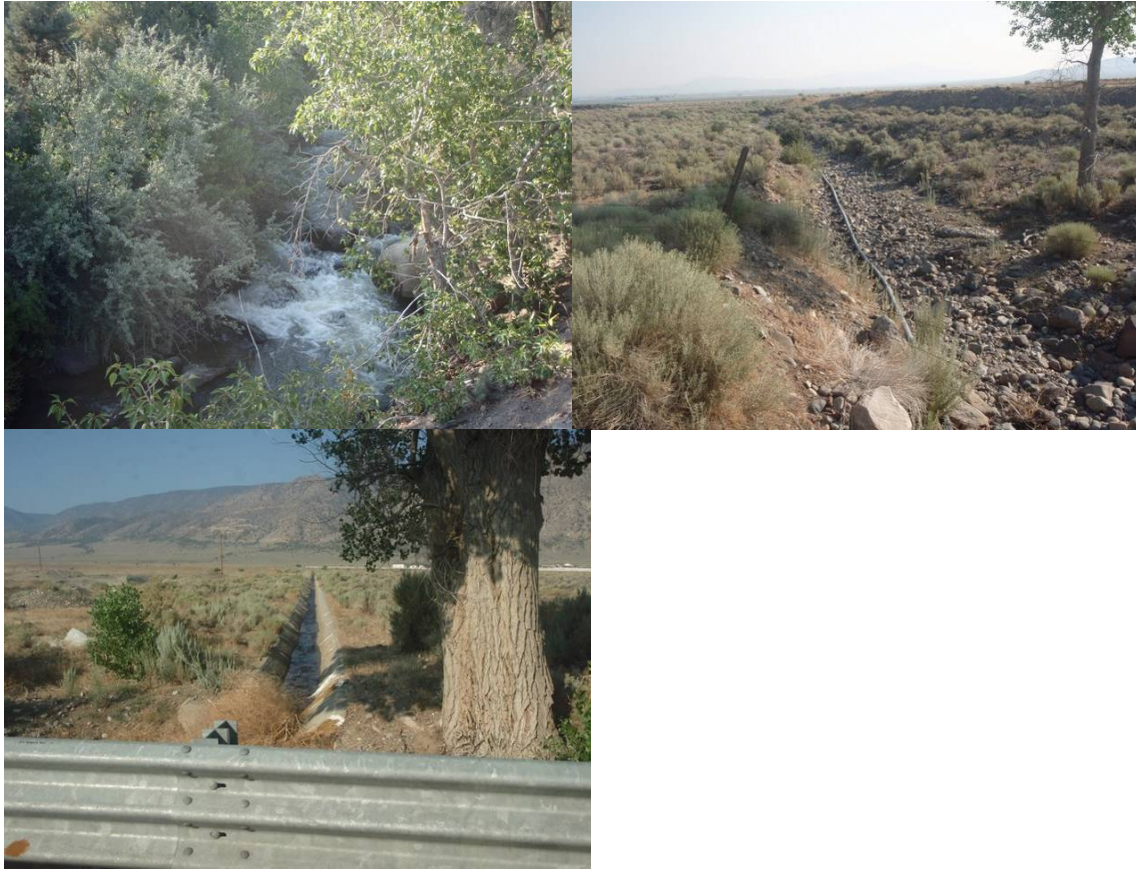
Figure 2.1-55. Series of pictures showing Desert Creek in its canyon (upper left), the dry creek bed in Smith Valley (upper right), and one of the ditches capturing its flow (lower left). The latter two are taken at highway 338.

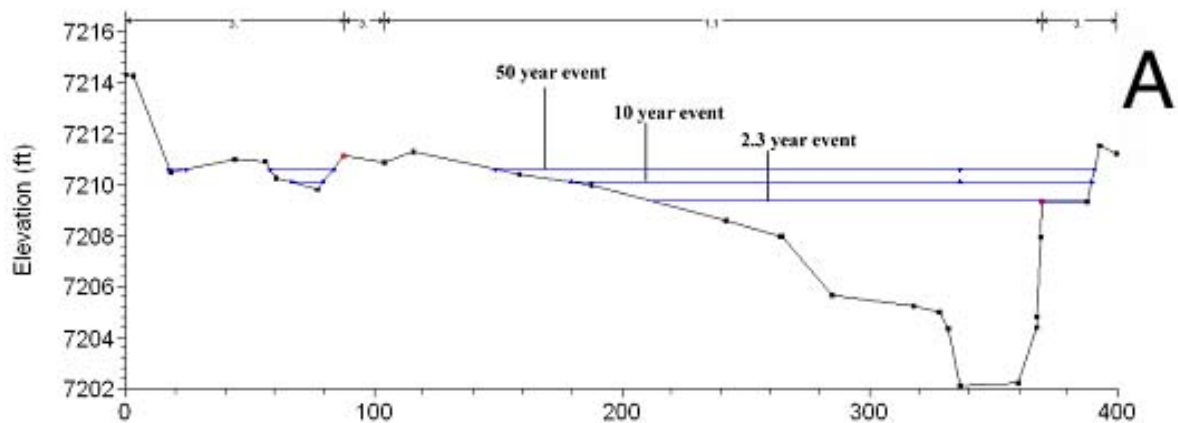
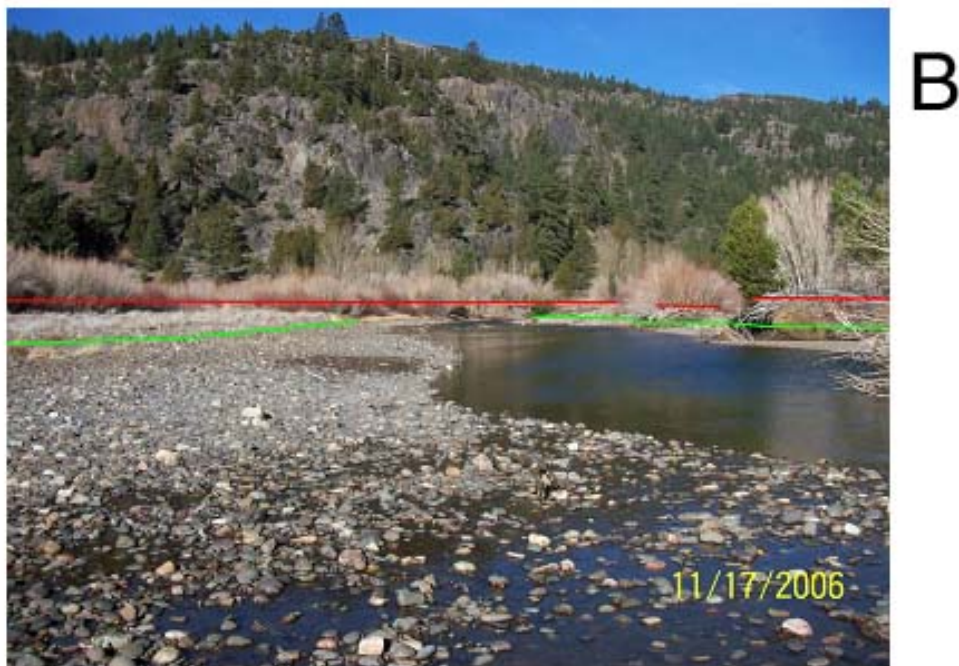
Figure 2.1-57. 2.1-57 A displays a typical cross-section plot for study reach WW2 depicting hydraulically modeled water surface elevations estimated to inundate the observed geomorphic surfaces. 2.1-57 B is a photo of study reach WW2 taken from river left looking downstream. Discharge is about 58 cfs. For comparison, the 2.3 year recurrence flow is about 1,251 cfs. The green line depicts the approximate elevation of the 2.3 year flood water surface, and the red line depicts the approximate elevation of the 50 year flood water surface.

Figure 2.1-57. 2.1-57 A displays a typical cross-section plot for study reach WW2 depicting hydraulically modeled water surface elevations estimated to inundate the observed geomorphic surfaces. 2.1-57 B is a photo of study reach WW2 taken from river left looking downstream. Discharge is about 58 cfs. For comparison, the 2.3 year recurrence flow is about 1,251 cfs. The green line depicts the approximate elevation of the 2.3 year flood water surface, and the red line depicts the approximate elevation of the 50 year flood water surface. 100

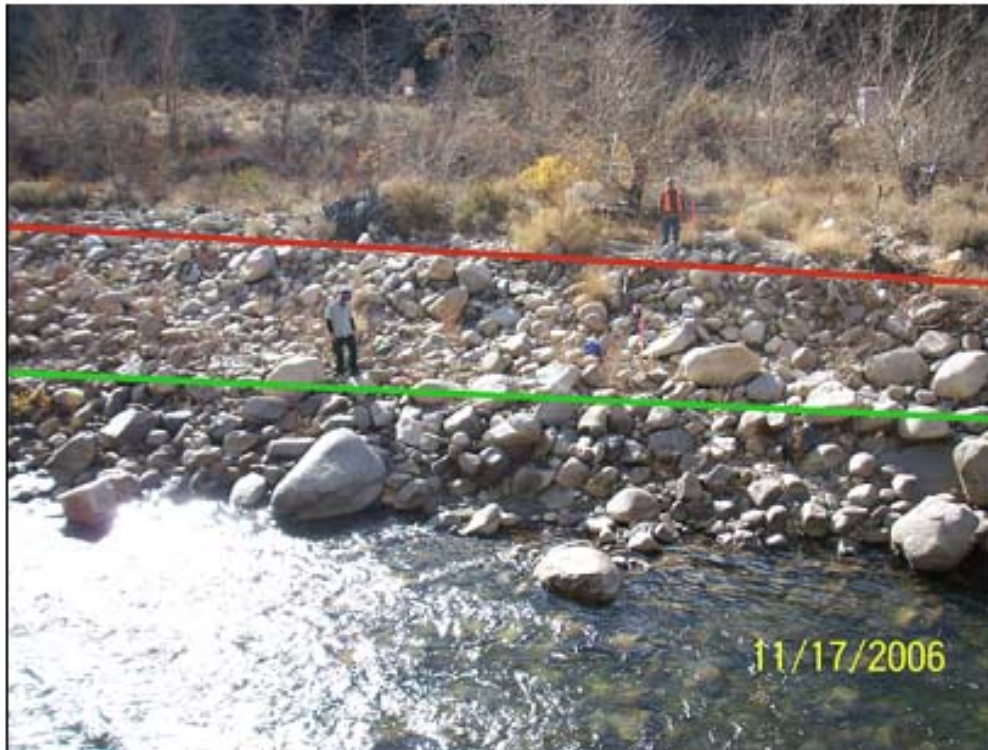
Figure 2.1-58. 2.1-58 A depicts a typical cross-section plot for study reach WW3 depicting hydraulically modeled water surface elevations estimated to inundate the two observed geomorphic surfaces. 2.1-58 B is a photo of deposits along river left of study reach WW3 taken from cliff on river right. Flow is from left to right and at a discharge of about 73 cfs. For comparison, the 1 year recurrence flow is about 570 cfs. The green line depicts the streamside edge of the surface inundated by the 2 year flood, and the red line depicts the stream side edge of the surface inundated by flows between the 50 and 100 year floods.

Figure 2.1-58. 2.1-58 A depicts a typical cross-section plot for study reach WW3 depicting hydraulically modeled water surface elevations estimated to inundate the two observed geomorphic surfaces. 2.1-58 B is a photo of deposits along river left of study reach WW3 taken from cliff on river right. Flow is from left to right and at a discharge of about 73 cfs. For comparison, the 1 year recurrence flow is about 570 cfs. The green line depicts the streamside edge of the surface inundated by the 2 year flood, and the red line depicts the stream side edge of the surface inundated by flows between the 50 and 100 year floods. 101

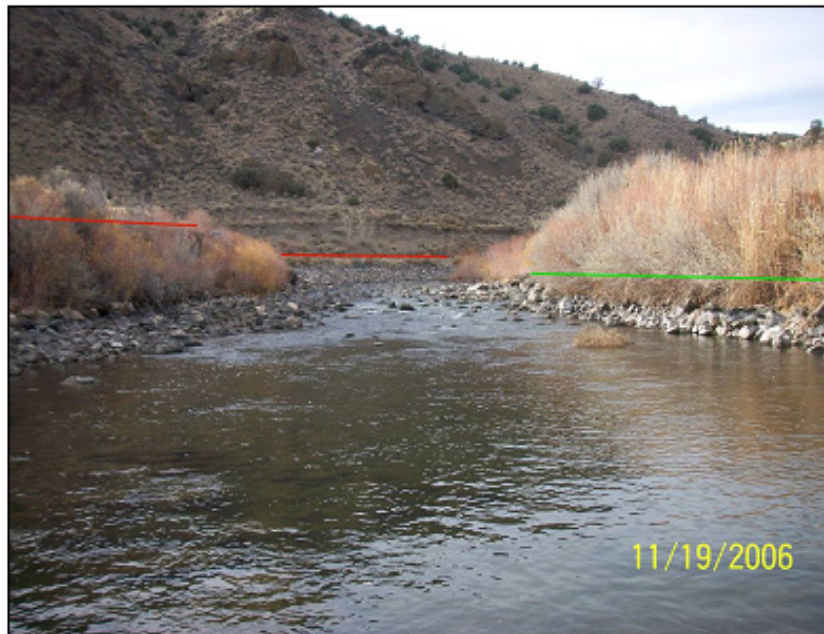
Figure 2.1-62. 2.1-62 A depicts a typical cross section plot of water surface elevations estimated to inundate the various geomorphic surfaces found in study reach WW6. 2.1-62 B is a photograph of study reach WW6 geomorphic surfaces taken looking upstream from the center of the channel. The red line depicts the elevation of the road surface on river right that forms a high surface that is not inundated by the 100 yr flood (left side of picture). The green line depicts the elevation of the streamside edge of the 25 yr floodplain on river left (right side of picture). Lower elevation gravels that are frequently inundated can be seen at the edge of the wetted channel on both sides.

Figure 2.1-62. 2.1-62 A depicts a typical cross section plot of water surface elevations estimated to inundate the various geomorphic surfaces found in study reach WW6. 2.1-62 B is a photograph of study reach WW6 geomorphic surfaces taken looking upstream from the center of the channel. The red line depicts the elevation of the road surface on river right that forms a high surface that is not inundated by the 100 yr flood (left side of picture). The green line depicts the elevation of the streamside edge of the 25 yr floodplain on river left (right side of picture). Lower elevation gravels that are frequently inundated can be seen at the edge of the wetted channel on both sides.....107
