Walker River Basin Assessment

Prepared For
U.S. Fish and Wildlife
Service
Lahontan National Fish
Hatcheries Complex
1340 Financial Blvd. #234
Reno, NV 89502

January 6, 2009

Prepared By
Otis Bay
Ecological Consultants
PO Box 929
Verdi, NV 89439
www.otisbay.com

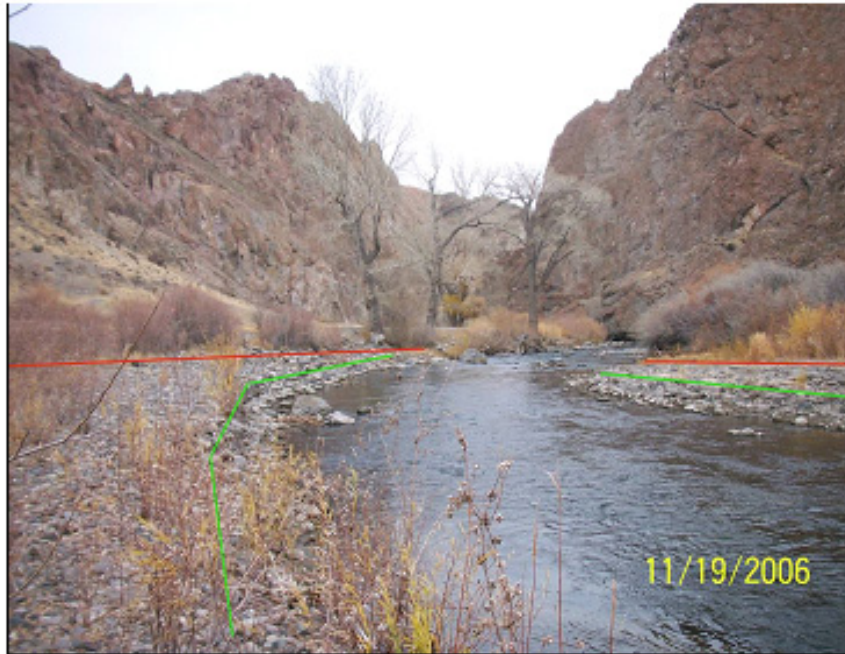
Figure 2.1-66. 2.1-66 A depicts a typical cross-section plot, looking down stream, of estimated water surface elevations for several flows responsible for inundation of the various geomorphic surfaces at a representative cross-section in study reach WW9. 2.1-66 B is a photograph of geomorphic surface in study reach WW9. Image is taken looking downstream from river left at a flow of about 44 cfs, flow is into the page. For reference, the 1 year recurrence flow is about 161 cfs. The green lines depict the elevation of the streamside edges of lower elevation surfaces on river right and left that are inundated yearly, and the red lines depict the streamside edges of higher surfaces that begin to be inundated by a 5 yr flow event.

At the study reach in WW9, HEC-RAS results suggest that floodplain surfaces are inundated by flows recurring between 5 and 10 years (Figure 2.1-66). This does not necessarily represent impaired floodplain connection however, as channel-forming processes in a canyon segment would be expected to differ somewhat from broad alluvial valleys. Several geomorphic features

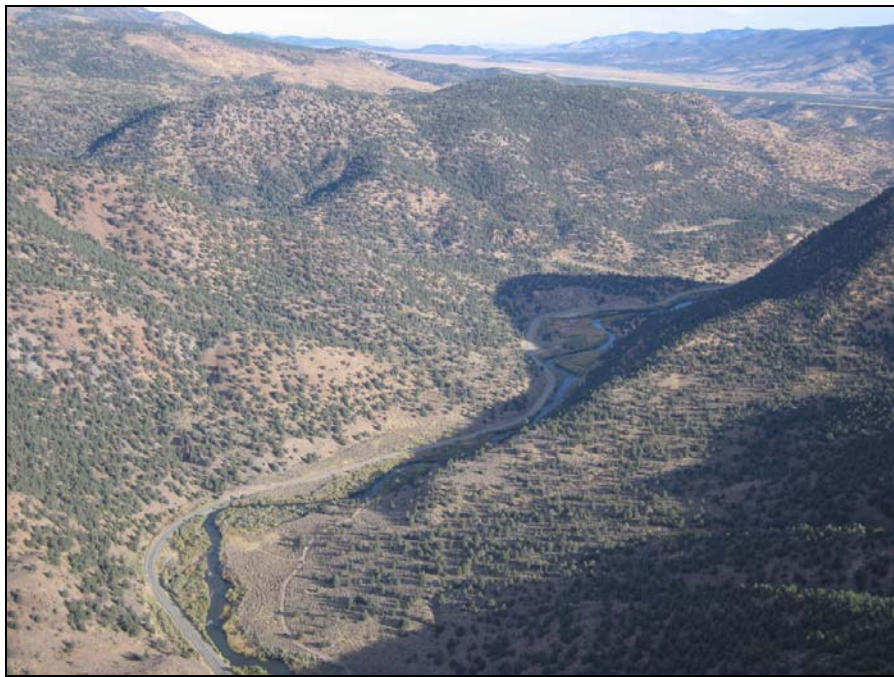
Figure 2.1-68. Aerial photograph of EW2 downstream of Bridgeport Reservoir as it flows through a relatively restrictive canyon. Flow is from the bottom to the top of the image.

EW2 begins just downstream of the Bridgeport Reservoir outflow (Figure 2.1-68). To the east, the steep lower slopes of the Sweetwater Mountains deliver colluvium directly to the stream at many locations. To the west, the Bodie Hills and Masonic Mountains present a source of colluvium to the canyon. Most colluvial deposits adjacent to the stream appear to be vegetated and stable. Steep banks are created at locations where the stream has worked into the toe of these deposits. Overall, the segment is high-gradient, with a gravel/cobble bed organized into riffle-pool sequences. There is deposition of alternating bars and point bars composed of gravel and cobble. In several sections, stable, vegetated gravel bars divide the stream. In general, riparian vegetation is dense near the stream throughout most of this segment. Near the middle of the reach, mass-wasting has created a channel constriction and ponded backwater. Large amounts of fine material appear to have been deposited in this vicinity, creating a wide cattail area with multiple narrow channels, and isolated ponds.

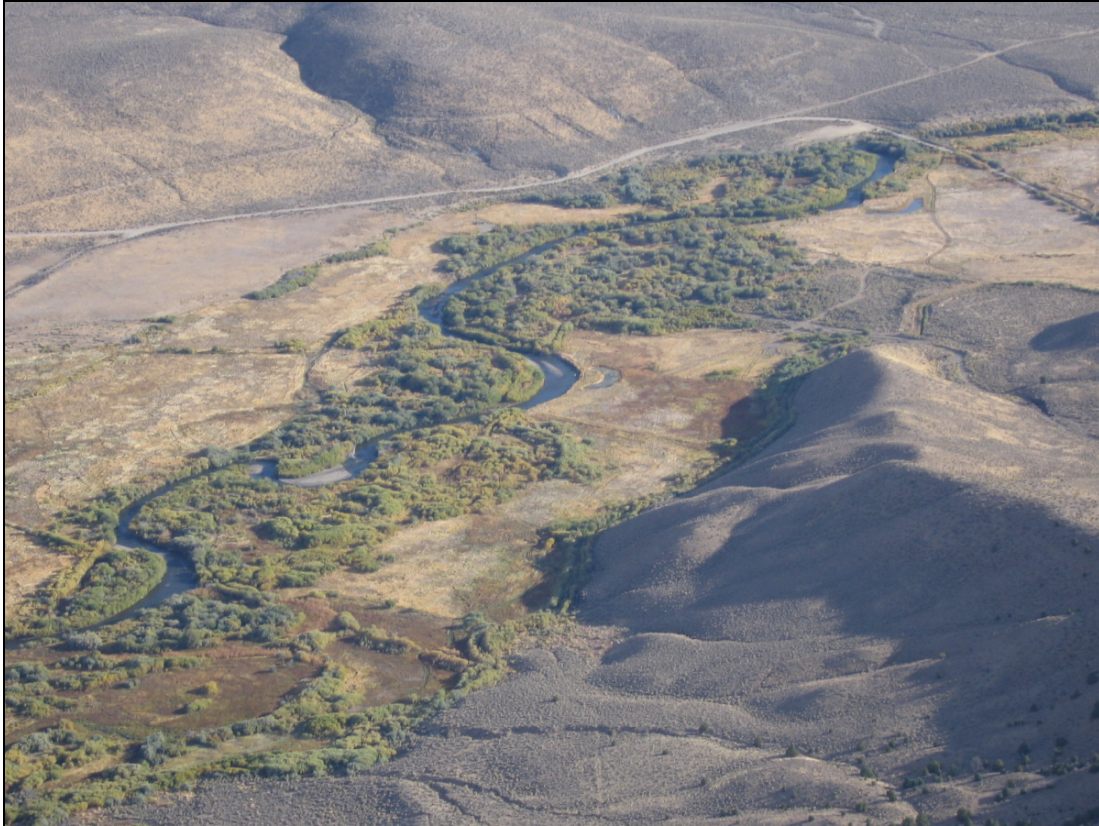
Figure 2.1-69. Aerial photo of the East Walker River in the area of the Rosaschi Ranch in EW3. Flow is from left to right across the image. The historically wide alluvial valley and unrestricted meander pattern are evident in the image.

In segment EW3, the valley width increases and an alluvial valley has developed (Figure 2.1-69). The valley margins are often defined by terraced alluvial fans and pediment surfaces whose sources are the Masonic Mountains to the south, and the Pine Grove Hills to the north (Dohrenwend, 1982). This segment is low-gradient and sinuous. In some locations, flow is divided into multiple channels separated by well-vegetated bars or islands. The stream bed is composed of gravel and organized in riffle-pool sequences. Finer gravels and sand are deposited in alternating bars and point bars. The river corridor consists of a significant floodplain with dense riparian vegetation, and inactive alluvial surfaces covered with upland vegetation.

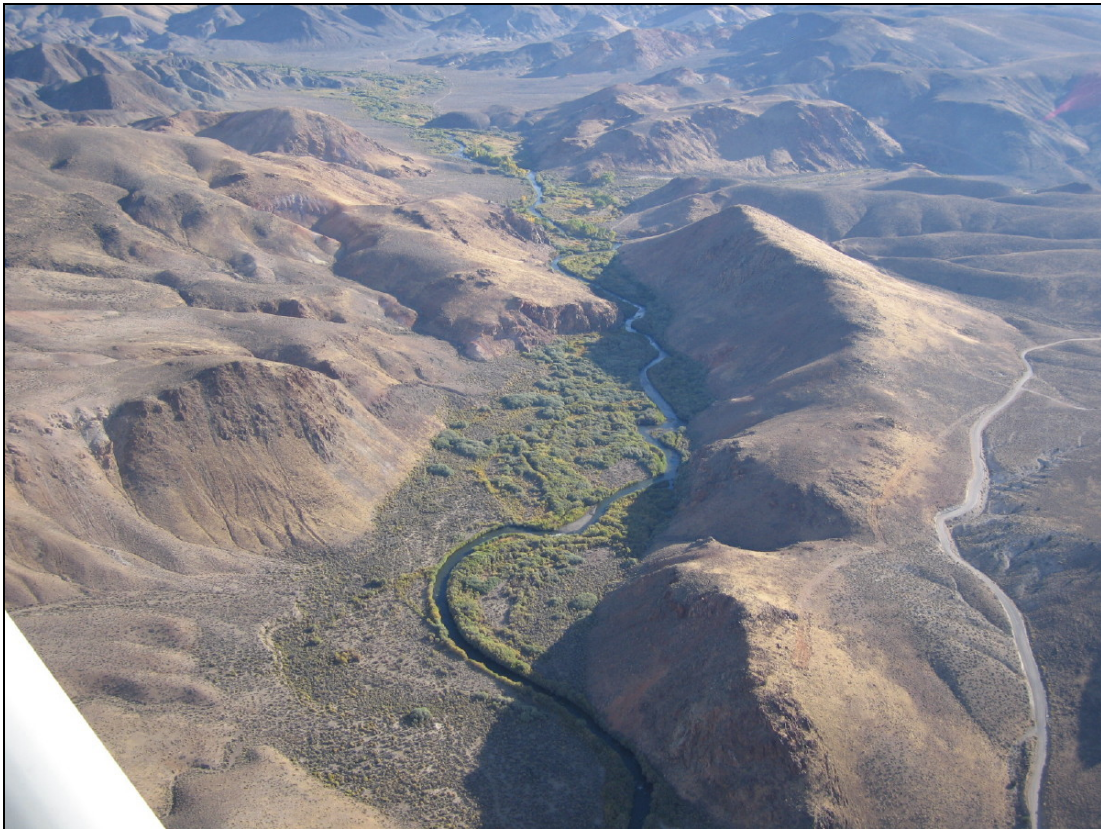
Figure 2.1-70. Aerial photo of the East Walker River in EW4. Flow is from the bottom to the top of the image. The confined meandering planform and closely coupled hillslopes processes are evident from the photograph.

Valley confinement increases at the upstream end of EW4 as the gradient increases and the river incises a relatively deep canyon. Much of the segment within the canyon is inaccessible by vehicle. Aerial photos suggest steep hillslopes directly border the stream in many places (Figure 2.1-70). The gradient remains low, and a meandering planform is evident, though channel migration is restricted. The streambed is composed of gravel/cobble material organized in riffle-pool sequences. Point bar deposition is common. At the downstream end of the segment, the canyon widens, and a well-vegetated floodplain develops.

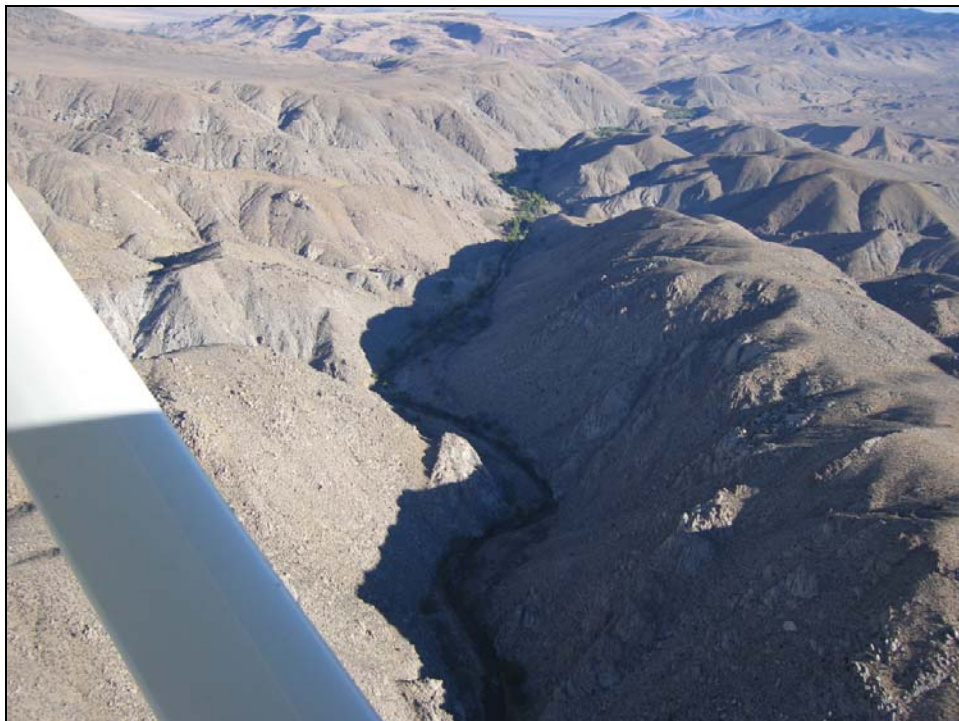
Figure 2.1-71. Aerial photograph of the East Walker River in EW5. Flow is from the bottom to the top of the page. The narrow confinement, low sinuosity, and closely coupled hillslope processes typical of the reach are evident in the image.

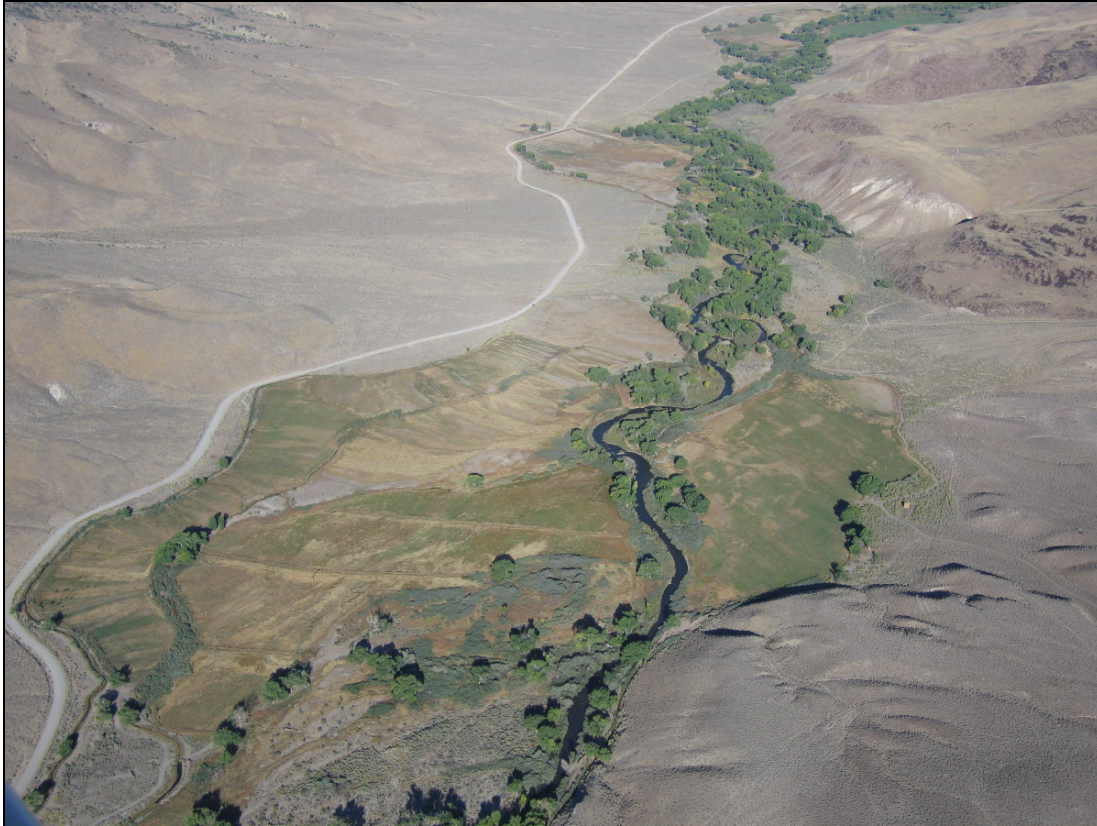
Figure 2.1-72. Aerial photograph of the East Walker River in EW6. Flow is from the bottom to the top of the page. As shown in the photograph, sinuosity increases downstream.

At the upstream end of EW6, the river exits the canyon and flows into the southern end of Pine Grove Flat, a relatively open valley (Figure 2.1-72). The valley floor is developed for grazing and other agricultural activities. Some areas appear to have been channelized, and lack a wide floodplain or riparian zone. This is particularly apparent in the middle of the reach. The river turns northeast and flows through a canyon separating the Cambridge and Gray Hills. The stream bed is primarily composed of gravel organized into riffle-pool sequences. In unconstrained portions, depositional features such as point bars and alternating bars are visibly apparent in aerial photography.

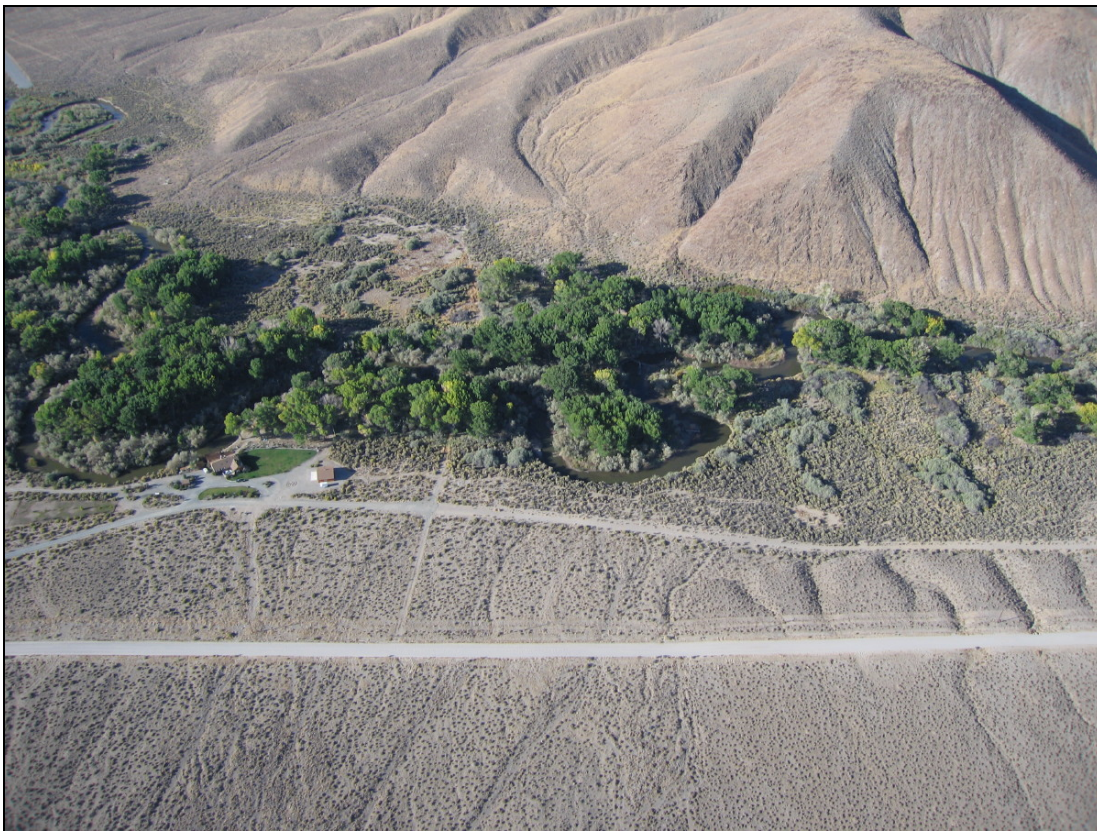
Figure 2.1-74. Aerial photo of the East Walker River in EW8. Flow is from left to right across the page. Notice the increasing valley confinement in the downstream direction.

At the upstream end of EW8, the river incises a canyon in the Cambridge Hills (Figure 2.1-74). The river is fairly low-gradient, and exhibits a restricted meandering pattern within the confinement of the canyon. The stream bed is composed of mobile sand over gravel and cobble. Sand and small gravel are deposited in alternating bars and point bars. Frequent meander scars suggest that the channel has migrated within the canyon. At the downstream end of the segment, the river flows into the southeastern portion of Mason Valley.

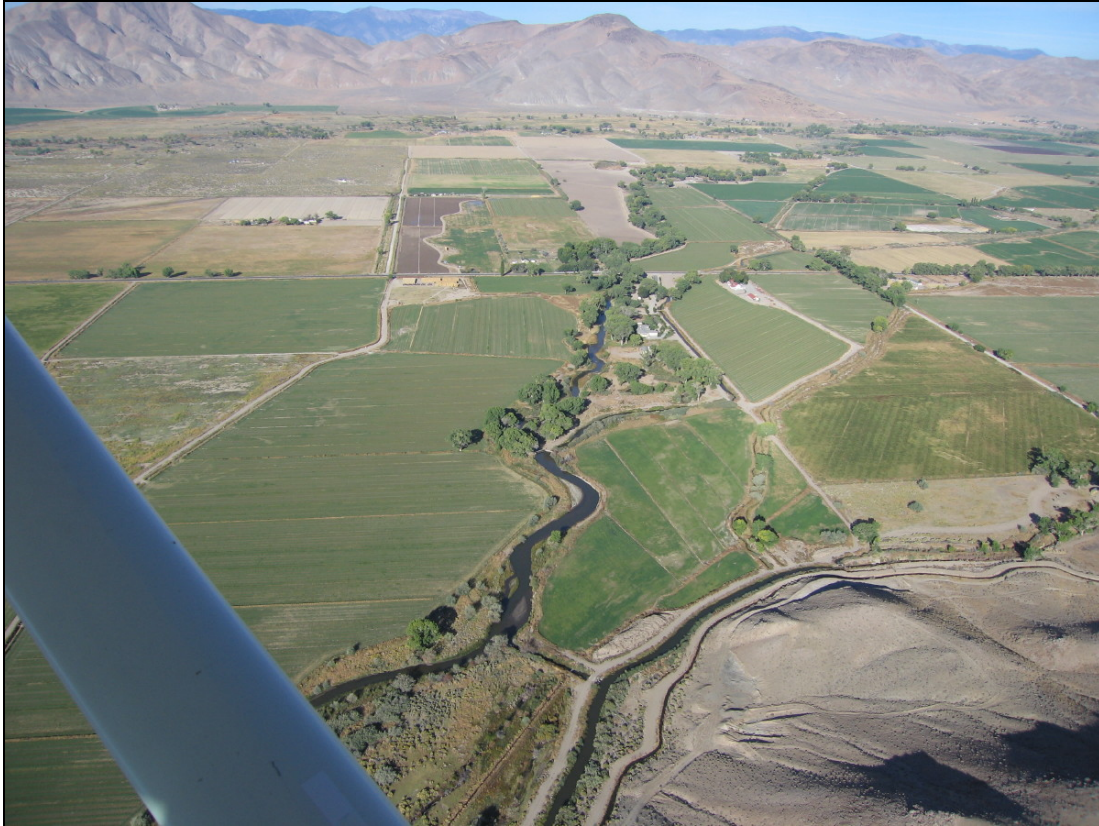
Figure 2.1-75. Aerial photograph of the East Walker River flowing through the Mason Valley in EW9. Flow is from the bottom to the top of the page. The portion of the river shown here flows northeast across the valley to the confluence of the East and West Walker Rivers. There is no hillslope constraint on channel planform, yet the channel is relatively straight possibly due to development in the floodplain.

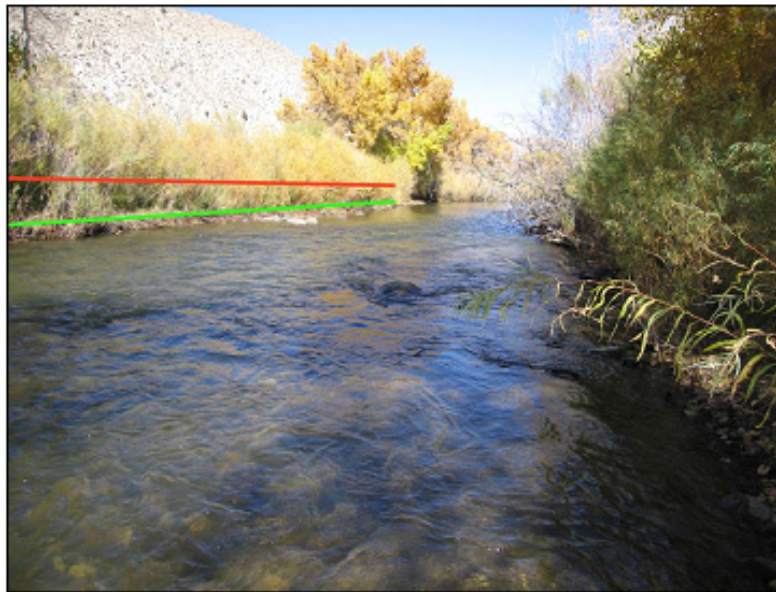
Figure 2.1-86. 2.1-86 A depicts a typical cross-section plot of estimated water surface elevations of flows inundating various geomorphic surfaces found in study reach EW5. Flow is into the page, putting river left on the left side of the image. Photograph of geomorphic surfaces in study reach EW5. 2.1-86 B is a photograph is taken looking downstream, with a streamflow of about 56 cfs. For reference the 1 year recurrence flood event is about 109 cfs at the Bridgeport gage. The green line depicts low-elevation surface that are inundated more frequently that every 1 year. The red line depicts the approximate elevation of the high floodplain that is inundated no more frequently than every 25 years.

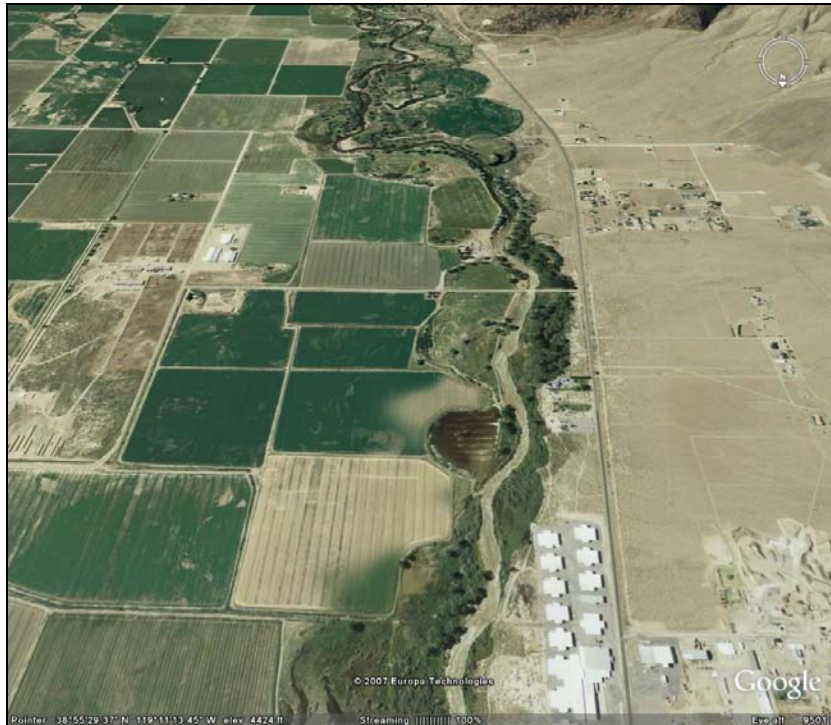
Figure 2.1-90. Aerial photograph of the Walker River flowing through the Mason Valley in W11. The view is looking upstream. The sinuous pattern below the confluence of the East and West Walker Rivers is evident at the top of the image. As floodplain development is increased, stream curvature is decreased. This can be seen at the bottom, downstream, portion of the image. (Google Earth, 2008).

W11 begins at the confluence of the West and East Walker Rivers (Figure 2.1-90). Following this confluence, the river flows north along the front of the Singatse Range. Directly downstream of the confluence, the river is relatively sinuous, meandering across a fairly wide floodplain. Continuing downstream from the confluence, the channel appears to be diked, and loses much of its sinuosity for the remainder of the segment. Some sections within this straightened portion still exhibit point bar deposition, and cut-bank development within an inset floodplain.

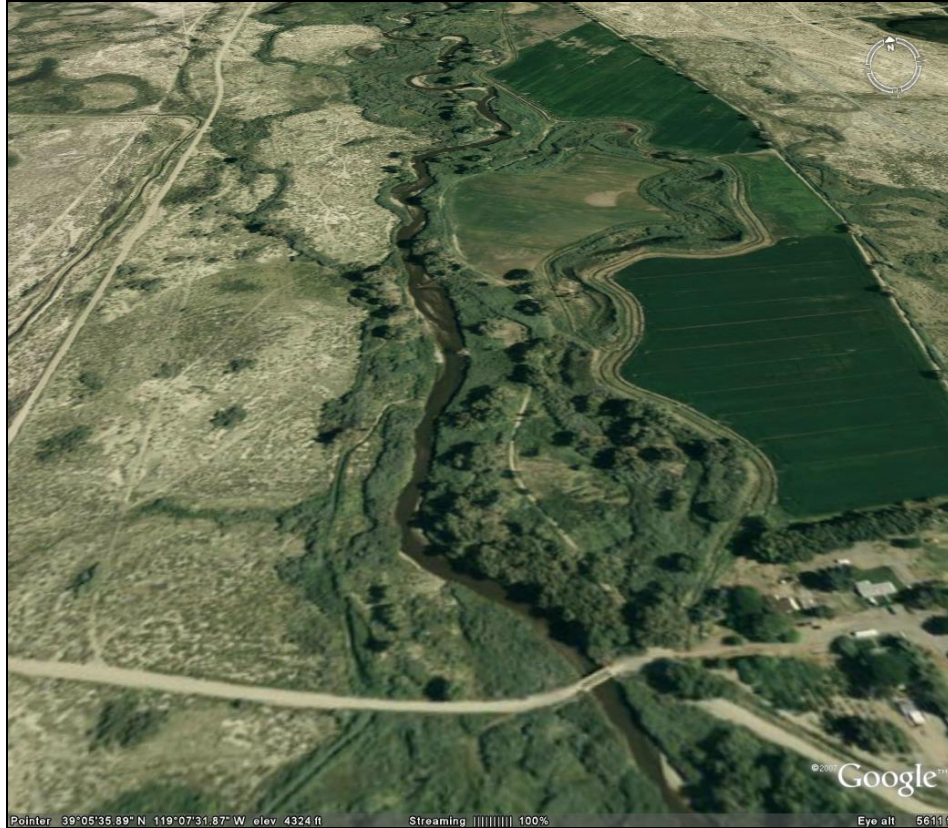
Figure 2.1-91. Aerial photograph of the Walker River flowing through the MVWMA in W12. The view is looking downstream. Relative to other areas of the Mason Valley, there is little floodplain development, and the channel may retain some of its historical morphology. (Google Earth, 2008).

W12 flows through a portion of the Mason Valley that has been under the management of the Nevada Department of Wildlife since 1955 (Figure 2.1-91). This has produced a relatively undeveloped condition that could be representative of the river prior to development in the Mason Valley. However, irrigation has altered the natural hydrology in this segment. This segment is low-gradient and sinuous. There is significant sand deposition on point bars, alternating bars, and in the adjacent floodplain. The floodplain is heavily vegetated, and fairly extensive. Wetlands and sloughs are frequent in the floodplain. The position of the river in this region has potentially varied widely during Quaternary time. There is geologic evidence that the river flowed out of the Walker Basin and into the Carson Sink through the Adrian Valley (Adams, 2007).

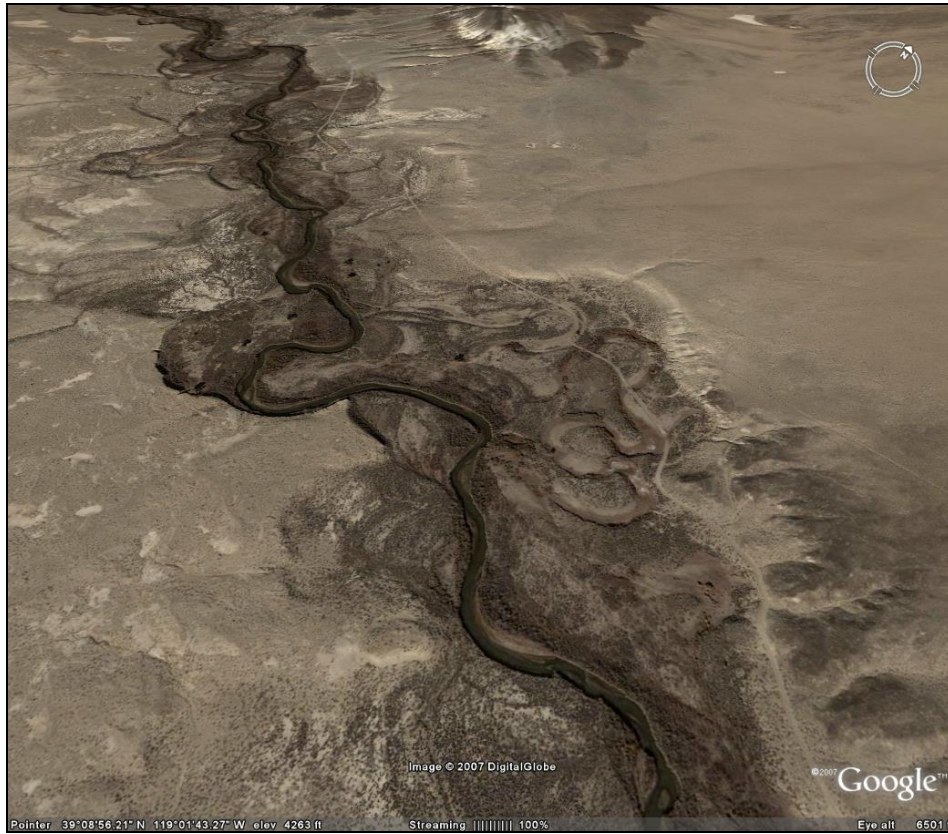
Figure 2.1-92. Aerial photograph of the Walker River upstream of Weber Reservoir in W13. The view is looking upstream. The river has incised lake and alluvial fan deposits here and created an inset alluvial valley. Historical evidence of channel migration is supported by oxbows and abandoned channels in the floodplain. (Google Earth, 2008).

The river turns sharply east then south in W13, leaving the open Mason Valley and flowing into incised fluvial and lacustrine deposits that form terraces on both sides of the river valley (Figure 2.1-92). Within the lateral confinement of these terraces, the river remains low gradient and sinuous with a well developed and unrestricted meander pattern. Well preserved meander scars, scroll bar deposits, and oxbows attest to a history of significant meander migration. Sinuous sections display point bar deposition and cut-bank erosion. Straighter sections display alternating bar deposition. The alluvial valley is well vegetated, and at the downstream end of the segment, the channel becomes split into multiple smaller channel that flow into sloughs and marches without a discernible main thread.

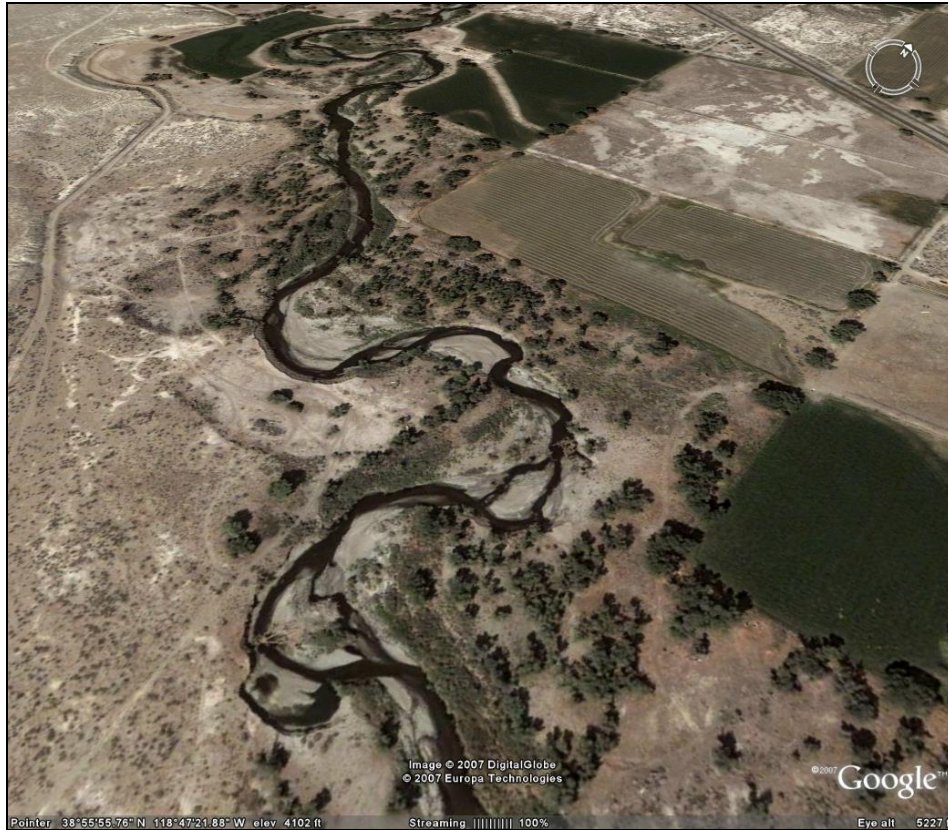
Figure 2.1-93. Aerial photograph of the Walker River downstream of the town of Schurz in W14. The view is looking upstream. The river has been incising lake sediments in response to base level drop of Walker Lake. (Google Earth, 2008).

W14 extends from below Weber Reservoir to the most recently exposed Walker Lake delta (Figure 2.1-93). On the ground observations were made downstream of the siphon at Schurz. In this region, the channel is narrowly incised up to 25 ft forming high vertical to near vertical banks. The channel incises lacustrine deposits from remnant high stands of Walker Lake (Adams, 2007). Narrow inset floodplain deposits occur within this confined corridor. Lateral migration in the form of large point bar deposits is evidenced by opposing steep cut-banks. Banks are actively slumping throughout the segment. The channel is generally low gradient, and displays an entrenched meander pattern. Downstream, channel confinement decreases somewhat.

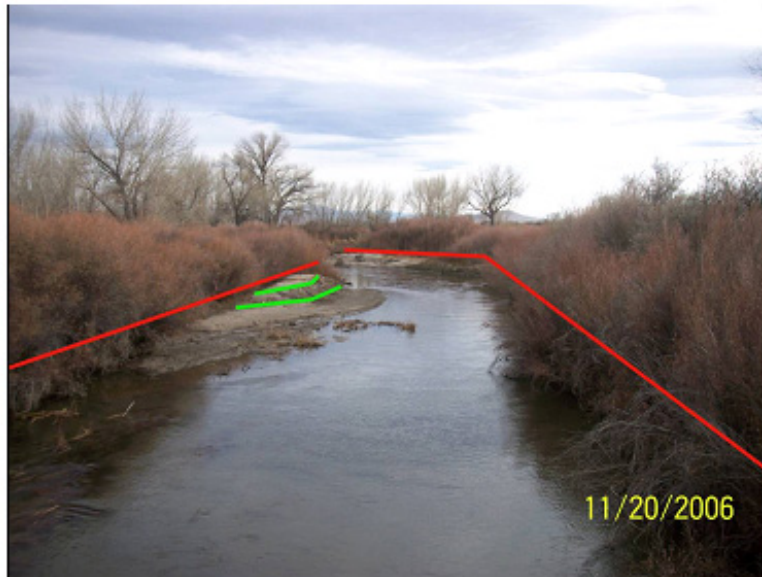
Figure 2.1-100. 2.1-100 A depicts a typical cross-section plot of estimated water surface elevations of flows inundating various geomorphic surfaces found in study reach W12. Flow is into the page, putting river left on the left side of the image. 2.1-100 B is a photograph of study reach W12 taken looking upstream at a flow of about 90 cfs. For reference the 1 year recurrence flood is about 36 cfs. The red lines delineate the approximate elevation of a laterally extensive floodplain that is inundated by flows between the 5 and 10 year floods. The green lines delineate streamside edges of transient depositional features that are more inundated approximately every year.

Figure 2.1-100. 2.1-100 A depicts a typical cross-section plot of estimated water surface elevations of flows inundating various geomorphic surfaces found in study reach W12. Flow is into the page, putting river left on the left side of the image. 2.1-100 B is a photograph of study reach W12 taken looking upstream at a flow of about 90 cfs. For reference the 1 year recurrence flood is about 36 cfs. The red lines delineate the approximate elevation of a laterally extensive floodplain that is inundated by flows between the 5 and 10 year floods. The green lines delineate streamside edges of transient depositional features that are more inundated approximately every year.....175

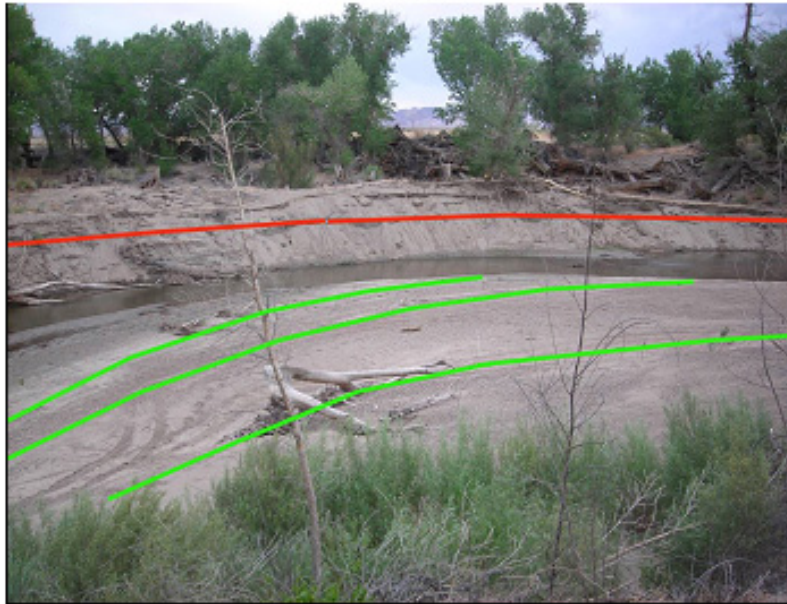
Figure 2.1-102. 2.1-102 A depicts a typical cross-section plot of estimated water surface elevations of flows inundating various geomorphic surfaces found in study reach W14. Flow is into the page, putting river left on the left side of the image. 2.1-102 B is a photograph of study reach W14 taken from river right, looking across the stream at a discharge of about 28 cfs, the 1 year recurrence flood is about 22 cfs. The red line depicts the approximate elevation of the 100 year flood which is contained within high elevation banks and terraces seen here on river left, and out of sight on river right. The green lines depict stepped surfaces that are found across the point bar, and which are inundated at various frequencies between 1.5 and 10 years.

Figure 2.1-102. 2.1-102 A depicts a typical cross-section plot of estimated water surface elevations of flows inundating various geomorphic surfaces found in study reach W14. Flow is into the page, putting river left on the left side of the image. 2.1-102 B is a photograph of study reach W14 taken from river right, looking across the stream at a discharge of about 28 cfs, the 1 year recurrence flood is about 22 cfs. The red line depicts the approximate elevation of the 100 year flood which is contained within high elevation banks and terraces seen here on river left, and out of sight on river right. The green lines depict stepped surfaces that are found across the point bar, and which are inundated at various frequencies between 1.5 and 10 years.....178

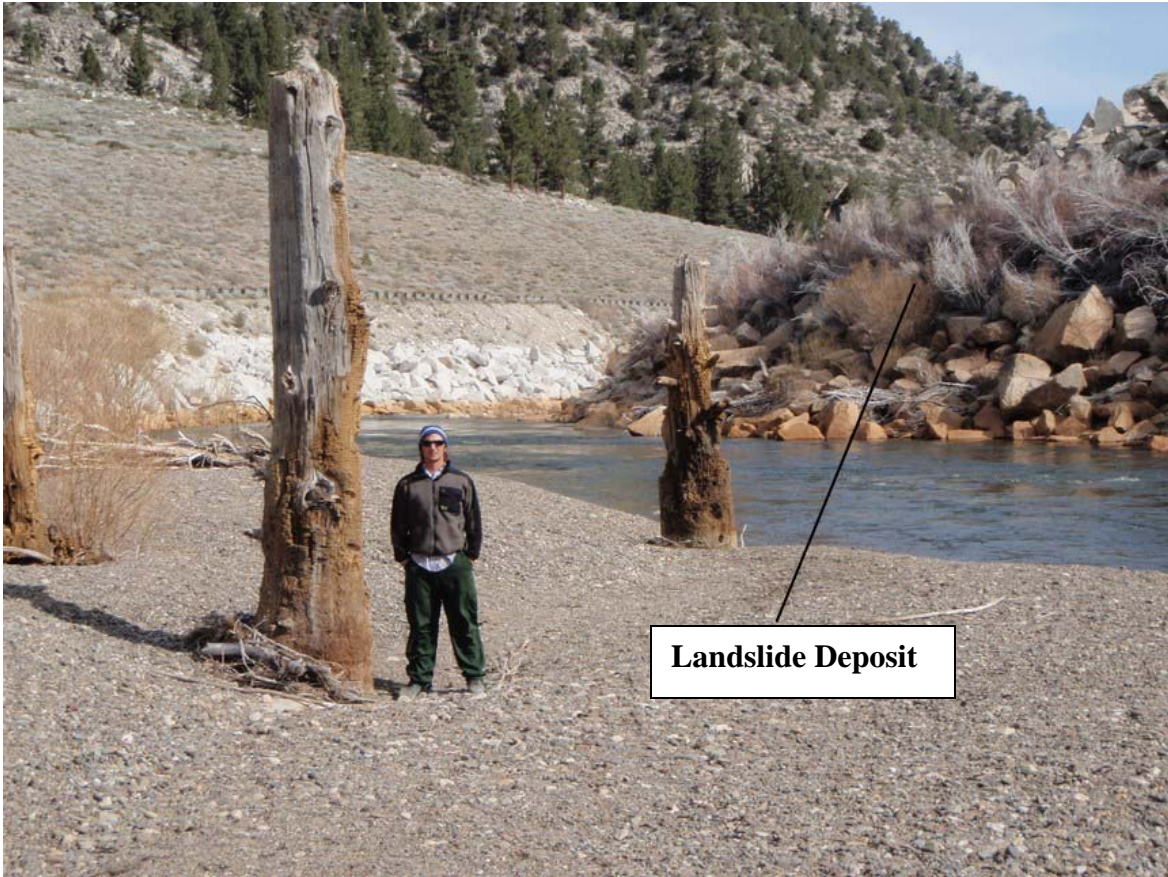
Figure 2.1-106. Landslide deposit and highway.

The landslide at Chris Flat at the start of the canyon is particularly interesting. There is evidence of trees previously been buried by deposition in a backwater of a landslide, the trees are now being exhumed and sediment is being remobilized by the river. During the 1997 flood this area degraded about four feet supplying several thousand tons of stored sediment to the river. (Figure 2.1-105 and Figure 2.1-106).

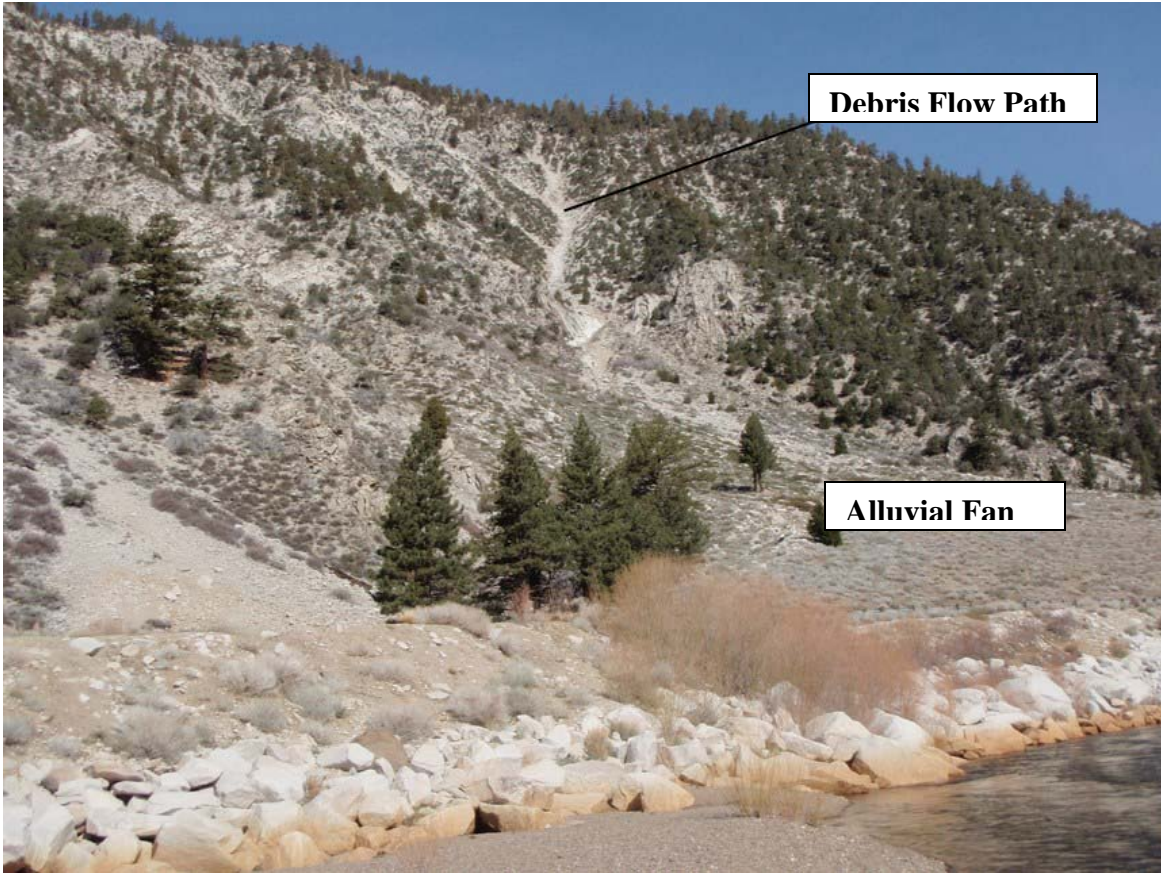
Figure 2.1-107. Debris flow path coming off the west side of the Walker Canyon just below Chris Flat.

Downstream of Chris Flat are several areas of mass wasting including debris flow paths and large eroding slopes. Much of the bedrock in this area is non-glaciated granitic rock that tends to produce coarse sandy soil known as grus. The result is that sediment ranging from sand to large boulders is being supplied to this segment (Figure 2.1-107 and Figure 2.1-108).

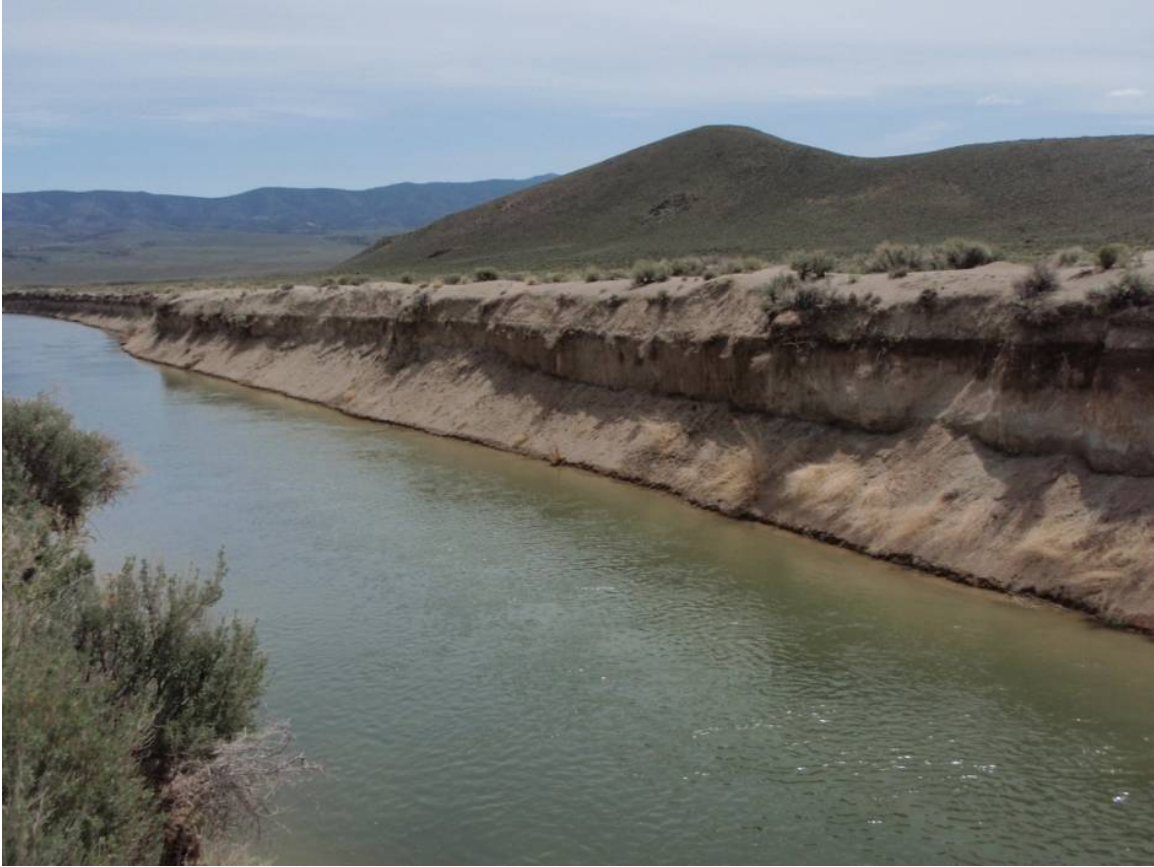
Figure 2.1-111. Over steepened banks on the Topaz return channel. These banks are approximately 20 ft high.

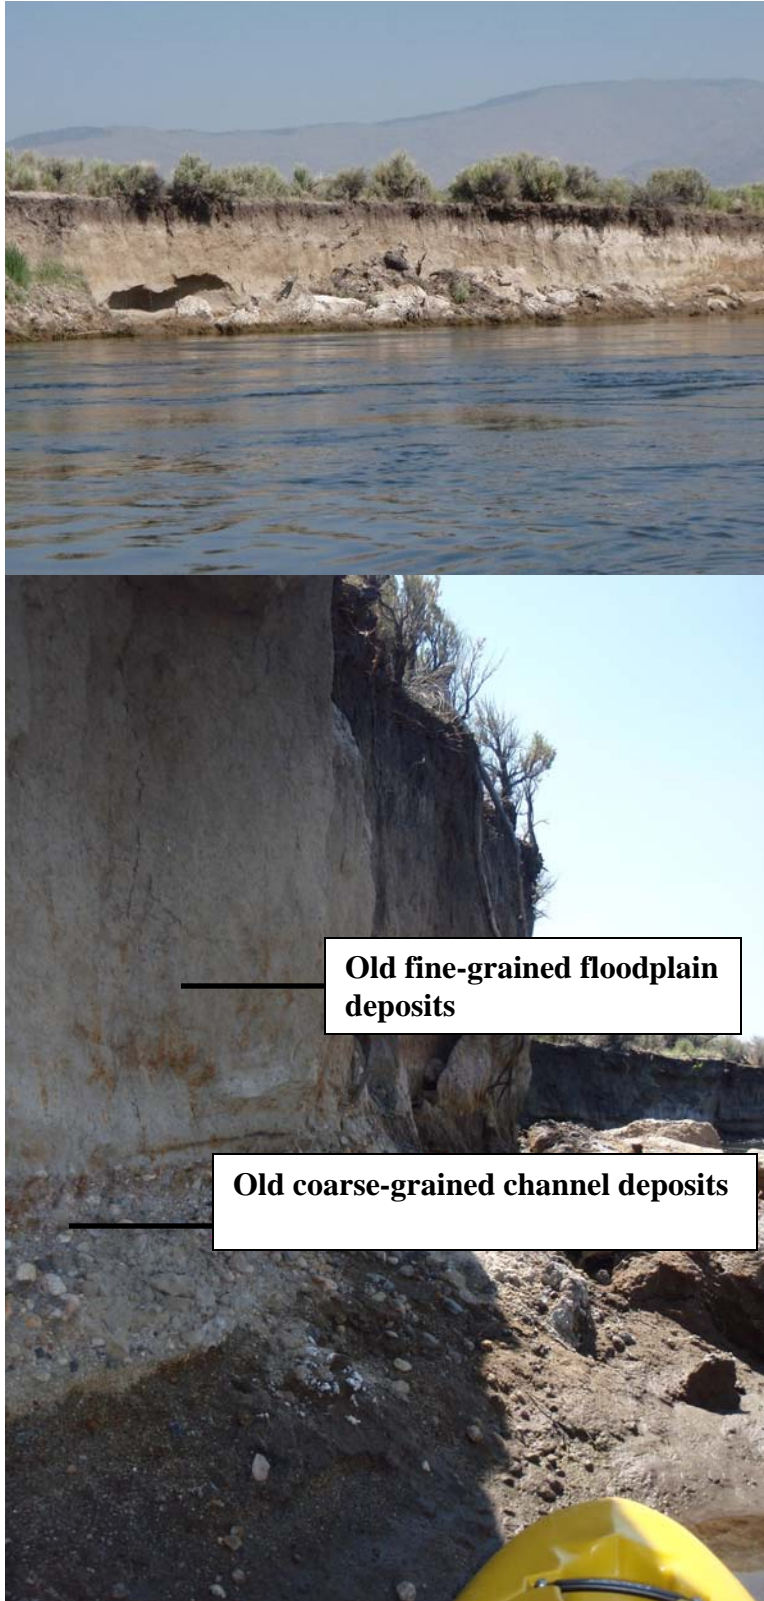
Figure 2.1-112. River is eroding into old floodplain deposits. Banks are six to eight feet high.

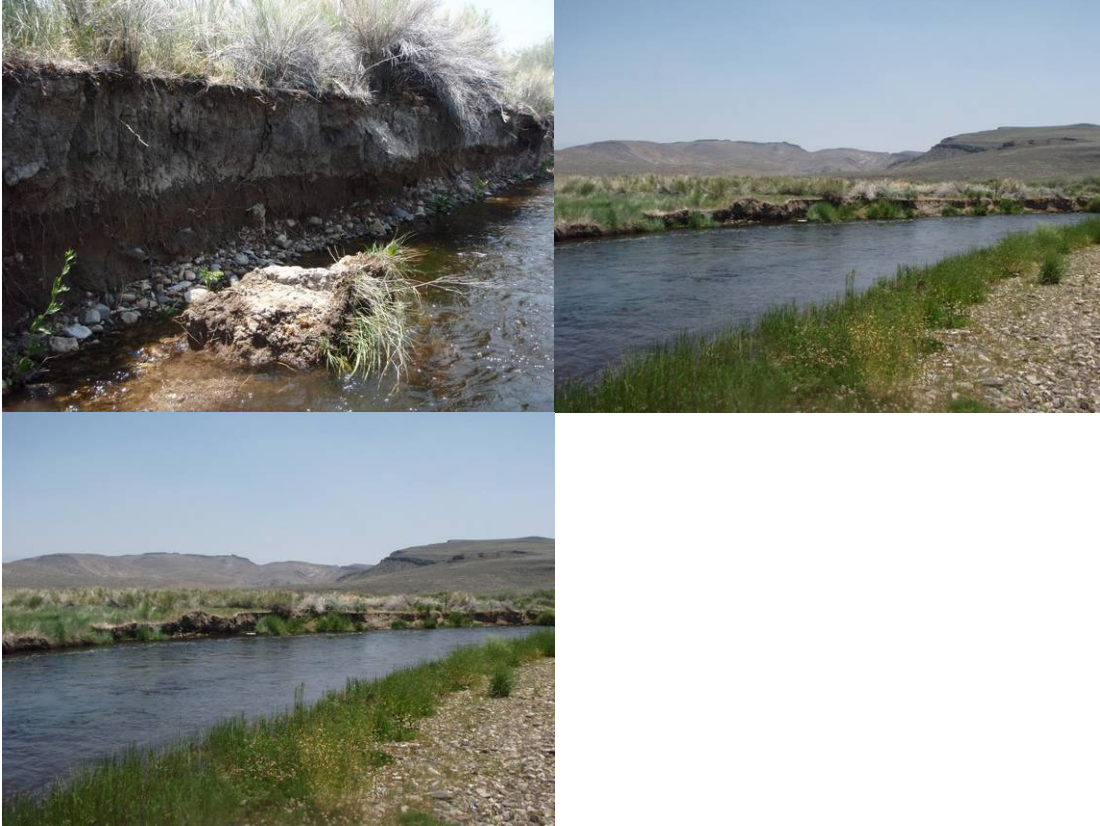
Figure 2.1-114. Actively meandering channel through Rosaschi Ranch. Note cohesive blocks of sediment falling in river and how vegetation is slowing erosion in the bottom left picture.

Near Rosaschi Ranch the river enters a larger valley (EW3) and receives additional flow and sediment from Sweetwater Creek which is a relatively large undammed tributary. The river is actively meandering here and there are areas of bank erosion and point bar deposition. The river is connected to its floodplain according to the results of HEC-RAS and HAR modeling, and does not appear to be actively incising. Larger trees along some of the banks appear to slow bank erosion (Figure 2.1-114).

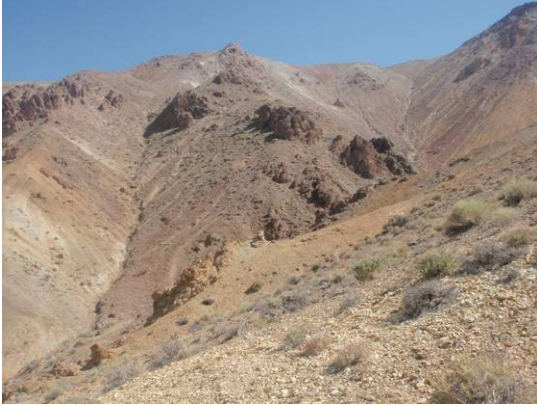
Figure 2.1-116. Erosive upland area.

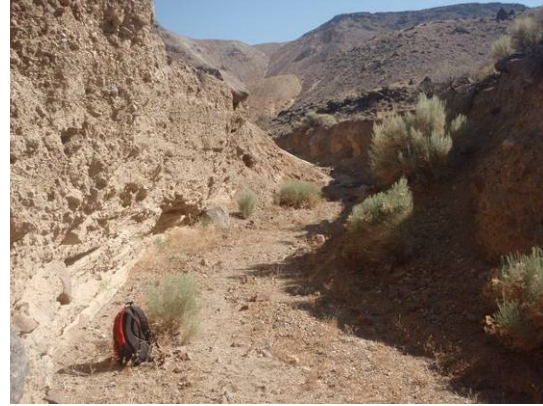
Figure 2.1-117. Main debris flow gully.

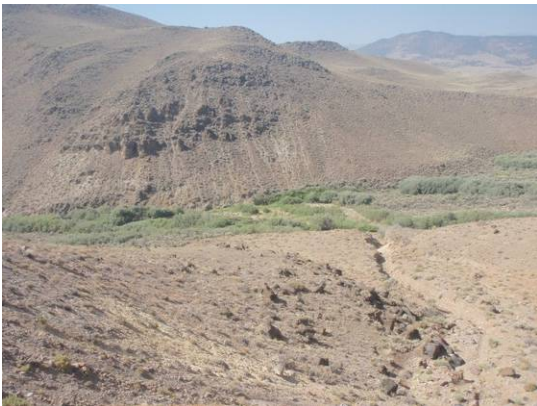
Figure 2.1-118. Looking south toward river of gully with gully right of center in picture.

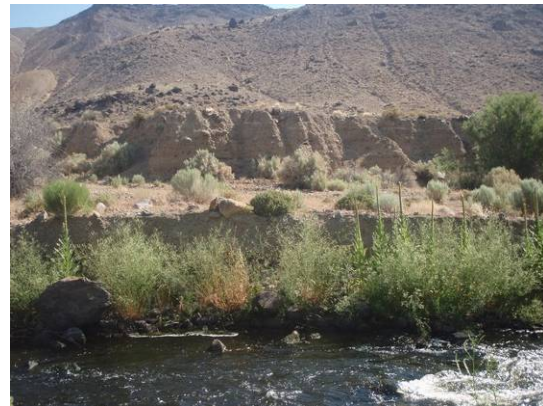
Figure 2.1-119. Multiple terraces at mouth of the gully represent different erosional periods.

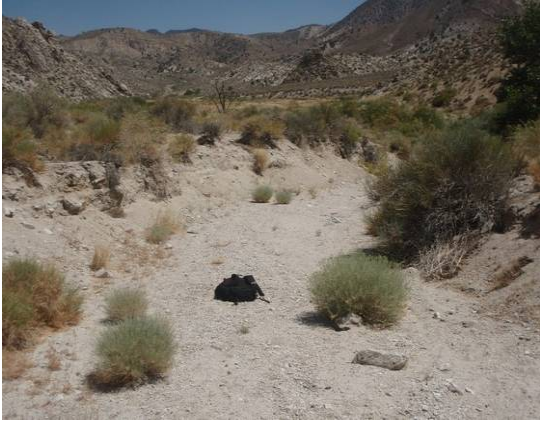
Figure 2.1-120. Grus-filled gully EW5.

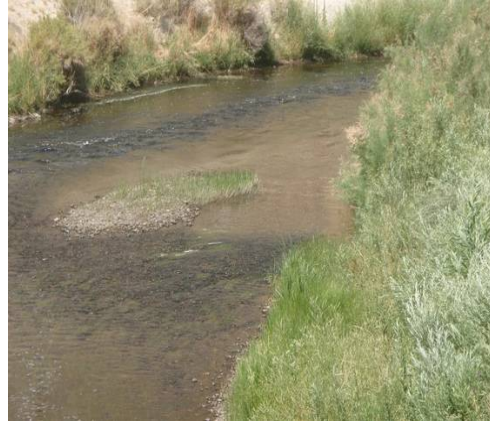
Figure 2.1-121. Note sand in the East Walker River.

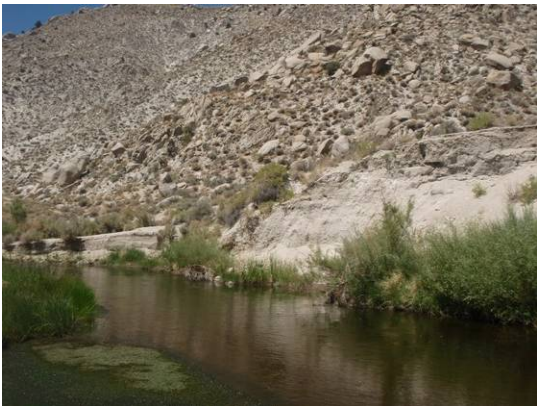
Figure 2.1-122. Large grus deposit eroding into river.
