Walker River Basin Assessment

Prepared For
U.S. Fish and Wildlife
Service
Lahontan National Fish
Hatcheries Complex
1340 Financial Blvd. #234
Reno, NV 89502

January 6, 2009

Prepared By
Otis Bay
Ecological Consultants
PO Box 929
Verdi, NV 89439
www.otisbay.com

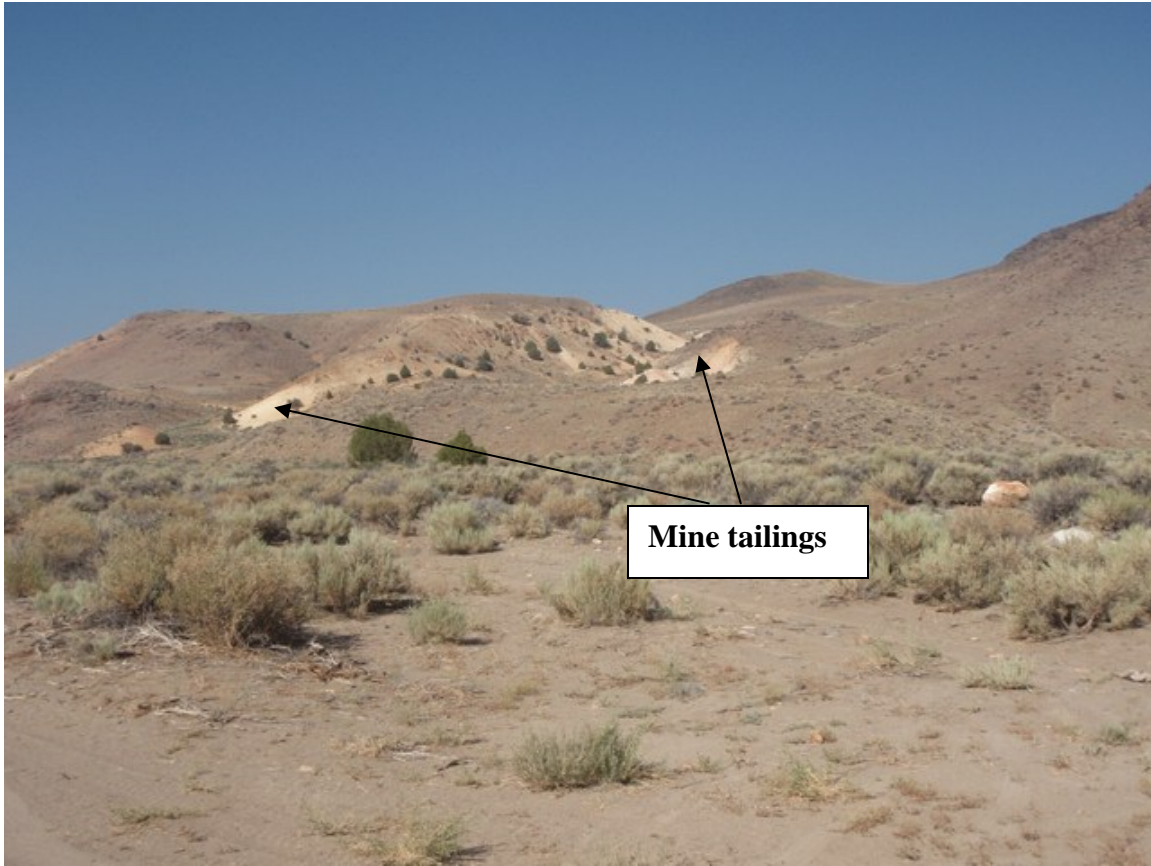
Figure 2.1-123. Mine tailings near Rosaschi Ranch in East Walker Basin.

The upland locations of most historic mining locations prevented direct impacts to river channels in the Basin. Currently, most mines in the area are relatively inactive. However, unfavorable soil chemistry limits revegetation resulting in long-term erodibility of tailings piles.

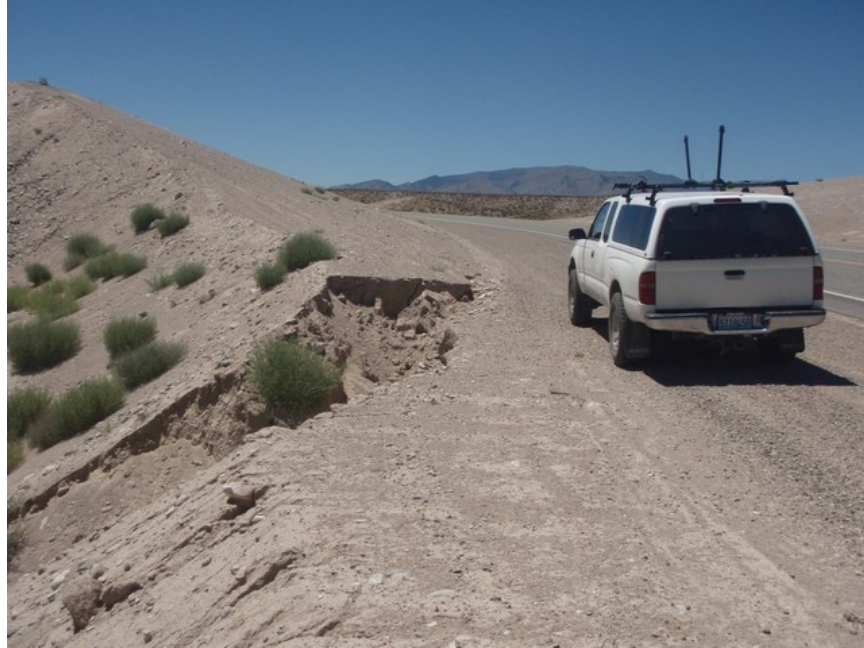
Figure 2.1-124. Large gully erosion off of highway fill slope near Wilson Canyon. The cutslope has just been regraded and no BMP's were evident.

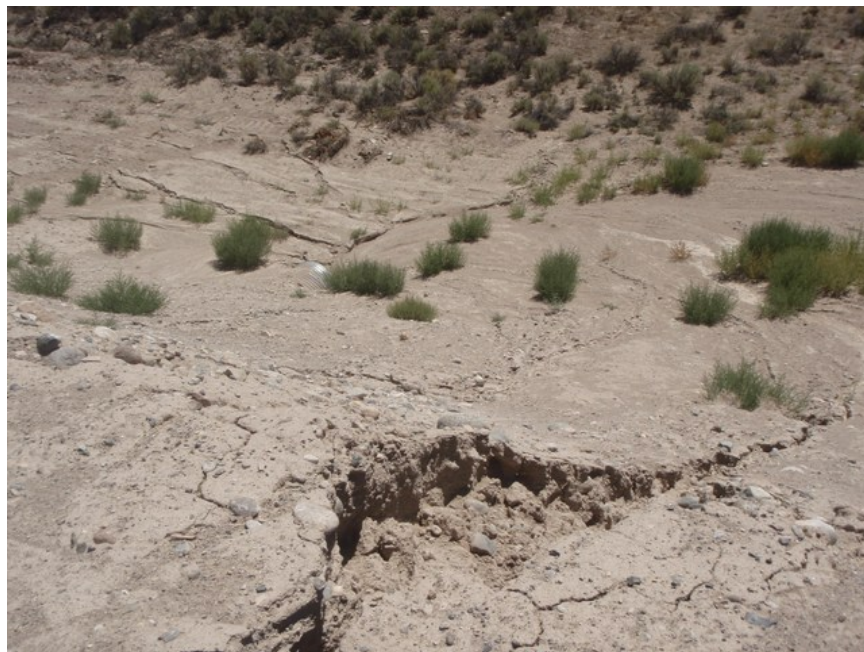
Figure 2.1-125. Sediment off of fill slope routed to culvert, no BMPs present.

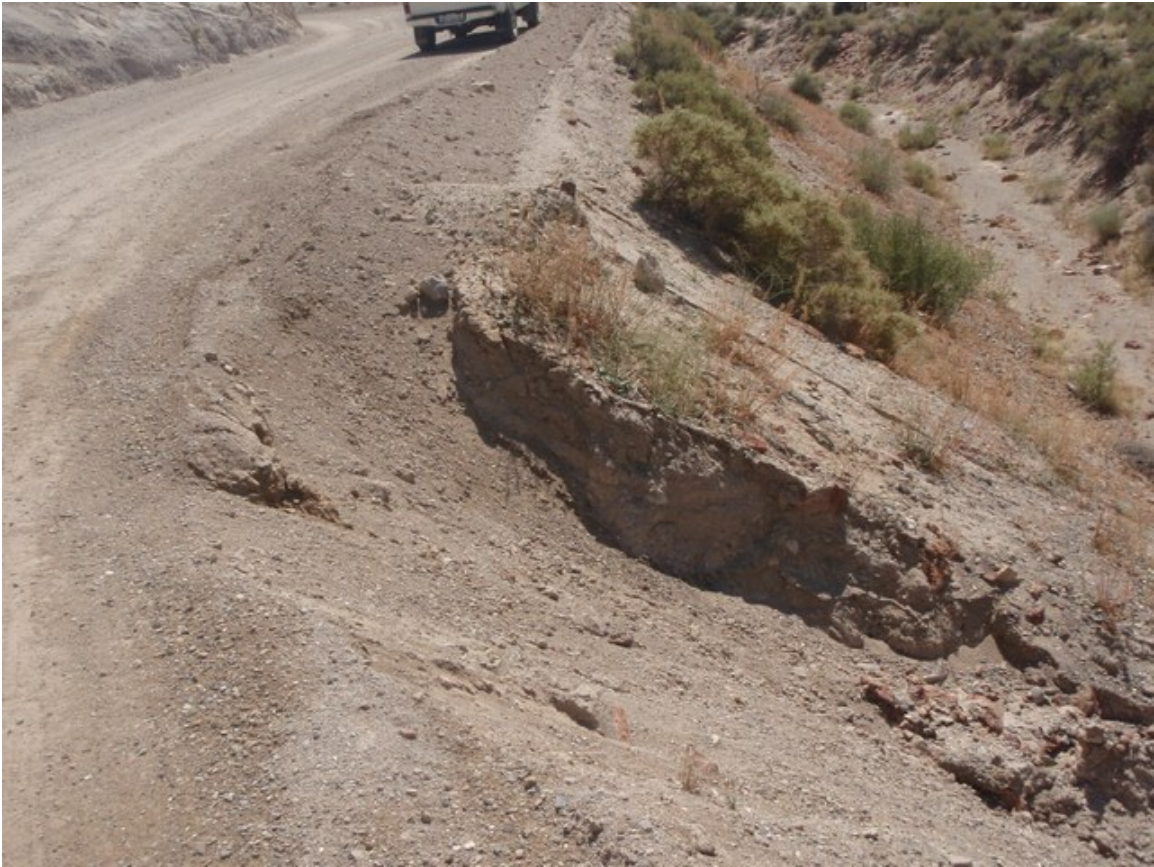
Figure 2.1-126. Side-cast berm has collapsed into the drainage.

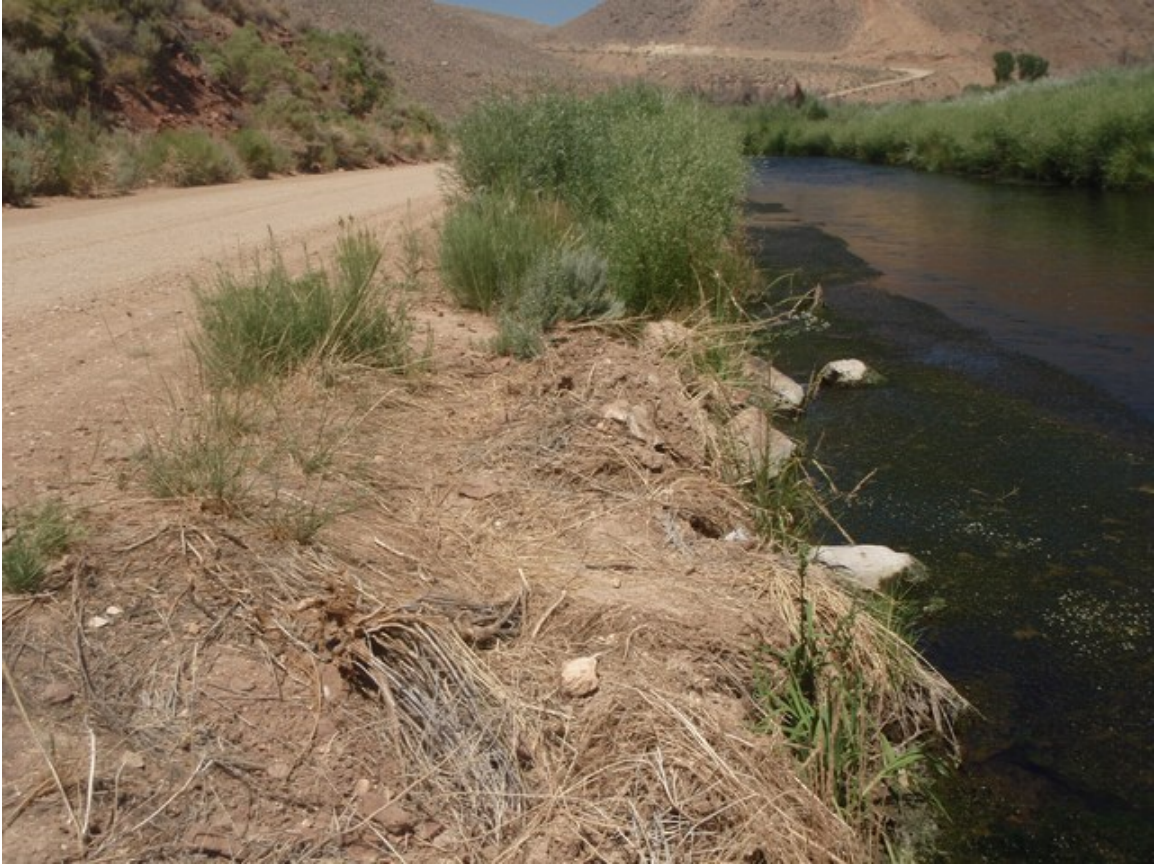
Figure 2.1-127. Side-cast pushed directly into the river.

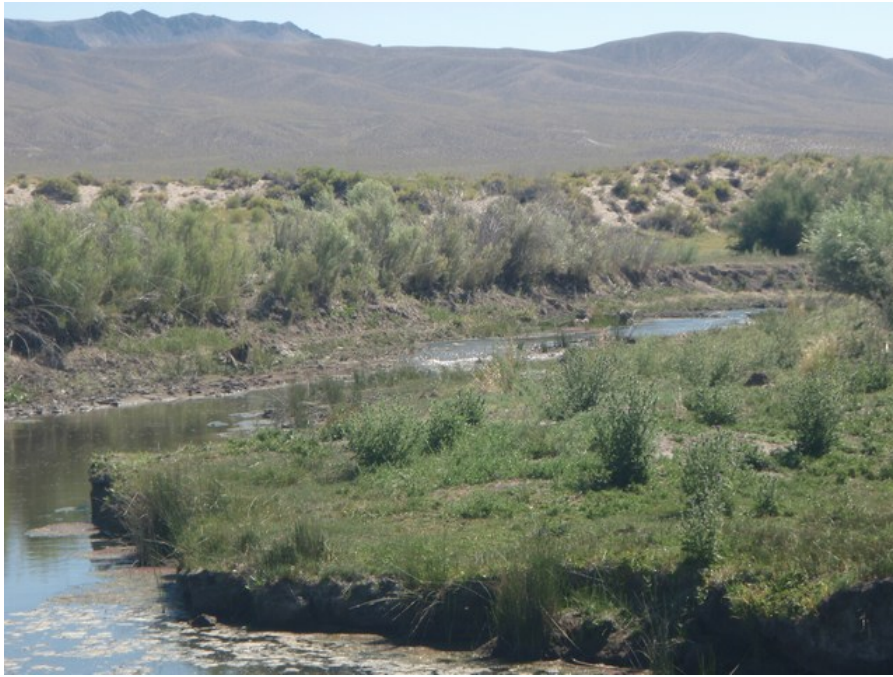
Figure 2.1-130. Walker River just upstream of Weber Reservoir.

Segment W13, just upstream of Weber Reservoir, was one of the few heavily grazed areas visited during the field survey. In this area extensive grazing has impacted areas of riparian vegetation. Figures compare the river channel just upstream of Weber Reservoir with the channel in the MVWMA where grazing is limited (Figure 2.1-130 and Figure 2.1-131).

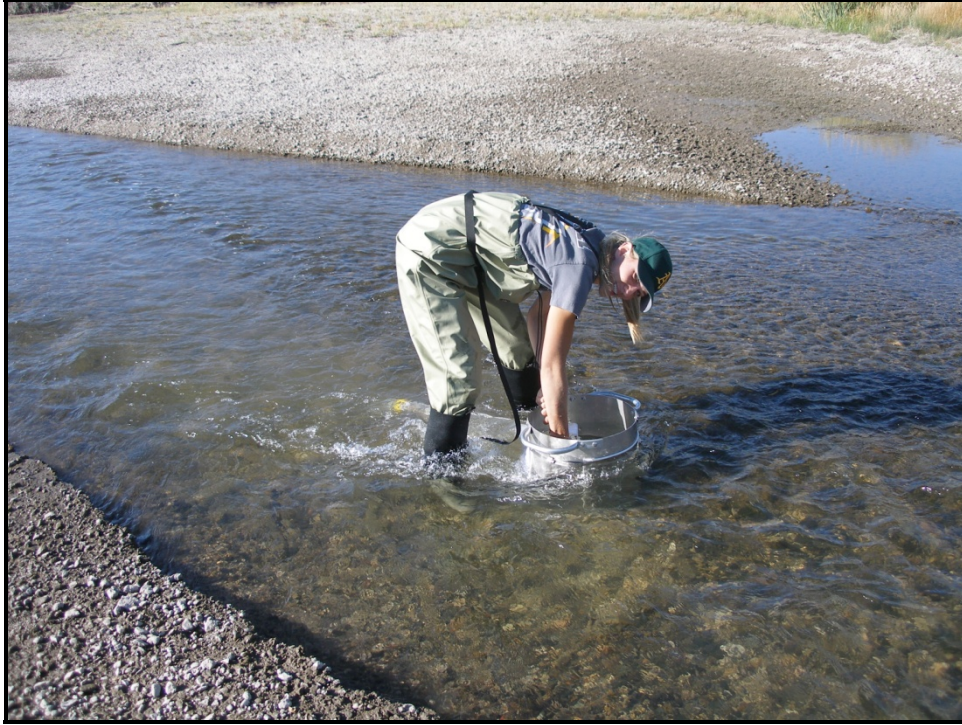
Figure 2.2-12. Depiction of Hess sampler being used at invertebrate site 5.

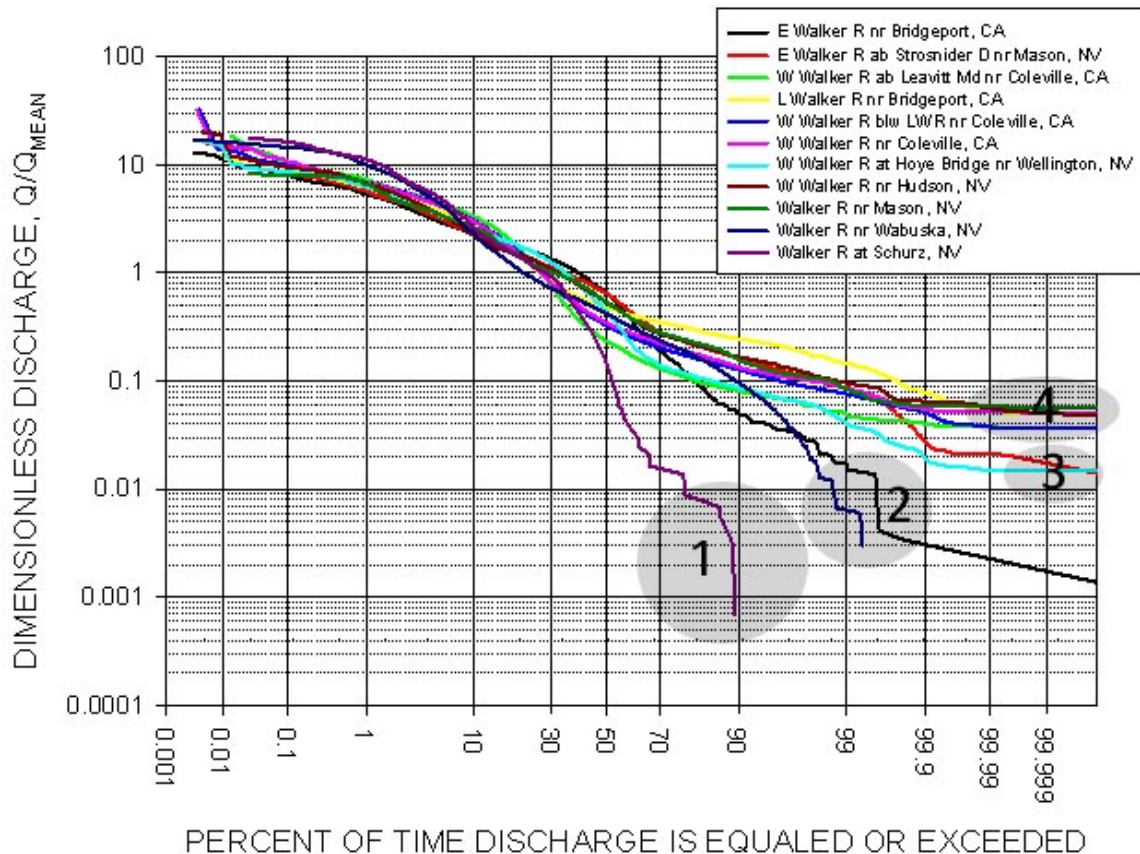
Figure 3.2-1. Scores given to the dimensionless flow duration curves for USGS gages.

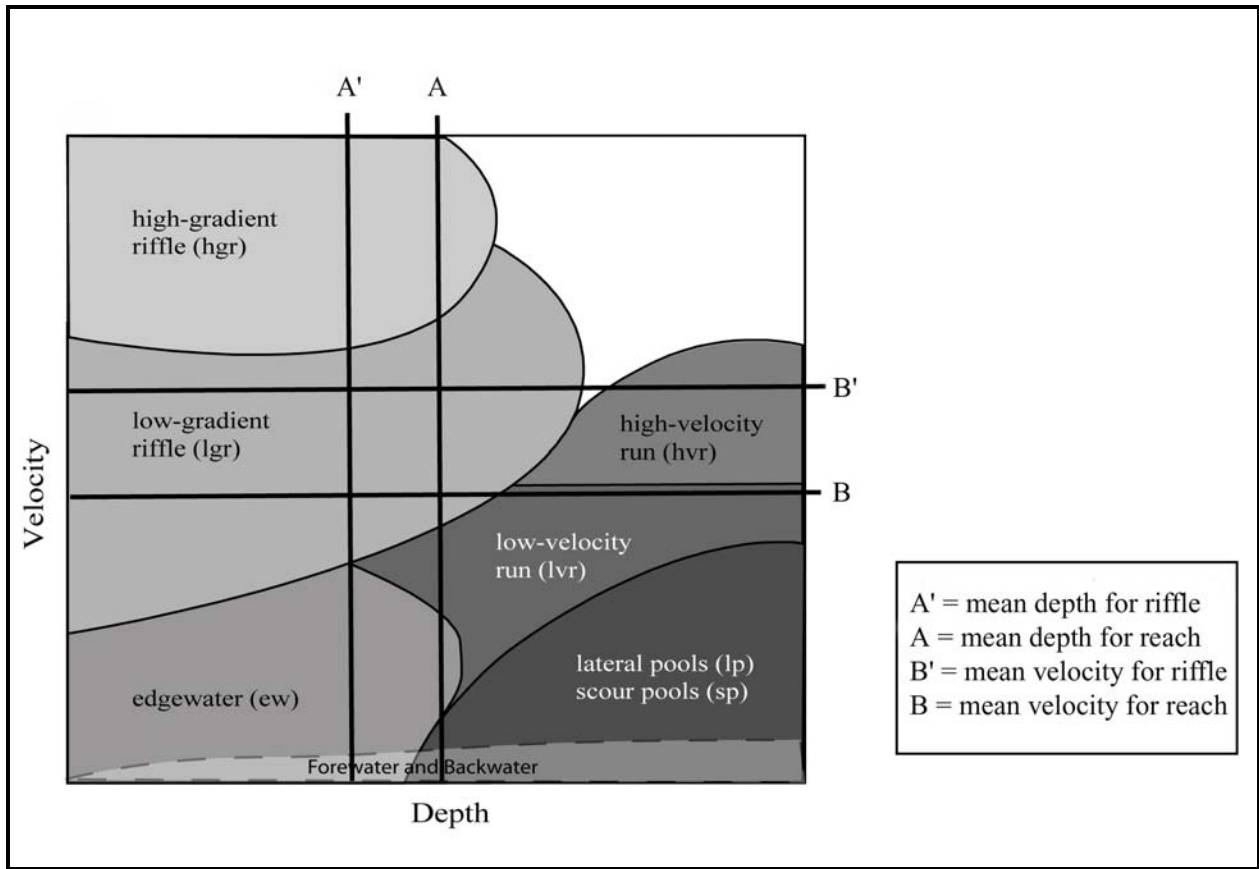
Figure 3.2-3. Plot of hydraulic zones for stream channels.
