SOUTHERN NEVADA
WATER AUTHORITY

**Synoptic Discharge Study
Big Springs and Lake Creeks, Snake
Valley, Nevada and Utah - March 5, 2014
and September 17, 2014**

December 2015

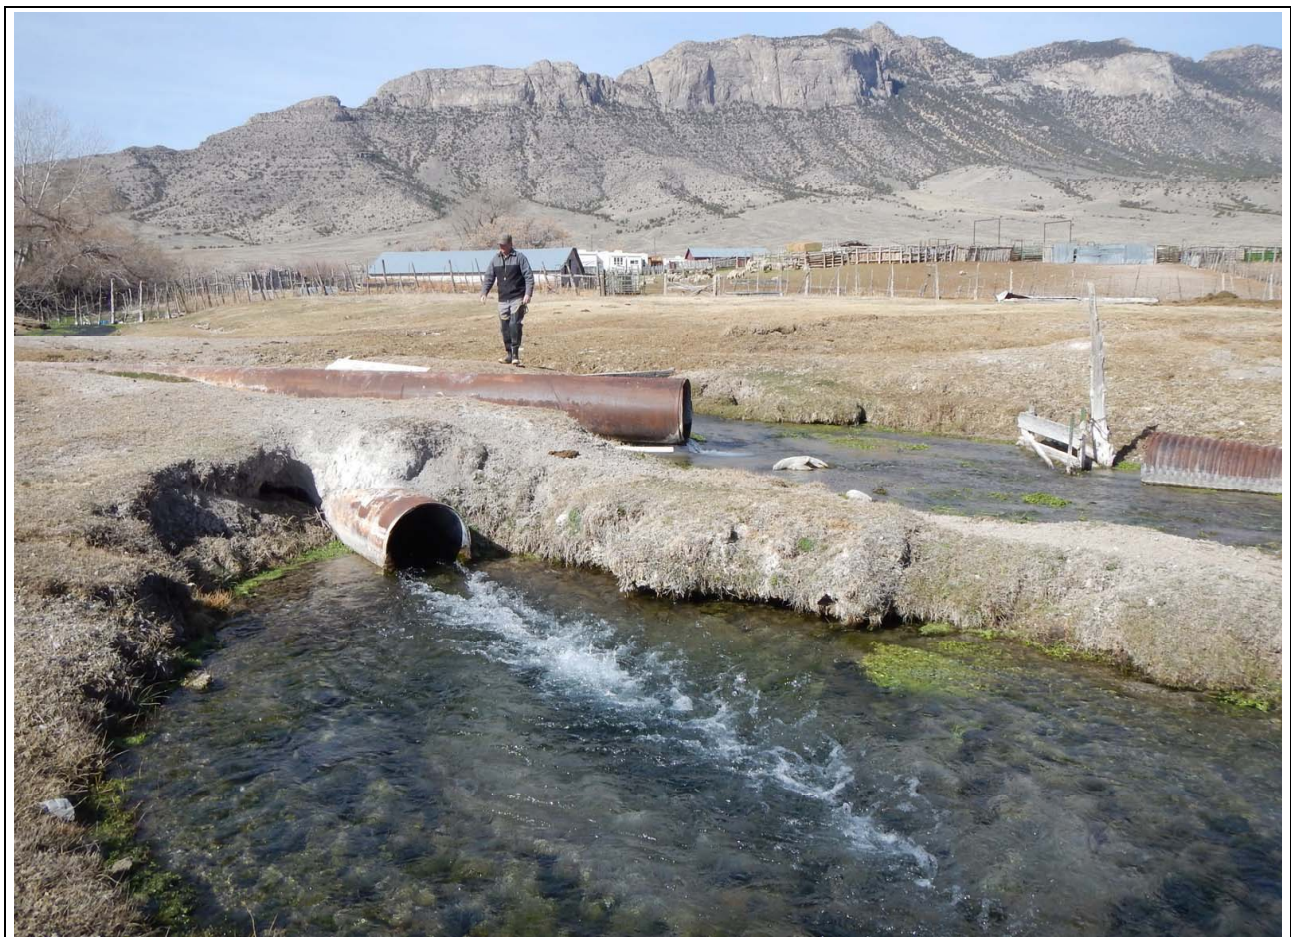
Figure 4-2
Looking southwest - Site 1.1.2 Big Springs Creek (foreground) and
Site 1.2.4 Okelberry Diversion Ditch (background)

Located approximately 100 yards downstream from Sites 1.2.1 and 1.2.2 are Sites 1.1.2 (North Channel/Big Springs Creek) and 1.2.4 (South Channel/Okelberry Diversion Ditch). Site 1.1.2 measures the total flow of Big Springs Creek and Site 1.2.4 measures the total flow of the Okelberry Diversion Ditch. Both of these channels are located in an active corral and meadow. The banks are grass-lined and heavily trampled by livestock. The bed material at Site 1.2.4 ranges in size from silts along the edges to coarse gravel and large cobbles with a few boulders present. At Site 1.1.2, the channel bed material is coarse gravel with a few large cobbles and small boulders. The crossing of the North and South channels is shown in [Figure 4-2](#). Measurements made at these sites are considered poor based on channel and flow characteristics observed during the measurements.

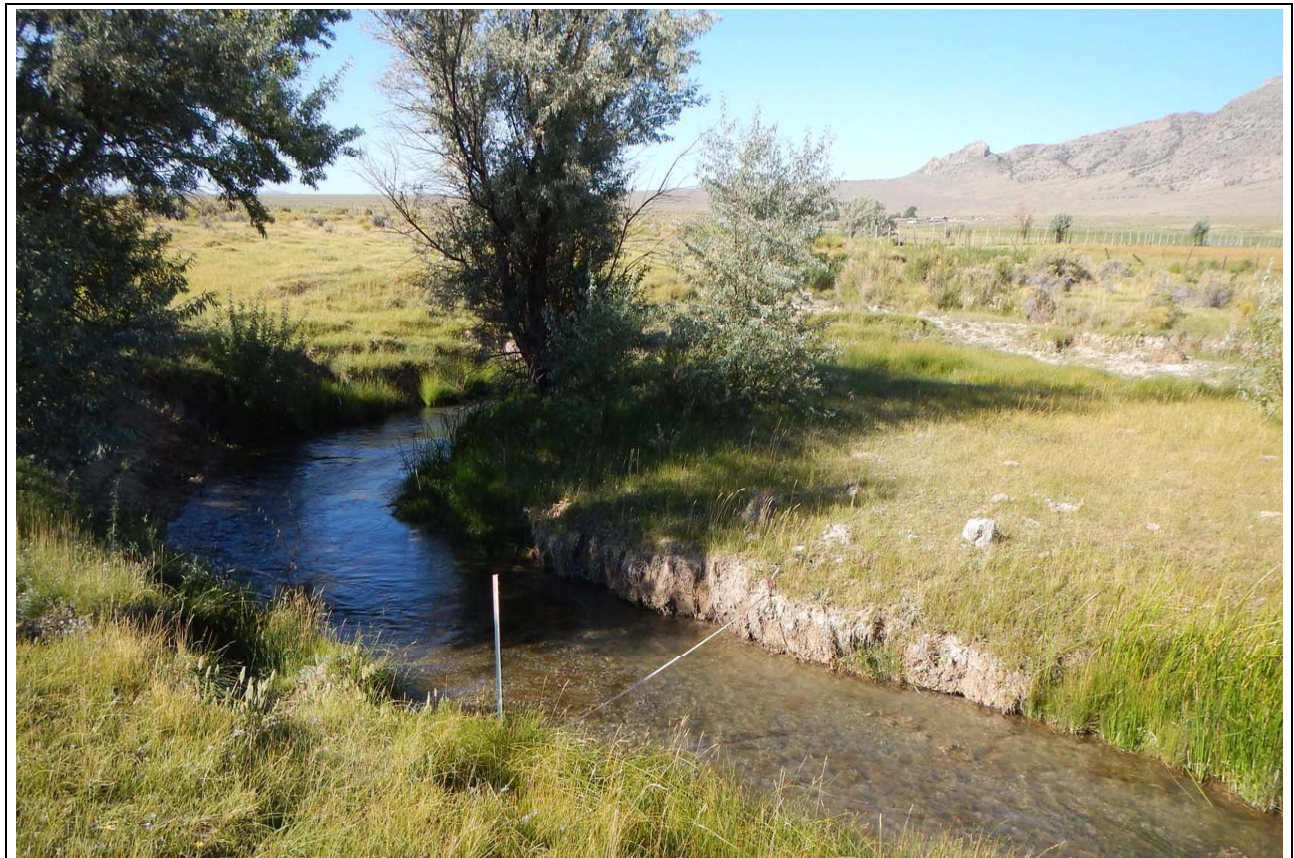
Figure 4-3
Site 2 During the Irrigation Season

Site 2 is characterized by steep, wet, grassy, sloughing banks. The sloughing has been exacerbated by livestock grazing in the area. Bed materials during the field events were firm, coarse sands and gravel with soft, silty areas along each bank. The control for the measurement section was the bank and stream bed. The stream flow was shallow, fast, turbulent and clear, and discharge measurements were rated as poor to fair based on channel and flow conditions observed during the measurements ([Figure 4-3](#)).

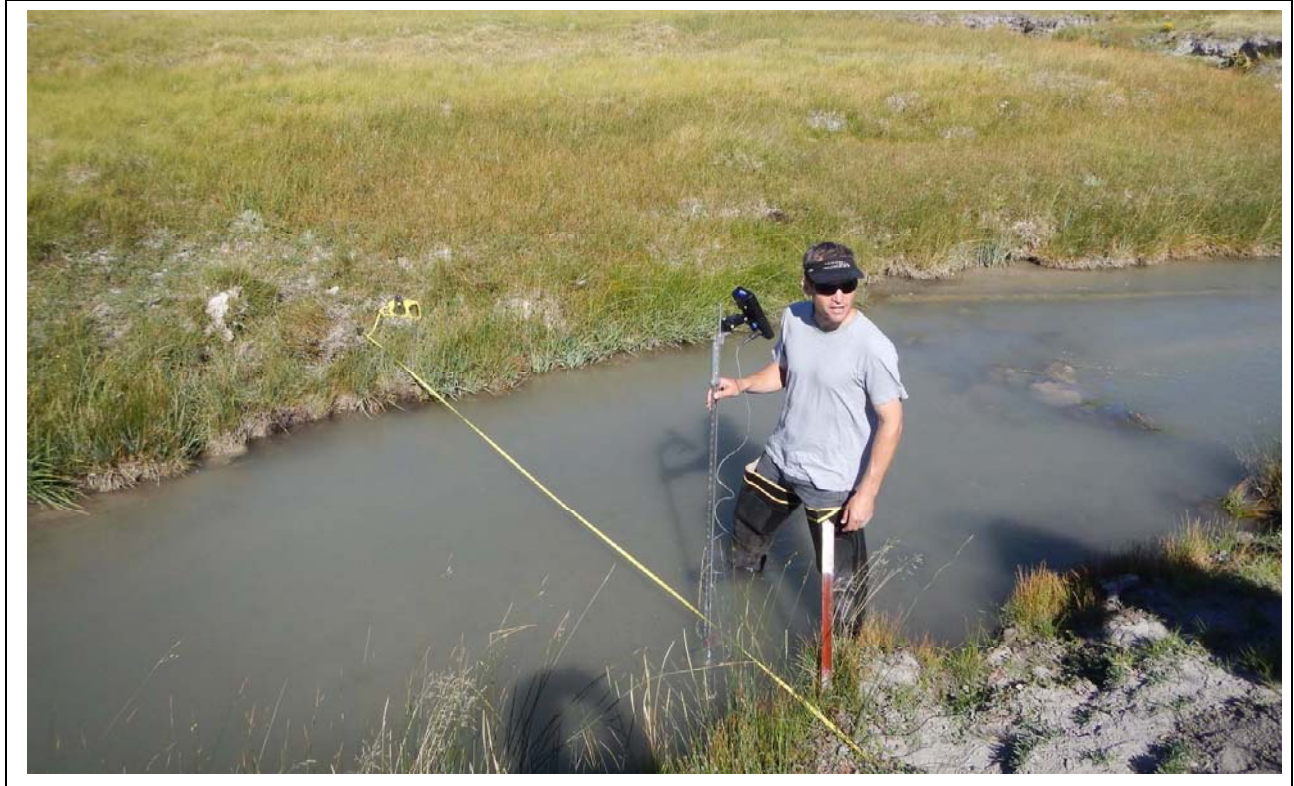
Figure 4-4
Site 3 During the Irrigation Season Measurement Field Event

Site 3, located approximately 0.9 miles downstream of Site 2, has steep, soft, silty, sloughing grass-lined banks. Like Site 2, the sloughing has been exacerbated by livestock grazing in the area. Unlike Site 2, the water clarity during the measurements was turbid and velocities slower. Bed material was soft and silty along both banks and became increasingly firm in the center of the channel. Cross section flow control was provided by the channel. Discharge measurements made during both seasons were rated poor based on the conditions observed during the study.

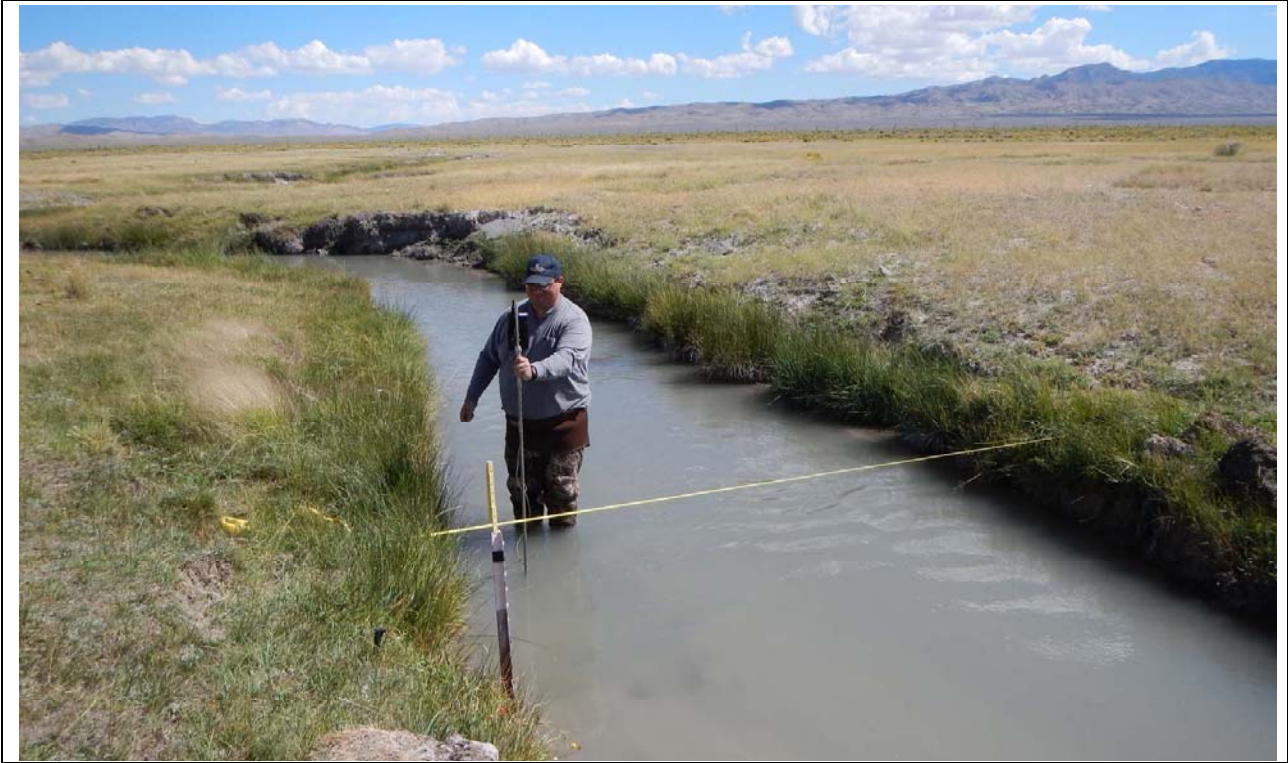
Figure 4-5
Site 5 Irrigation Season Measurement

The measurement section of Site 5 has nearly vertical banks and the channel is typically more than over one foot deep. The bed material is very soft silts becoming increasingly soft from the center of the channel towards the banks. During the measurements the velocity was slow and the water very turbid. Flow control at Site 5 is the stream bed and banks. Measurements made at Site 5 are rated poor based on the channel characteristics and flow conditions observed during the field events. A photo of Site 5 is shown on [Figure 4-5](#). Both during non-irrigation and irrigation seasons small losses of 0.5 and 0.2 cfs respectively were observed along the reach defined by Sites 4 and 5.

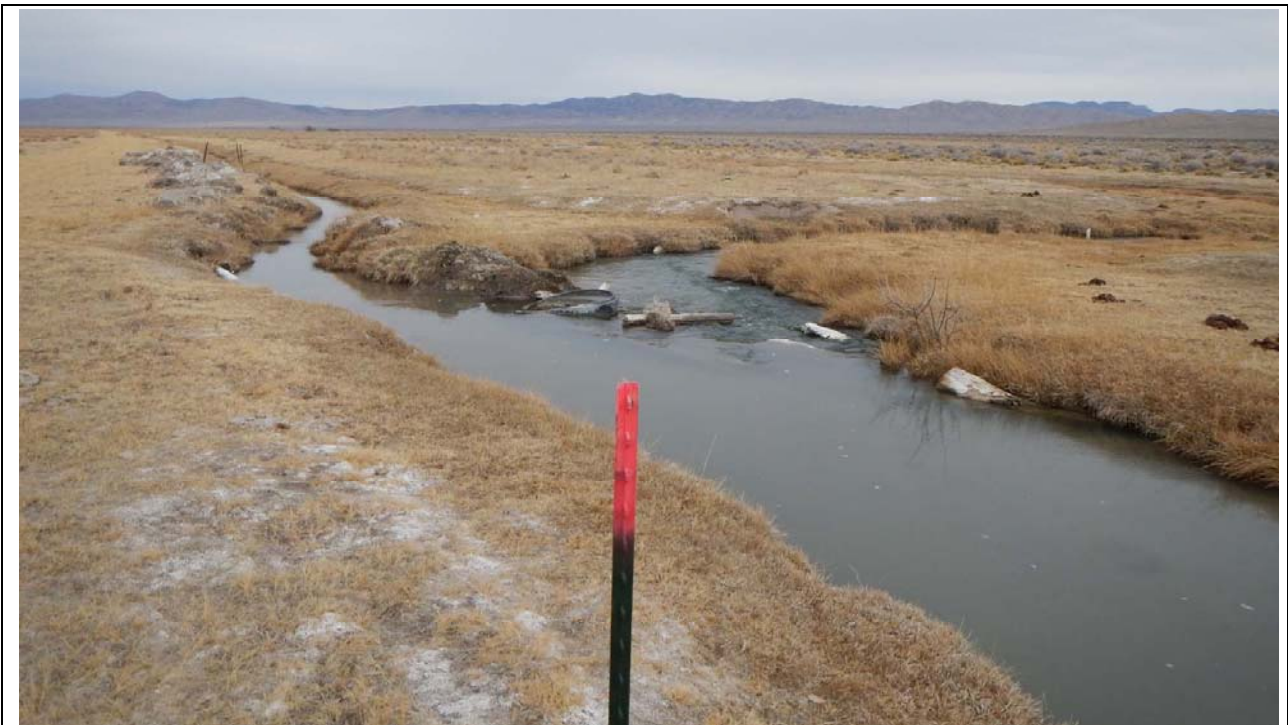
Figure 4-6
Site 6 Looking Downstream at the Control. House Diversion Ditch is on the Left Side of the Photo.

Physical characteristics of the channel at Site 6 are similar to those observed at Site 5. The channel becomes increasingly deeper with vertical silty banks and soft silty bed material. At Site 6, an artificial control has been installed across the channel to allow water to be diverted into the House Ditch. The control is stable and made up of tires, plastic tarps, wood, rocks and other debris. As a result, the control velocities during the measurements were slow. The slow velocity resulted in a large silt bar forming along the left bank at the mouth of the House Ditch. The elevation of the control and the large silt bar at Site 6 regulate the amount of water entering the House Ditch. Discharge measurements were rated as poor based on the channel characteristics and flow conditions observed during the field events. A photo of Site 6 is shown on [Figure 4-6](#). The measurements indicate that the reach between Sites 5 and 6 gains 1.2 cfs in the non-irrigation season and 0.4 cfs during the irrigation season.

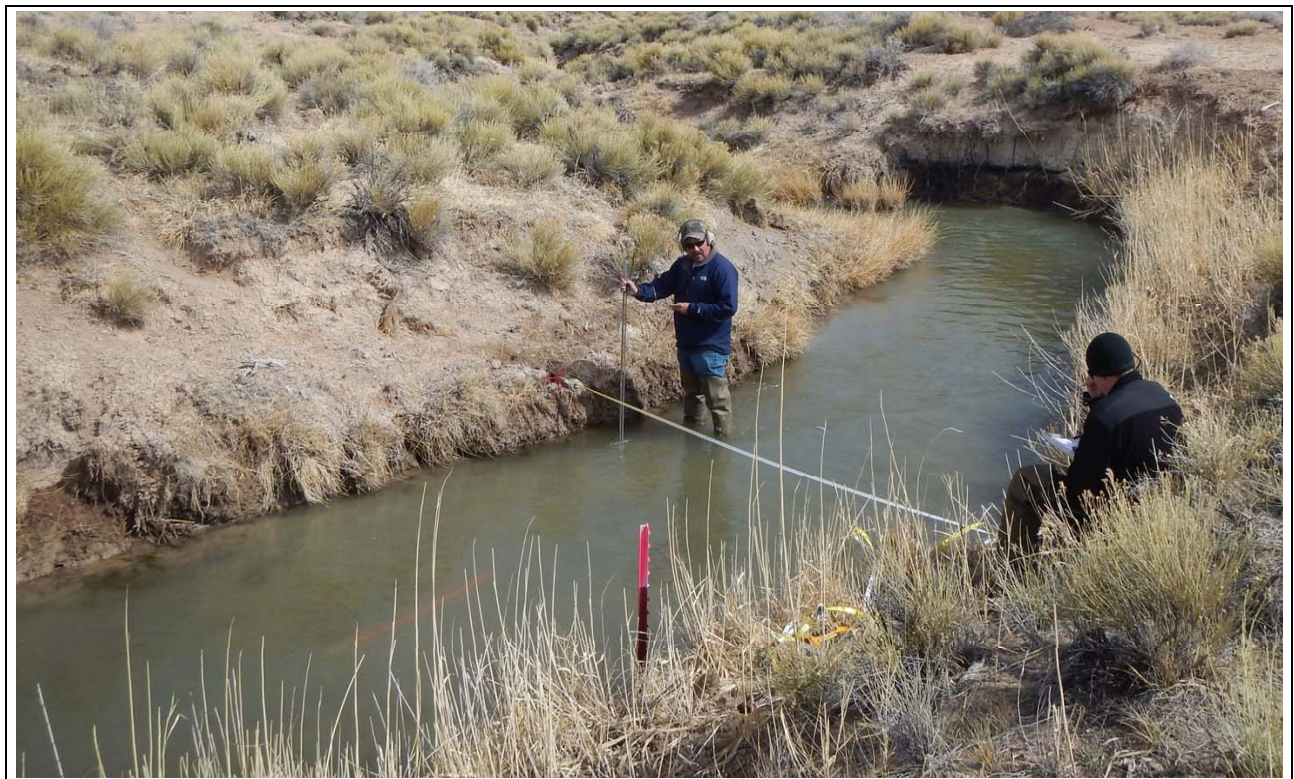
Figure 4-7
NDWR Staff Measuring Site 7 During the Non-Irrigation Season

Phreatophytic shrub-lands with sparse perennial grasses line the steep banks at Site 7. Unlike other locations, Site 7 is deeply incised approximately 6-8 ft below the elevation of the flood plain. During the measurements, velocities were higher, and the depths were shallower when compared to Site 6. Bed material is soft silt along both banks, with firm gravel making up the center of the channel. Measurements were rated from fair to poor based on the channel characteristics of the site and flow conditions observed during the study. A photo of Site 7 is shown on [Figure 4-7](#).

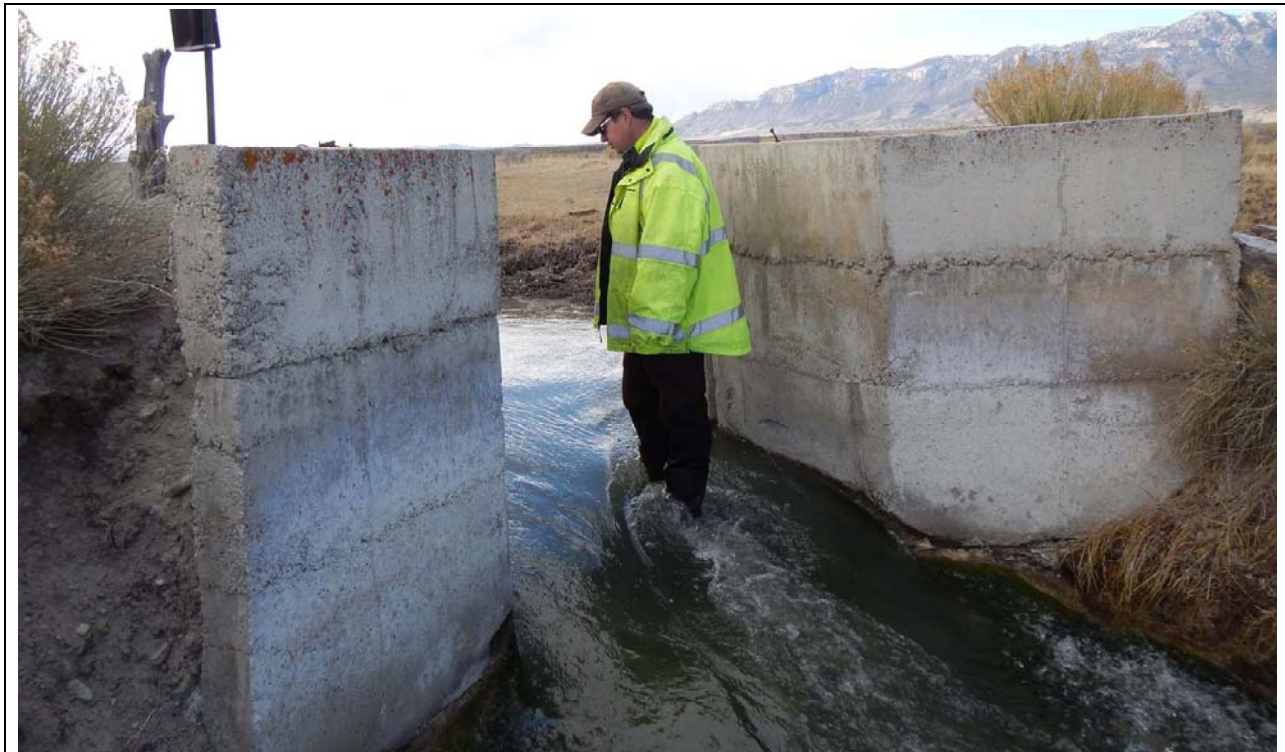
Figure 4-8

SNWA Staff Inspect Site 8 During February 2014 Pre-Event Field Trip

diverted into the High-line Ditch during either field event. Site 8 is a concrete structure similar in design to a modified Parshall Flume and is shown on [Figure 4-8](#). Grooves in the concrete allow the addition or removal of flash boards to modify the volume of water diverted into the high-line ditch. Having shallow depth and a short cross section, measurements made at Site 8 are considered poor. During the measurements, water at the site was turbid.

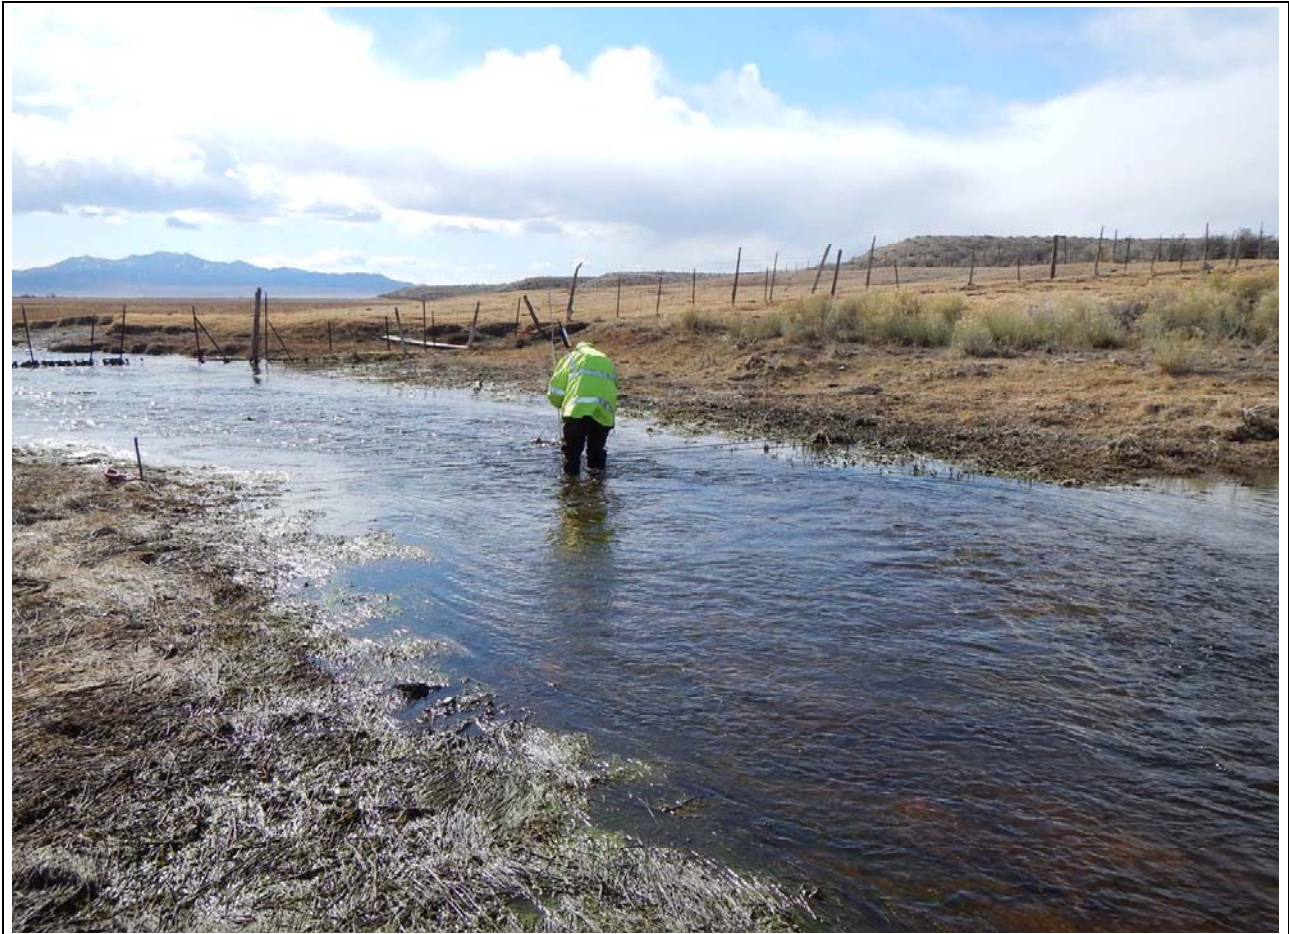
Figure 4-9
Site 12 During Non-Irrigation Season

Site 12 is located in a discrete channel downstream of the diffuse irrigation areas. A photo of Site 12 is shown on [Figure 4-9](#). It is located in a broad channel heavily overgrown with perennial meadow grasses with a soft, silty bed that has been heavily trampled by livestock. Prior to the measurements, the channel was cleaned and groomed to obtain more accurate results with the conditions present. At the time of the measurements, the control for the channel was a restriction in the channel caused by vegetation. Measurements at the site are considered poor based on the channel conditions.

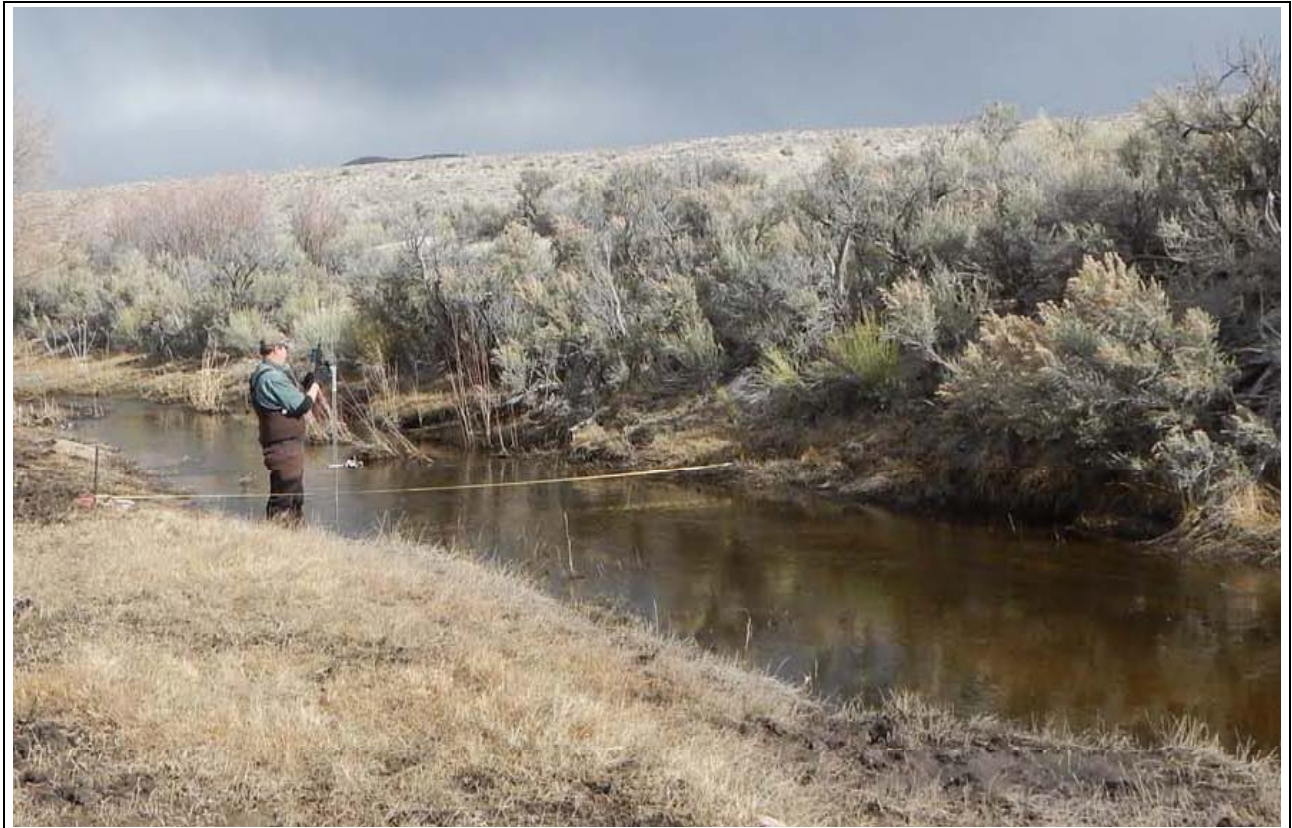
Figure 4-10
Site 13 During the Pre-Event Field Trip February 2014

Site 13, located above Pruess Lake, was the last downstream measurement section of the study. The channel changed from a broad meadow at Site 12 to a narrow channel at Site 13 as shown in [Figure 4-10](#). The channel has soft, steep banks and heavy aquatic plant growth that was cleaned out prior to the field events. The control during the non-irrigation season portion of the study was ice, vegetation and debris located downstream. During the irrigation season the channel itself controlled the discharge. Measurements are considered poor based on the channel conditions at the time of each field event.

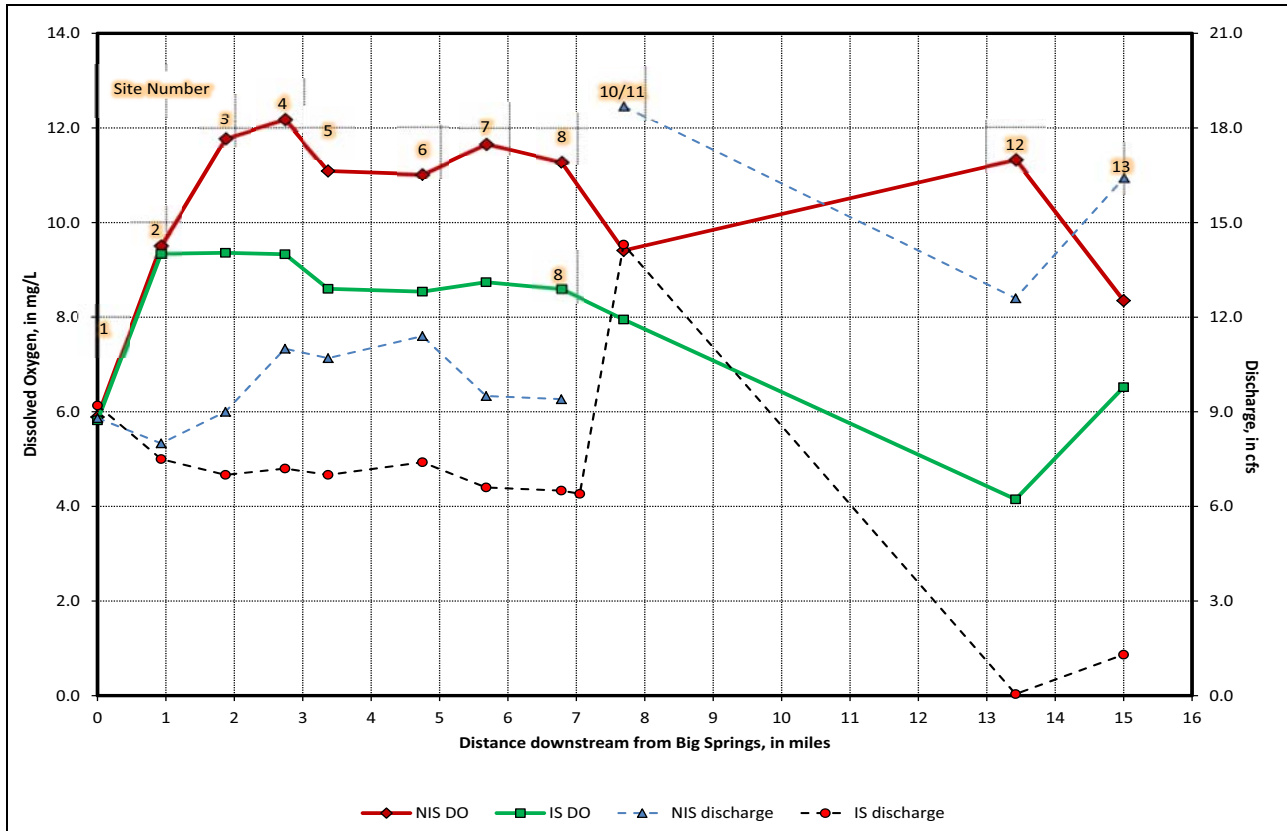
Figure 4-12
Dissolved Oxygen and Discharge Measurements During Irrigation and Non-Irrigation Seasons

Between Sites 4 and 5 there was a decrease in DO values during both seasons. From Site 5 to Site 6 the DO values were consistent and then increased between Sites 6 and 7. When the discharge data is reviewed the velocities decrease between Sites 4 and 5, are similar between Sites 5 and 6, and increase again between Sites 6 and 7. These higher velocities occur where the water becomes more turbulent allowing aeration of the water, which increased the DO values. From Site 7, downstream, the values remain relatively constant to Site 8. Downstream of Site 8, there is a large decrease in DO

measured at Site 10 and 11 during both seasons. This is caused by the observed large inflow of groundwater, which has a much lower DO value, into Lake Creek at Dearden Springs.

DO values measured at Site 12 during the non-irrigation season are similar to those measured at Site 8, and then decrease sharply at site 13. Irrigation season measurements demonstrate a very low DO at Site 12 and a measured increase at Site 13. Velocity measurements at Site 12 indicate a nearly stagnant pool during the irrigation season (0.06 ft/sec), and the inflow of water from Clay Spring and groundwater contributes to the increase in DO observed at Site 13. During the non-irrigation season the inflow of water from Clay Spring and groundwater results in lower DO values.

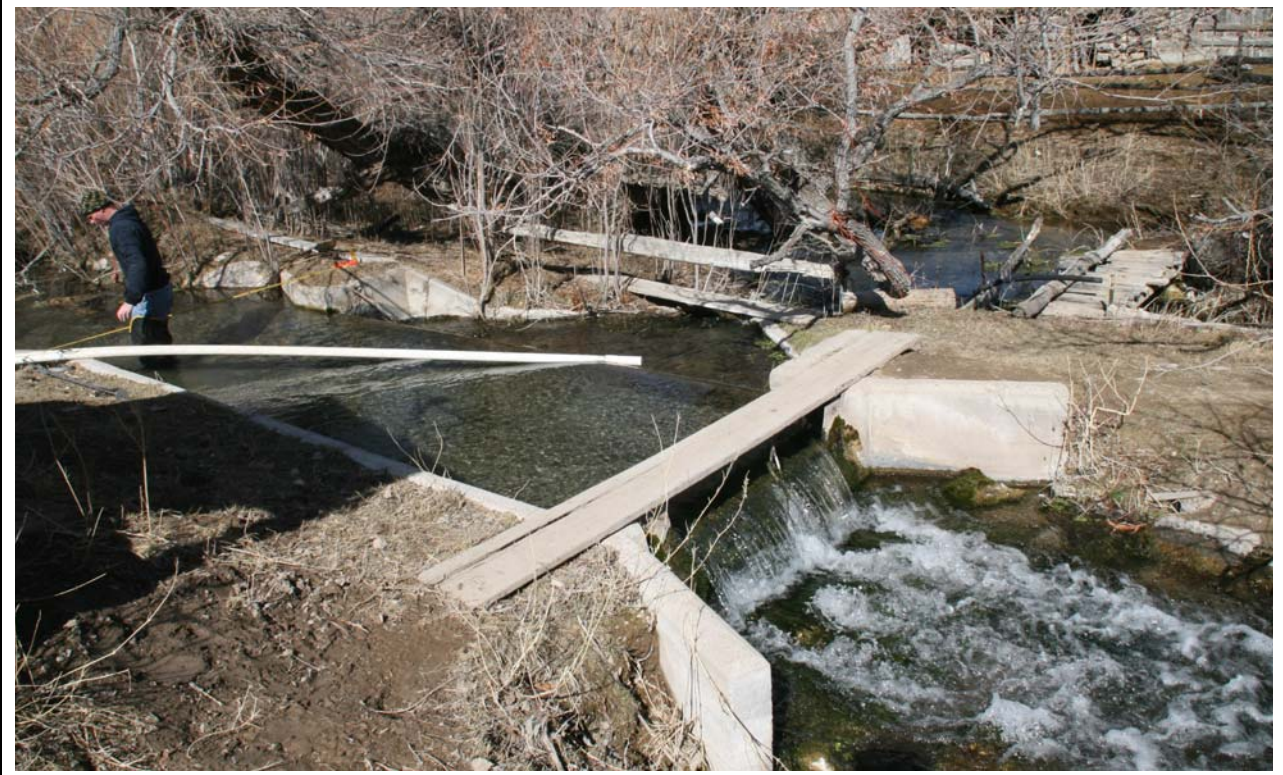
Figure D-1
Big Springs South Channel Weirs

Big Springs are located approximately 18 miles southwest of Garrison, Utah at the base of the eastern flank of the southern Snake Range, in Nevada. Spring discharge at Big Springs occurs from two major springheads into two channels, identified as North Channel and South Channel, which are separated by a narrow strip of land approximately 10-15 feet (ft) wide. Two gaging stations are maintained by USGS Water Science Center through a joint funding agreement with SNWA and Nevada Division of Water Resources (NDWR) which measure discharge in the channels. The gaging stations are located approximately 25 ft downstream of the spring orifices. Photos of the South and North Channels downstream of the gages are presented in [Figures D-1](#) and [D-2](#), respectively.

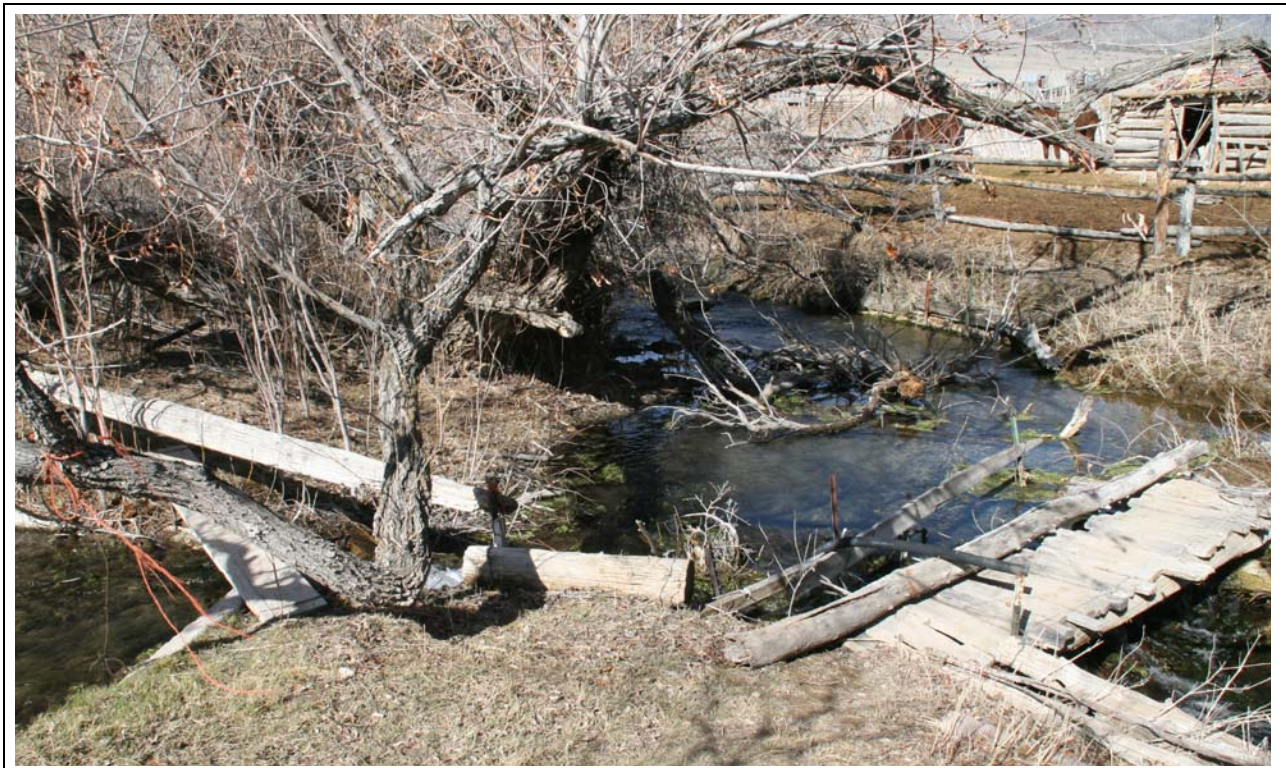
Figure D-2
Big Springs North Channel

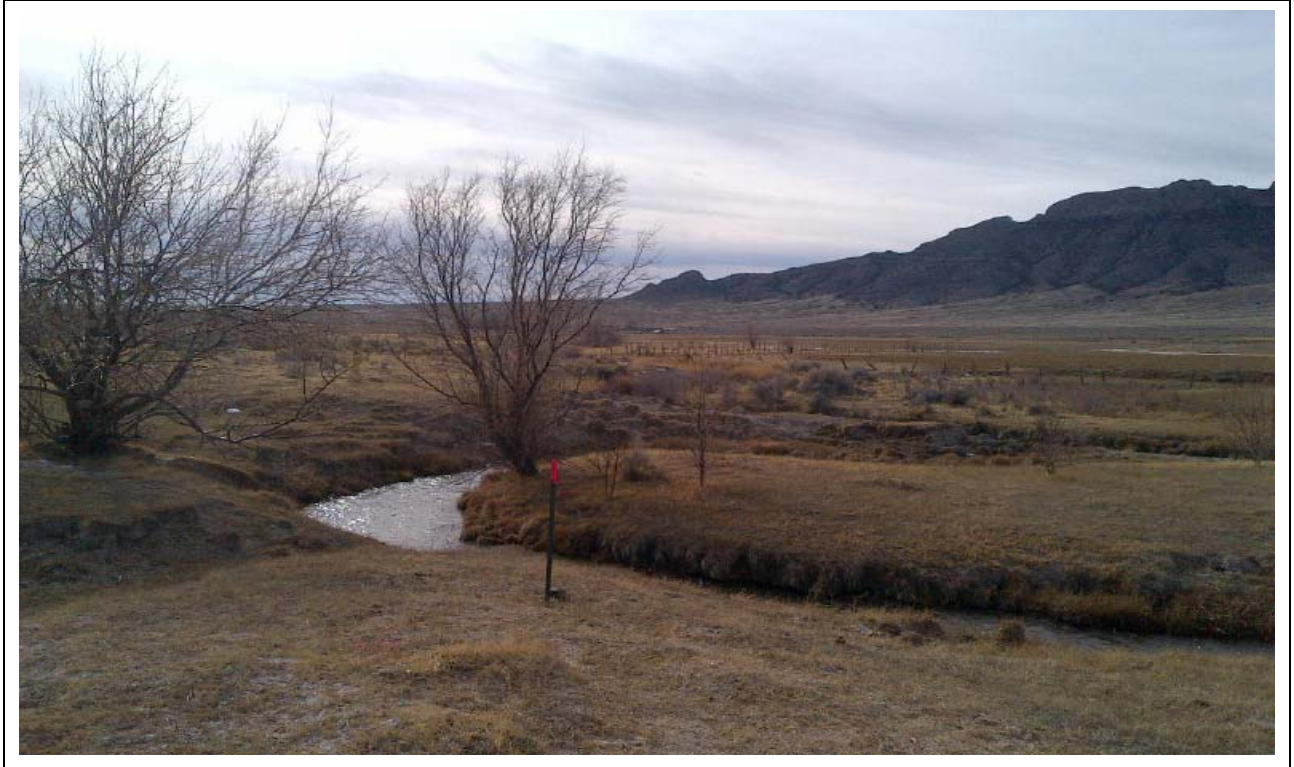
Figure D-5
Big Springs Creek at Upstream Okelberry Meadow Site 2

Irrigation water that infiltrates and is not consumed by evapotranspiration (ET) may return to Big Springs Creek as seepage. Water from the Okelberry Diversion Ditch has also been observed in the past returning to Big Springs Creek as overland flow. A photo of Big Springs Creek at the Okelberry upper meadow (Site 2) is presented in [Figure D-5](#).
