Las Vegas Wash Vegetation Monitoring Report, 2015

December 2016

**SOUTHERN NEVADA WATER AUTHORITY
Las Vegas Wash Project Coordination Team**

**Jason R. Eckberg
Southern Nevada Water Authority
100 City Parkway, Suite 700
Las Vegas, Nevada 89106**

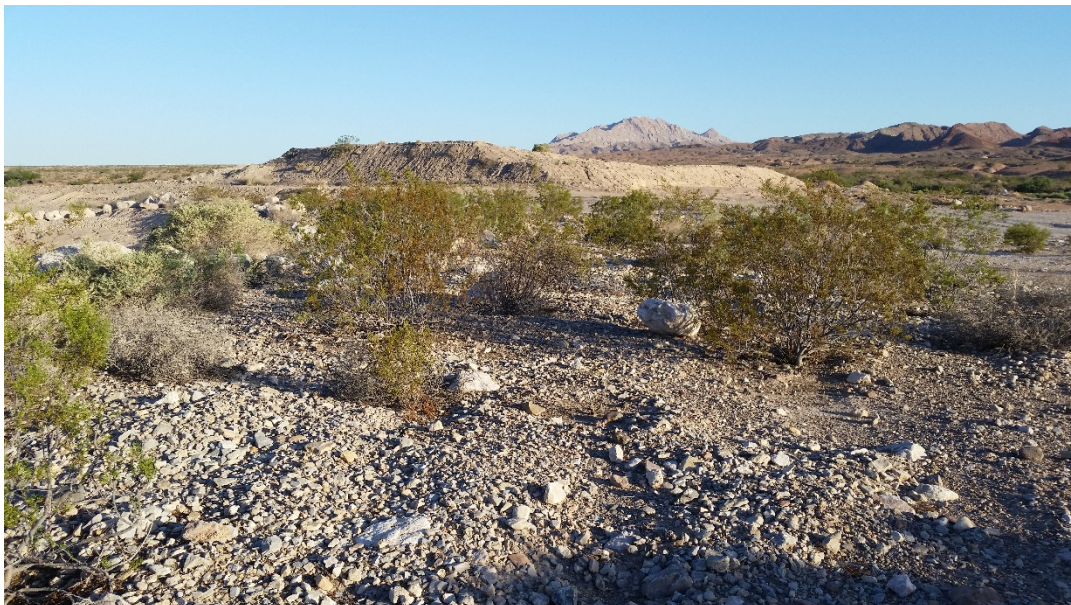
Figure 3. Creosote bush dominate the Upstream Bostick North revegetation site in 2015.

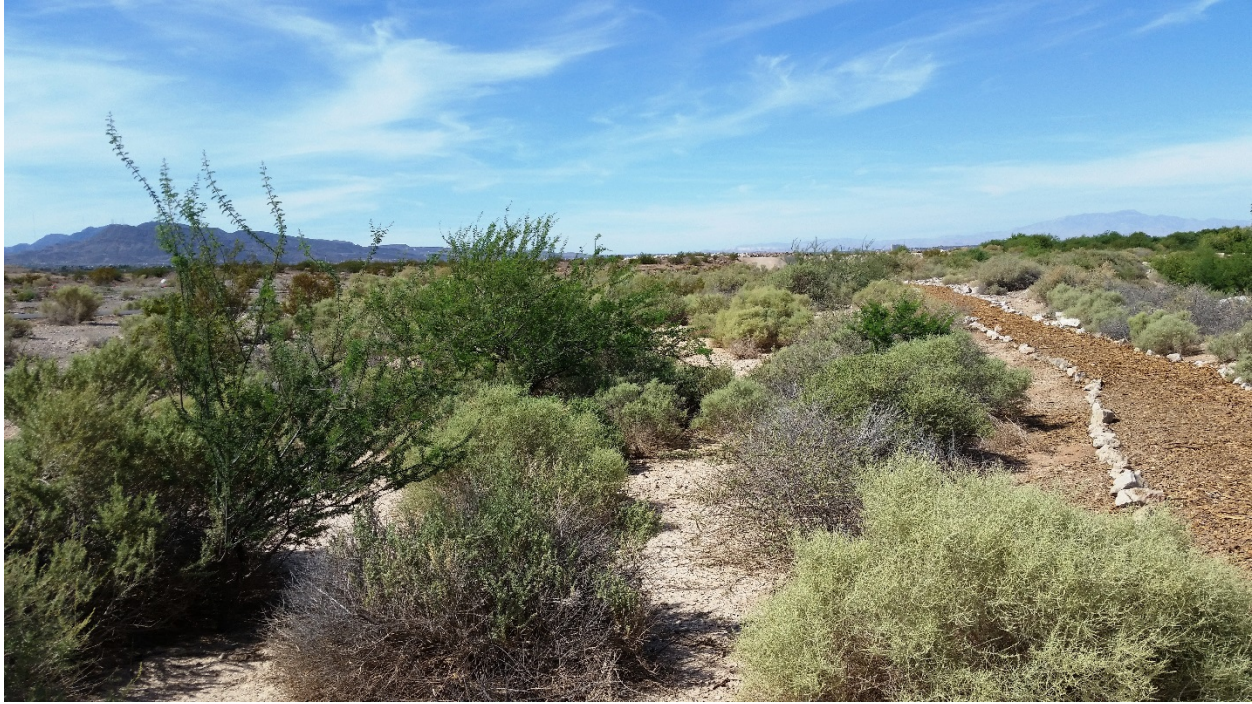
Figure 6. Desert saltbush and cat-claw acacia are prominent in the Upstream Calico North non-wetland revegetation site in 2015.

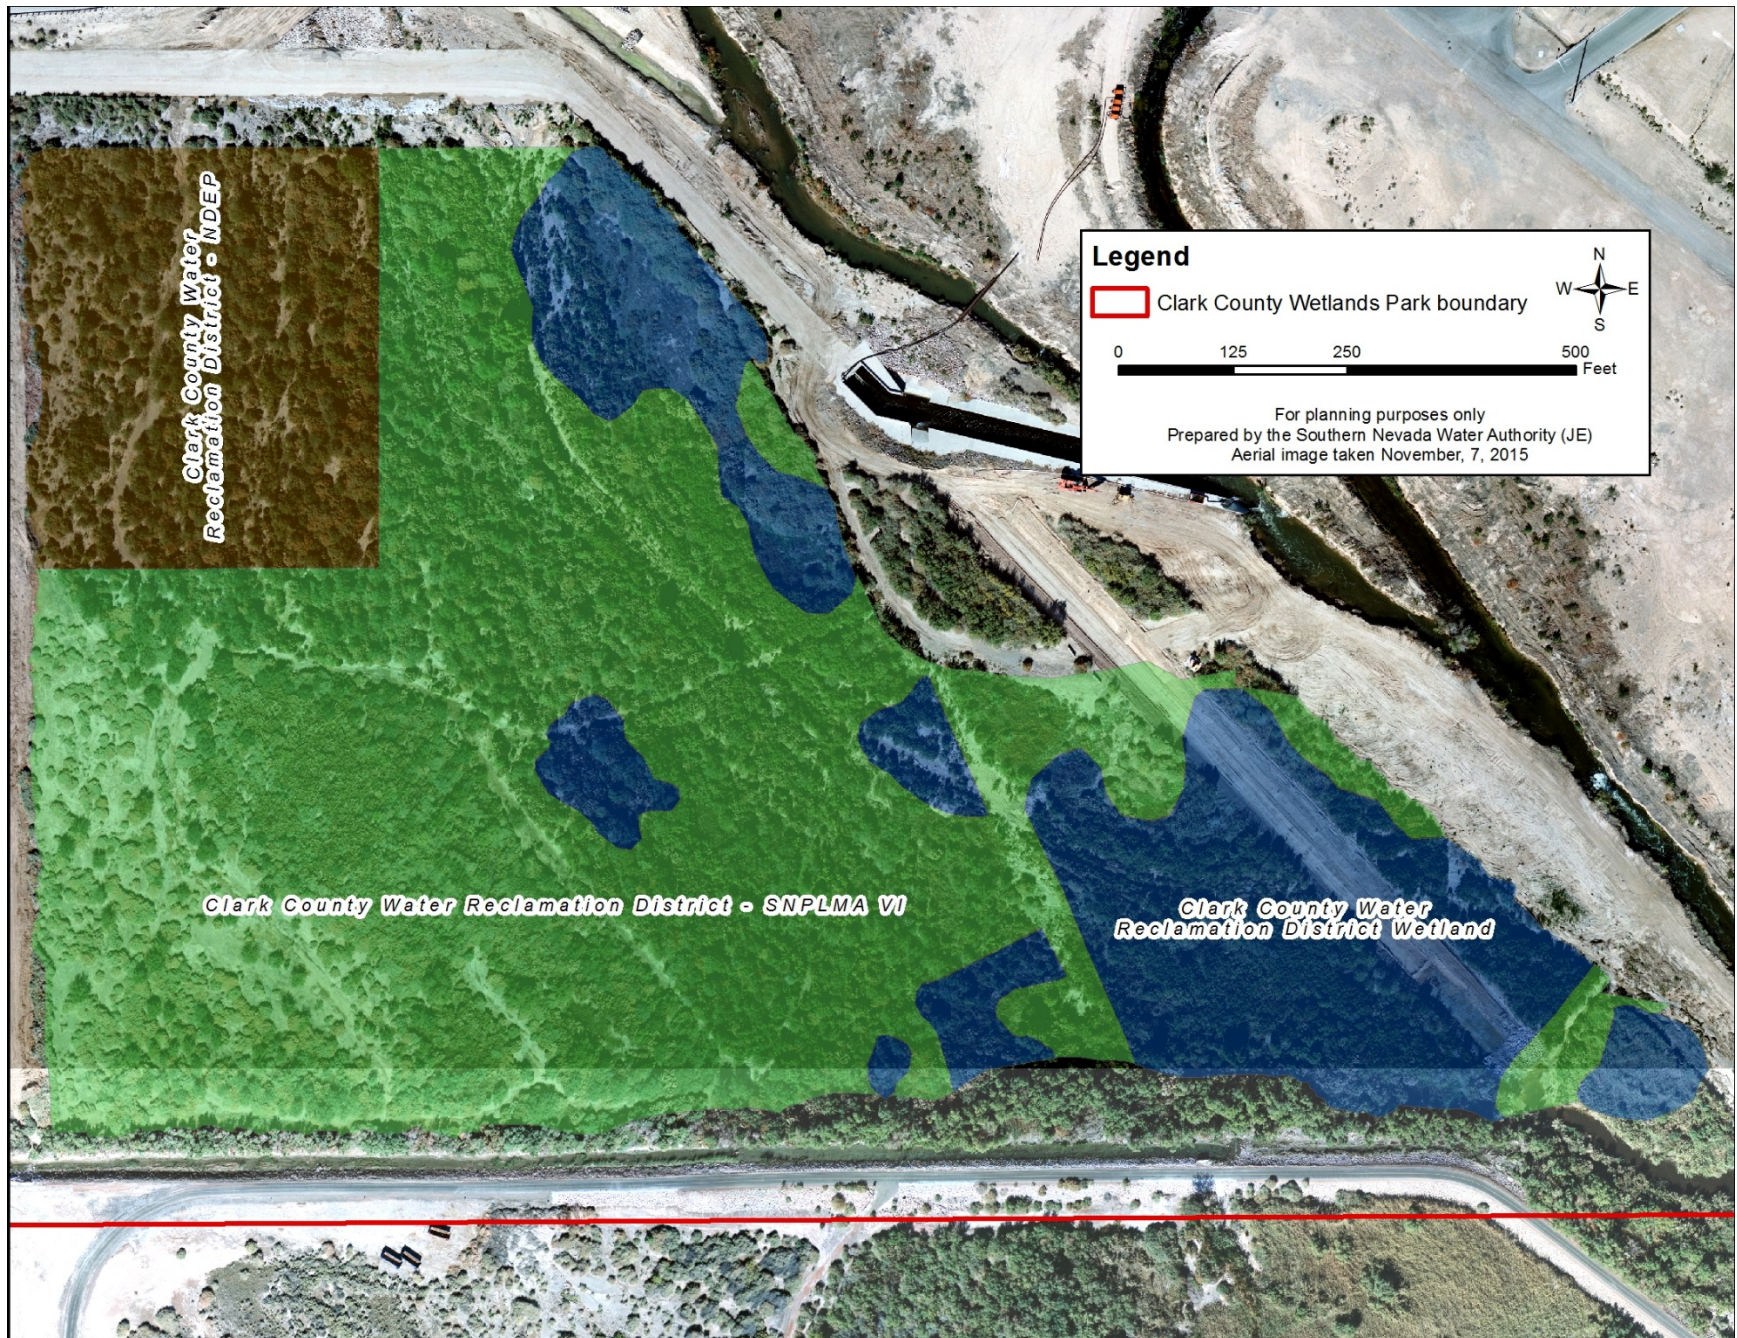
Figure 7. Aerial photograph of the 2015 delineated Clark County Water Reclamation District revegetation sites.

The percentage of cover in terms of noxious weeds has increased over the past few growing seasons. It is now over 10% of the site as a whole and over 13% in the wetland monitoring areas. The increase can mostly be attributed to the increase in tamarisk on the site. There is still a stand of tamarisk on the southern border of the site along Monson channel, kept in place for security concerns. In addition, up to the time of the 2015 monitoring there was a stand of tamarisk to the

west of the revegetation site as well. This stand was removed as part of the current construction project. These two stands likely resulted in the reestablishment of tamarisk on the site which dominated the site prior to 2010. As noted in previous reports, the shallow groundwater table as well as often the presence of surface water makes this site easy for self-germination of all types of plants.

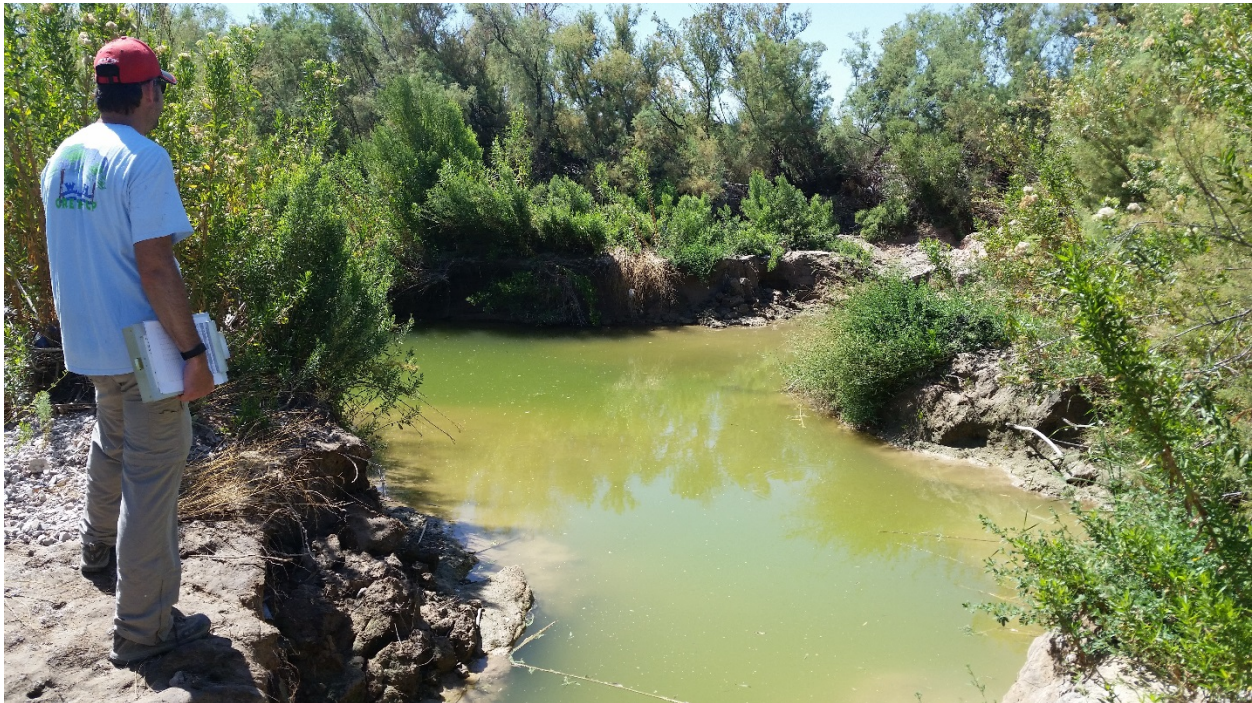
Figure 8. Erosion reveals how shallow the groundwater is at the Clark County Water Reclamation District revegetation site in 2015.

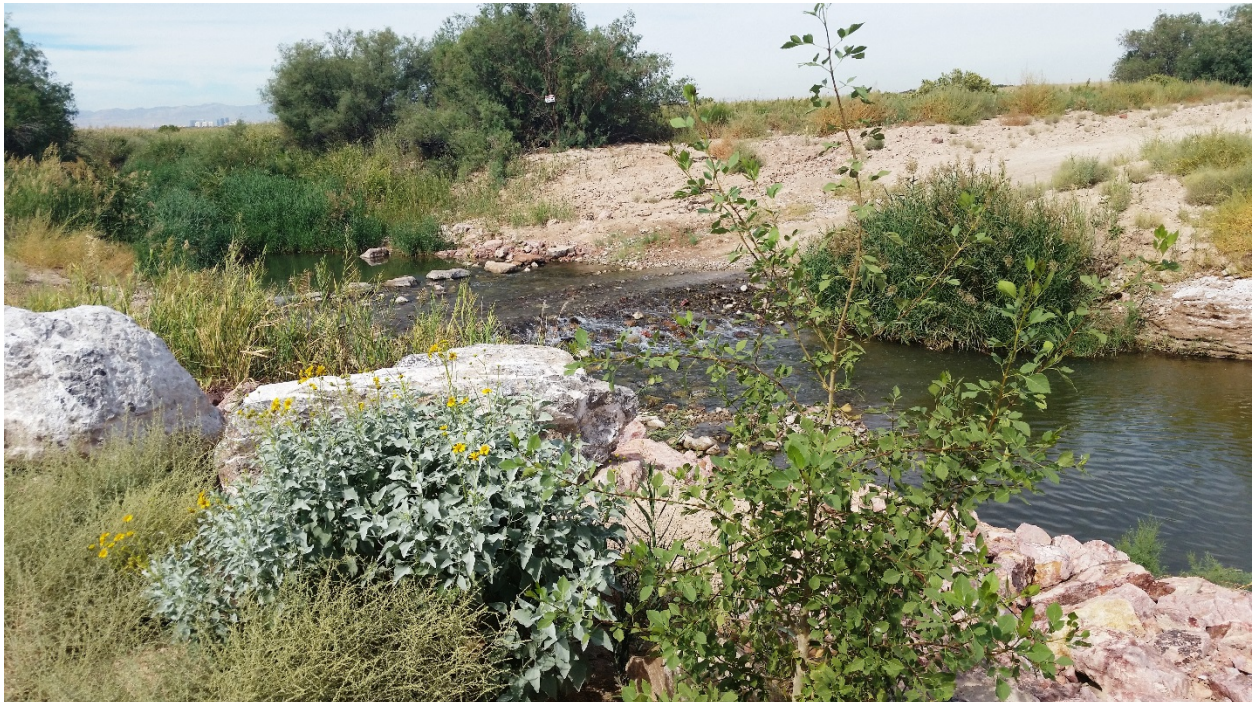
Figure 13. Established vegetation at the Duck Creek Upper Narrows South 2 revegetation site along the banks of the Duck Creek Channel in 2015.

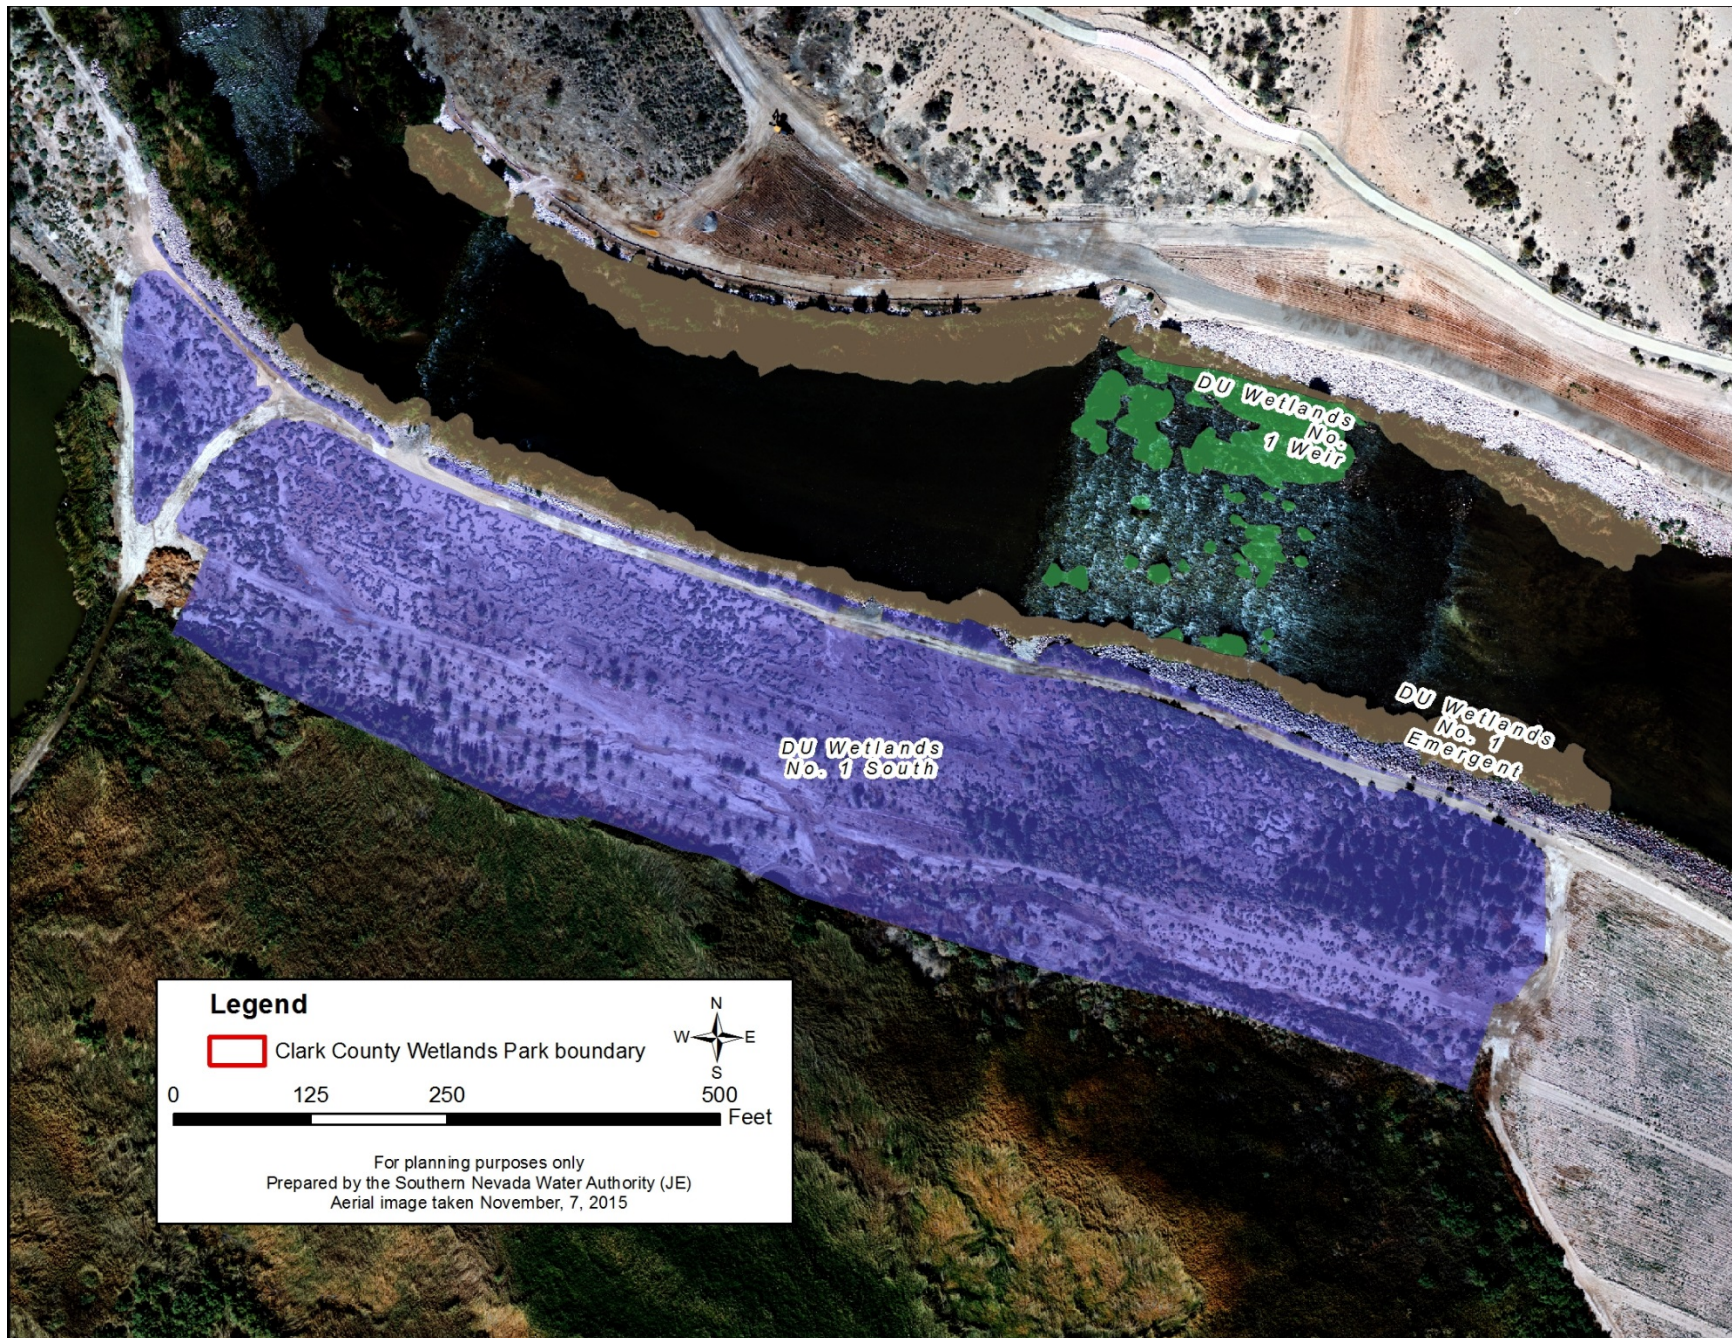
Figure 14. Aerial photograph of 2014 delineated DU Wetlands No. 1 Weir revegetation sites.

The DU Wetlands No. 1 Weir was completed in early 2013 and the revegetation sites were planted soon thereafter. The actively planted DU Wetlands No. 1 Emergent (DU1E) was planted through the winter months and DU Wetlands No. 1 South (DU1S) was planted with a Green-Up in March of 2013. The third site associated with this weir is the passive wetlands that established on the Weir itself, DU Wetlands No. 1 Weir. This passive site had its first monitoring in 2015, using ArcGIS to measure the 0.5 acres of wetland vegetation which had 75-100% total cover. The active site also had 75-100% total cover but was monitored in the field to include species specific information. DU1E had 35 species documented on it, just one less than in 2014. Although the species richness was similar, there were four species found in 2015 that were not found in previous monitoring. One of these new species, was new for the Wash as a whole as well, Shoestring acacia (*Acacia stenophylla*). This is a common landscape plant that is native to Australia. DU1S, the lone non-wetland site at this weir, was mistakenly not monitored in the field despite only being in its third growing season. Its total cover was monitored using ArcGIS and will be monitored in the field in 2016.

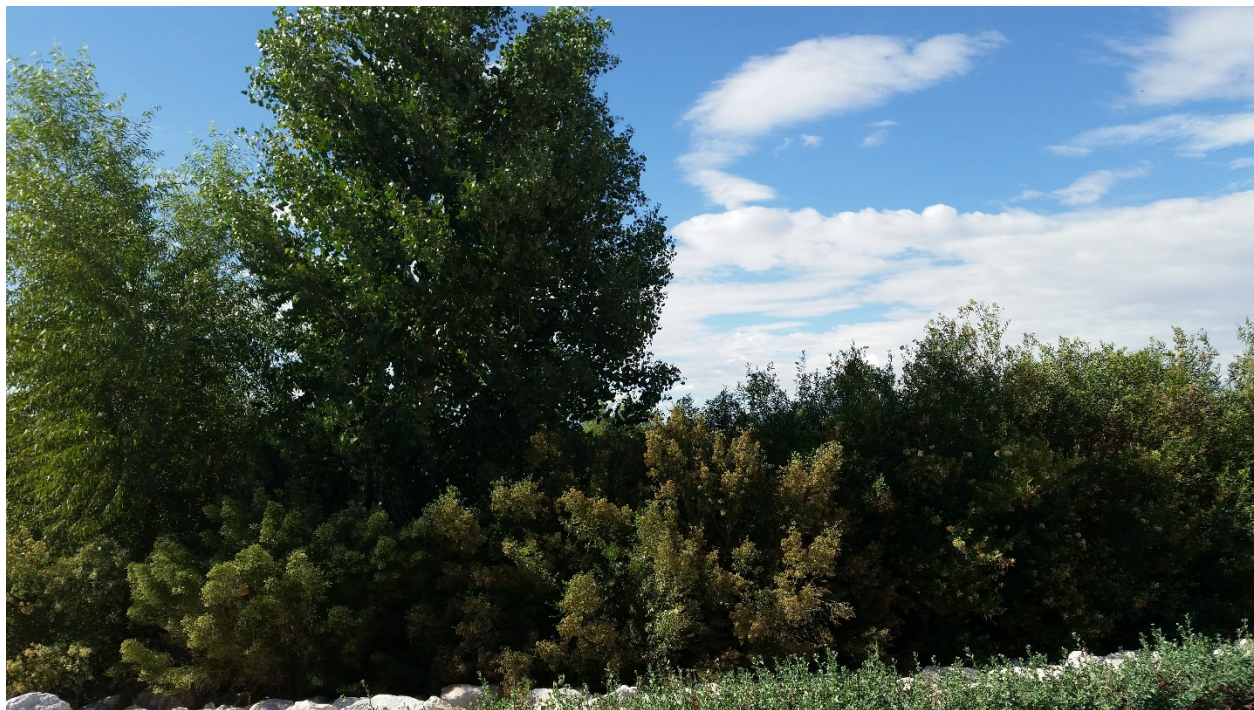
Figure 15. Mature riparian vegetation along the banks of the Wash at the DU Wetlands No. 1 North revegetation site in 2015.

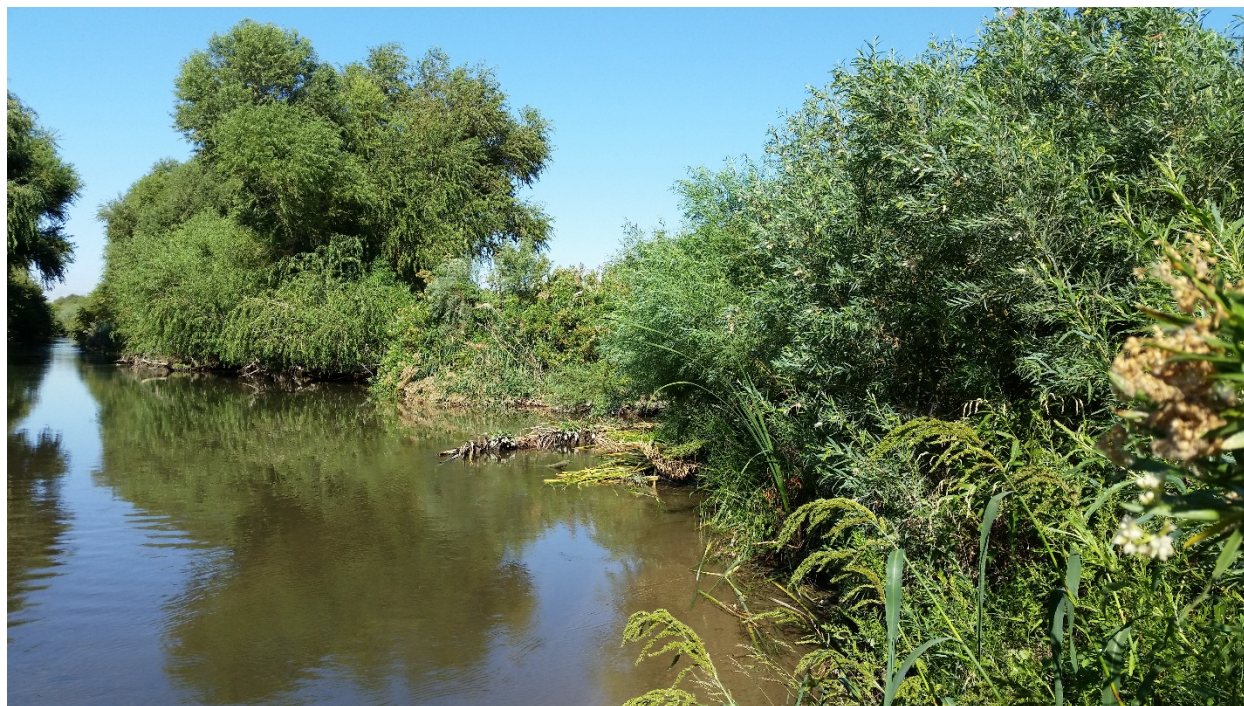
Figure 17. Upstream Historic Lateral North - Wetland has very dense riparian and wetland vegetation in 2015.

Three of the 12 revegetation sites at the Historic Lateral Weir were monitored in the field in 2015 (Table 11; Figure 17). Because most of the sites are 15 years old, they are almost always monitored in the field on alternating years based on the monitoring criteria. In addition, because of their age, most of the sites also have the maximum total cover value of 75-100%. Only two of the younger sites have lower total cover values. Upstream Historic Lateral Soil Stockpile had just 5-25% coverage, which has been the same for the previous four growing seasons. This site was a mitigation planting for an area used as a stockpile for rock. Because of this, the soils are extremely compacted and it is much further from surface or ground water than most sites. It is not expected to have any significant increase in plant cover. Upstream Historic Lateral South Upper Plateau 2 has had 50-75% total cover the past two growing seasons. Much of this site is very dry and once irrigation ceased after two growing seasons, there was a normal decline in plant cover. Being in its fifth growing season, it is likely to increase in total cover as the plants continue to mature. The Historic Lateral Weir wetland site was monitored for the first time in 2015. This is the passive wetland vegetation that has established on the weir itself. Because of its location, it is unsafe to physically access the site to get plant specific information. Therefore, it will likely only be monitored using ArcGIS as it was this year.

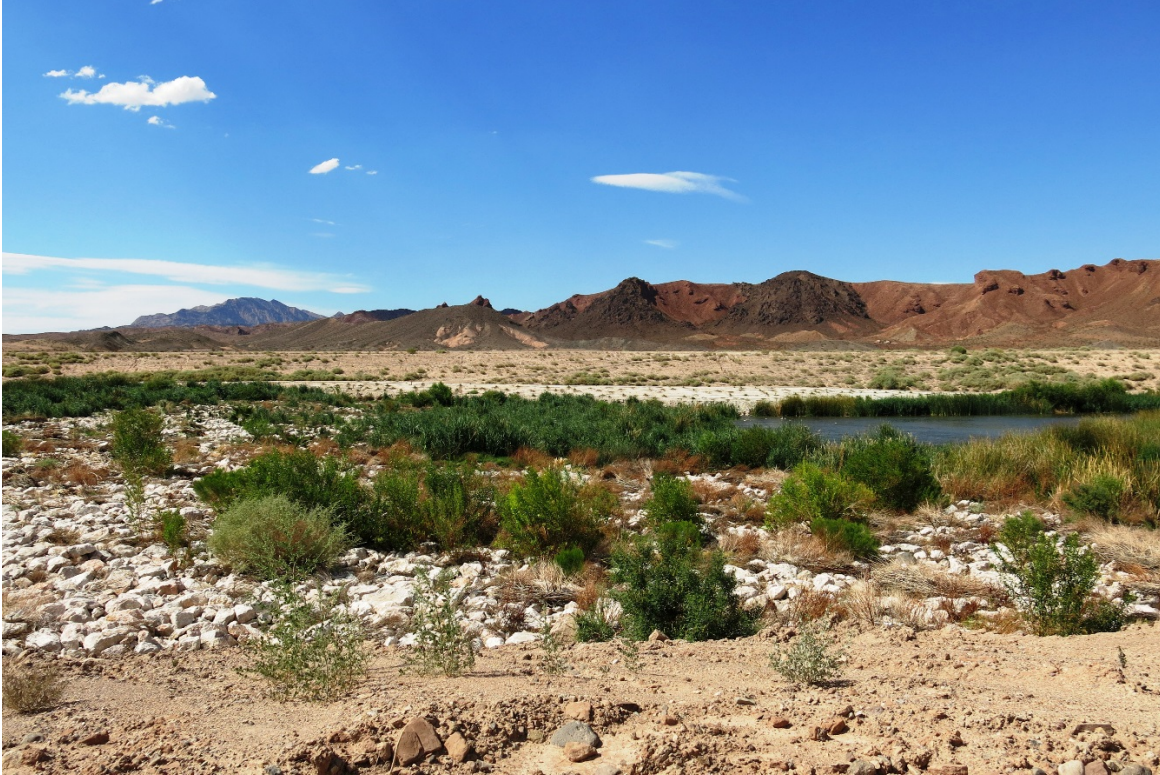
Figure 19. The Homestead Weir had nearly four and a half acres of vegetation established on it in 2015.

This part of the Wash was one of the most incised and as a result, the upland areas are 30 or more feet off the floodplain of the Wash. This results in the areas being very dry and will likely not see very high plant cover. Both Lower Narrows Homestead South 1 and 2 have 50-75% total cover with the vast majority of it coming from a single species, four-wing saltbush (*Atriplex canescens* var. *canescens*). Some additional plantings will take place in 2016 and 2017 to increase diversity on the sites. With the harsh conditions better understood, appropriate plant material will be more likely to succeed.

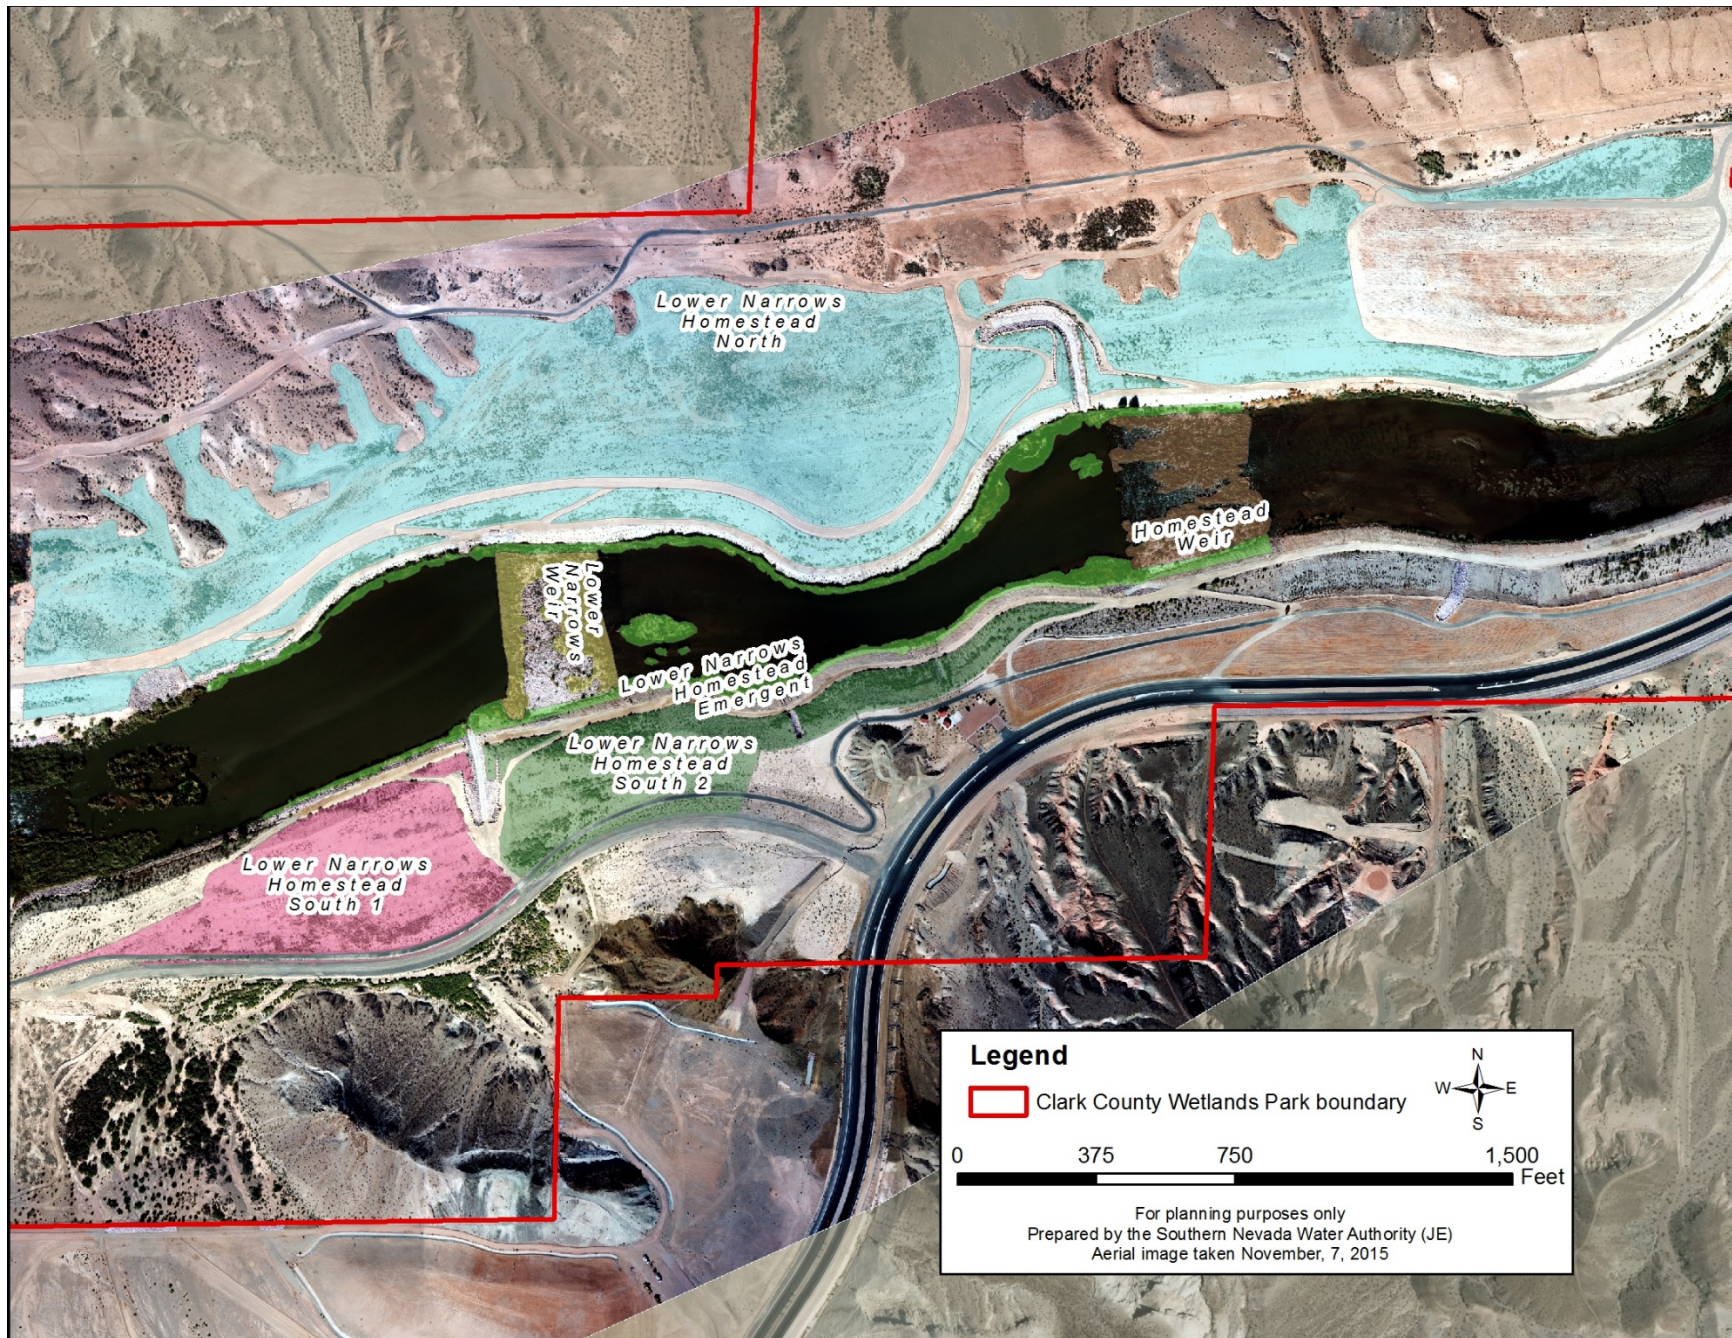
Figure 20. Aerial photograph of 2015 delineated Lower Narrows and Homestead Weirs revegetation sites.

Four of the revegetation sites at the Lower Narrows and Homestead Weirs (Table XX; Figure XX) were actively planted while two are passive wetlands. The two passive wetlands are new to monitoring in 2015. Lower Narrows Weir and Homestead Weir (Figure XX) are the passive wetlands that self-established on the two weirs themselves. They were monitored using ArcGIS in 2015 and will likely always been monitored remotely as they are difficult and unsafe to access by foot to get plant specific information.

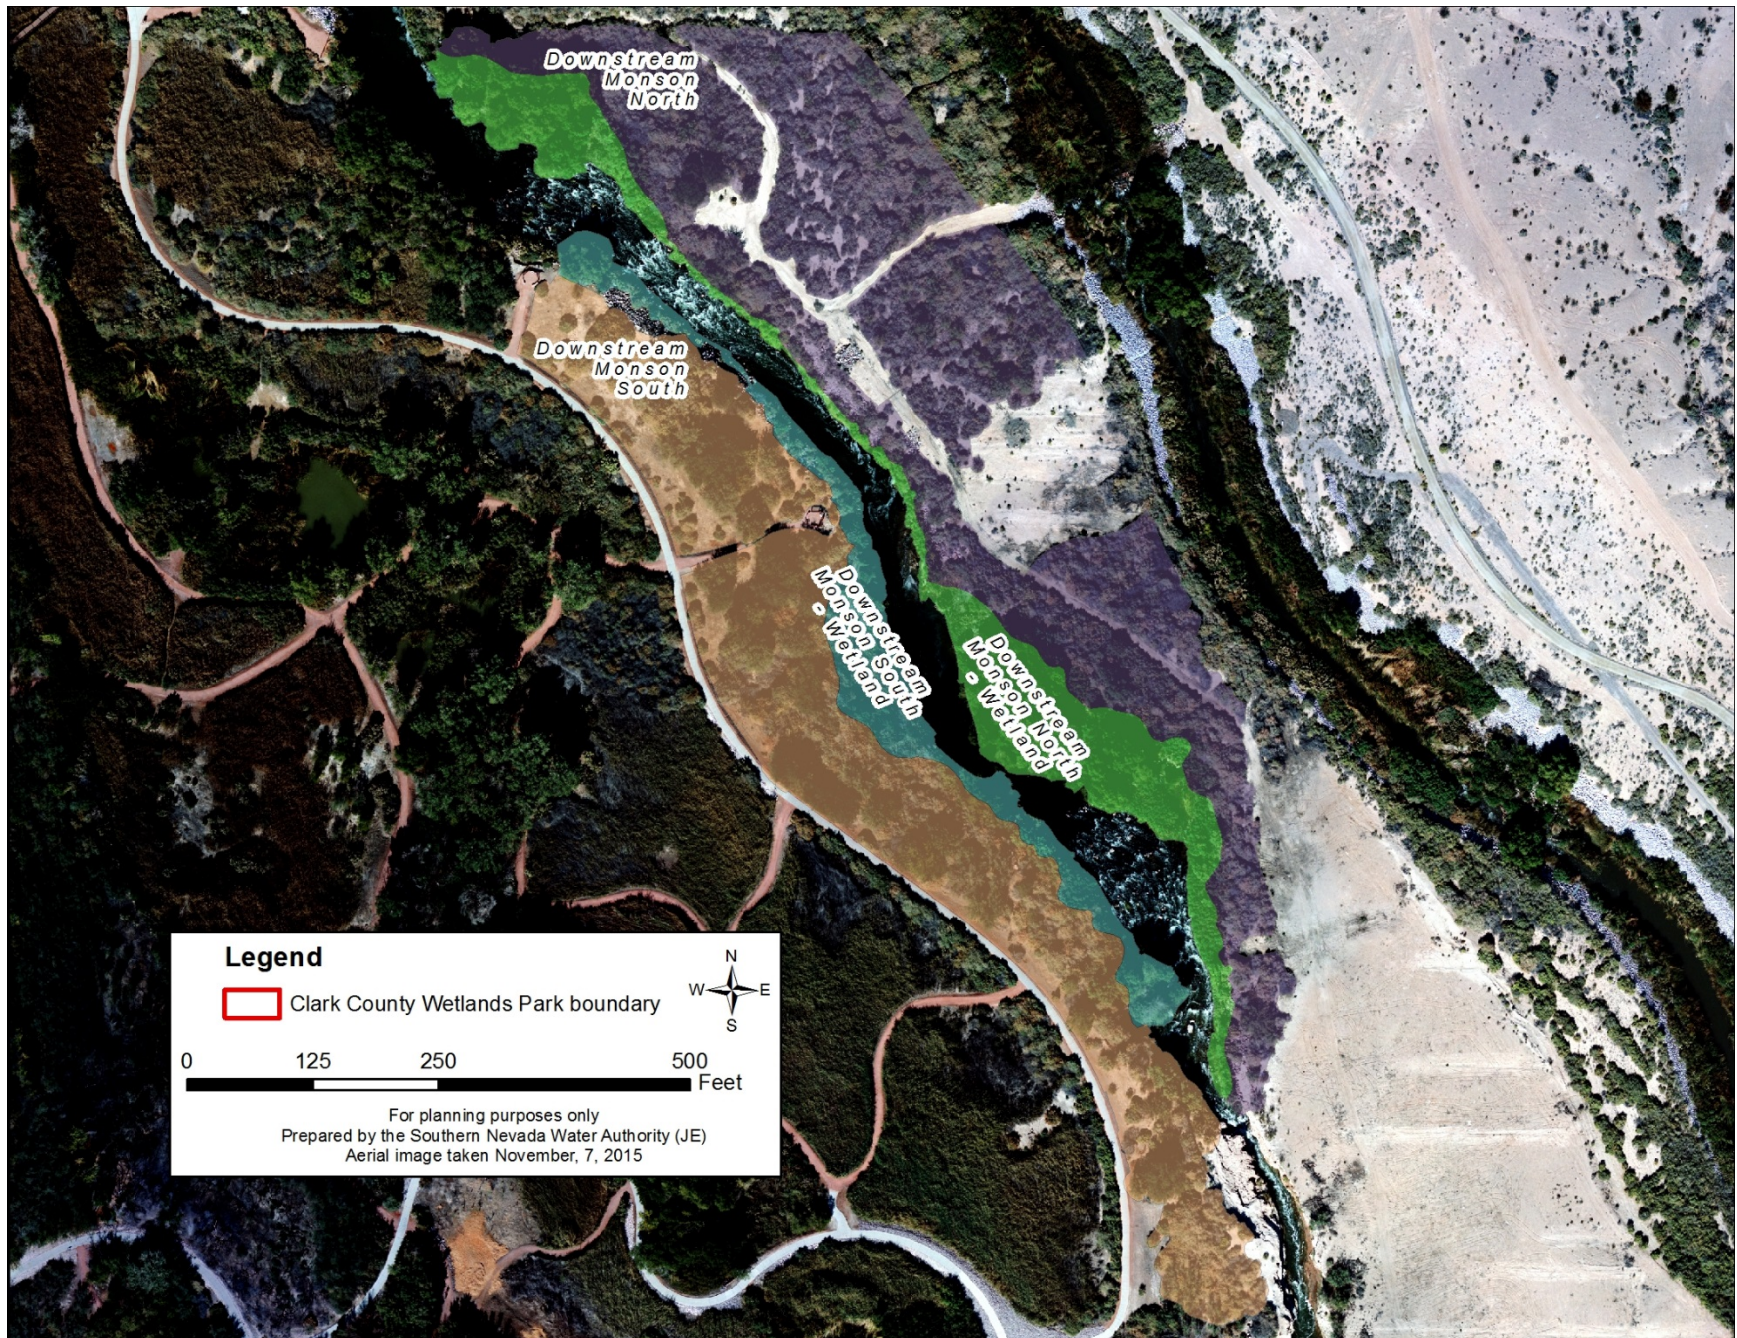
Figure 21. Aerial photograph of 2015 delineated Monson and Visitor Center Weirs revegetation sites.

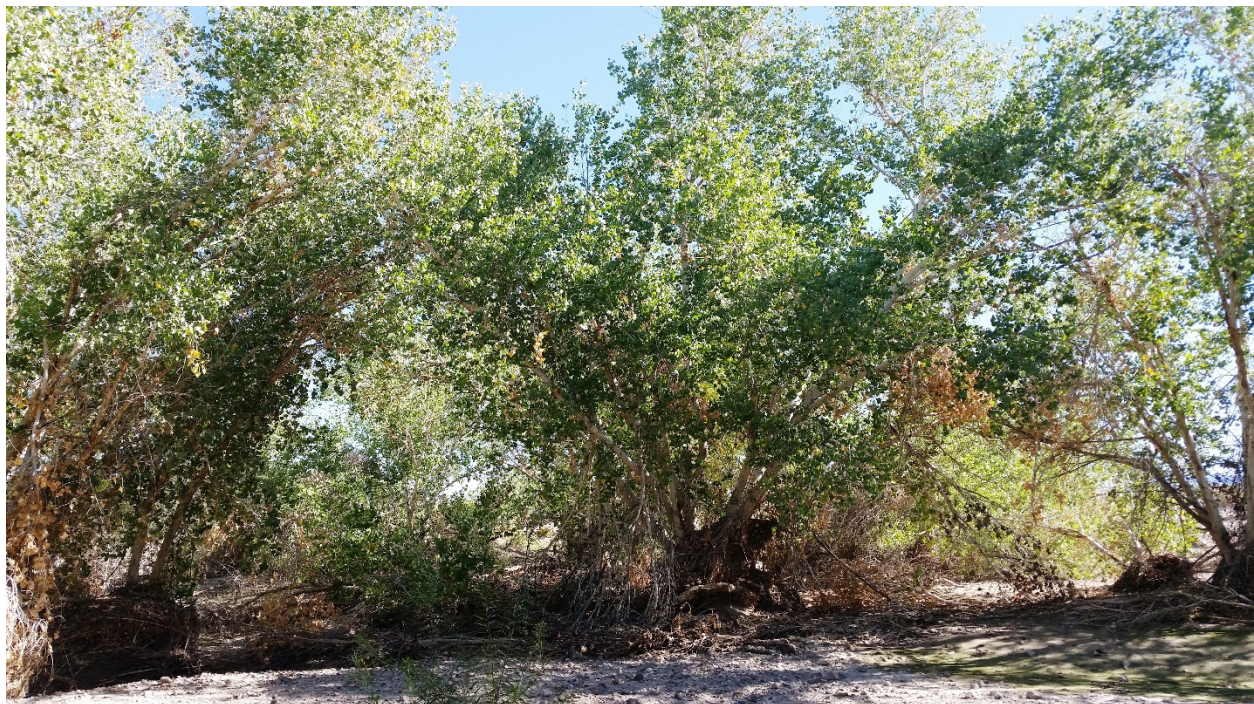
Figure 22. Mature cottonwood trees fill the Downstream Pabco South revegetation site in 2015.

Only three of the fourteen sites did not have the maximum total cover value in 2015 of 75-100%. These are three of the younger sites, Downstream Pabco North planted in 2009, and Downstream Pabco South Upper Plateau and Downstream Pabco South Upper Bank, both planted in 2011. These sites are also the furthest from the Wash of all the sites at Pabco Road Weir which explains their lower total cover. However, their total cover is still very high and stable, which are criteria for calling them successful revegetation sites.

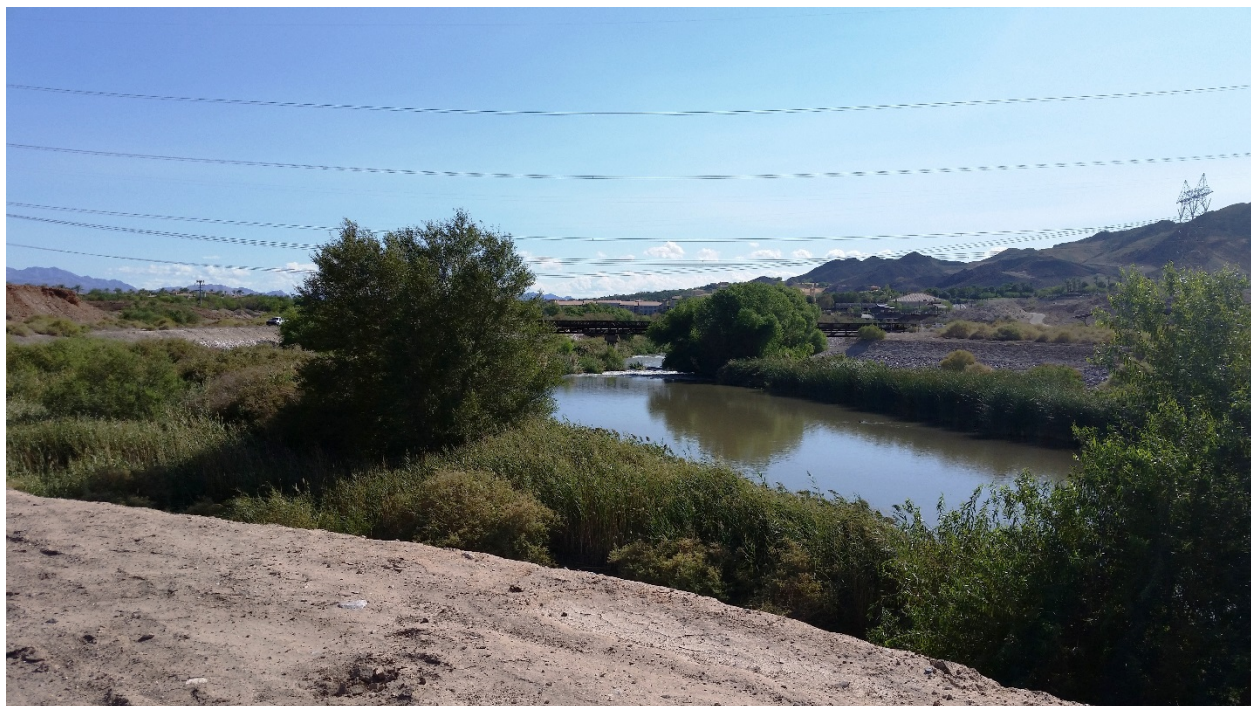
Figure 25. Riparian and wetland revegetation sites at the Powerline Crossing Weir have varied structure in 2015.

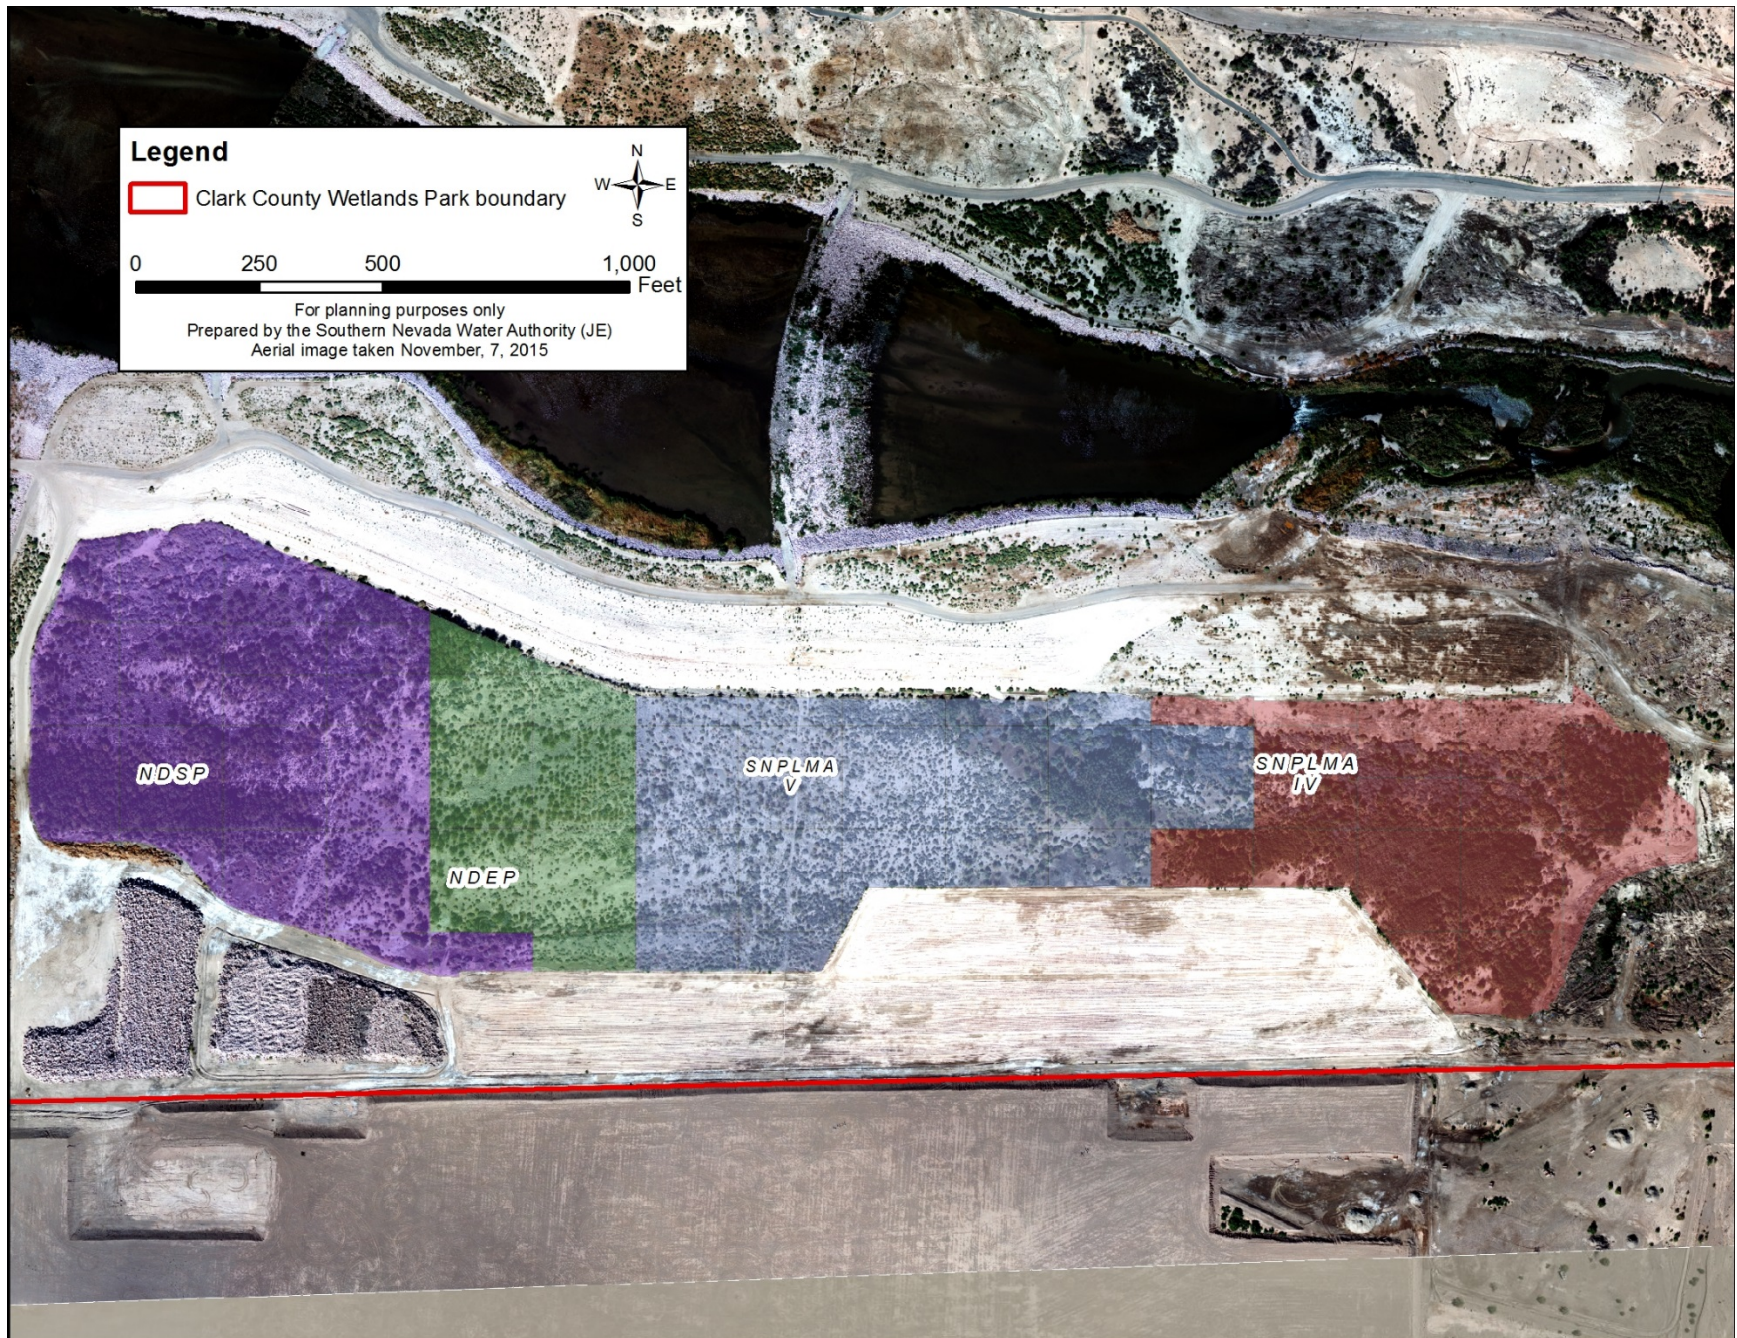
Figure 27. Aerial photograph of Site 108 with 2015 delineations based on funding source.
