Water Resources Division

Field Guide to Spring Valley Monitoring Program Springs

April 2012

Prepared by:
Southern Nevada Water Authority
Water Resources Division
P.O. Box 99956
Las Vegas, Nevada 89193-9956

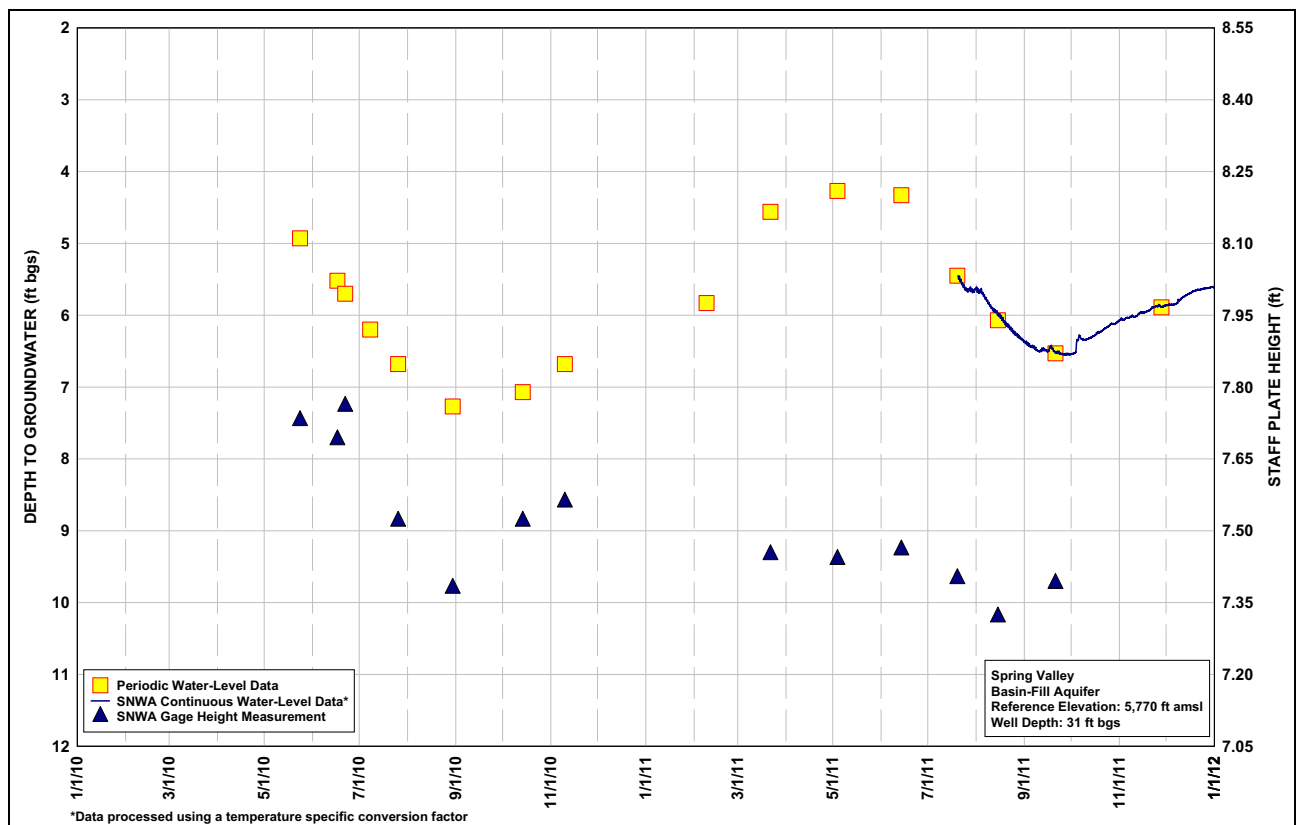
Figure 2-8
Hydrograph of Blind Spring

A hydrograph of water-level data collected at the piezometer is presented on [Figure 2-8](#). The staff-plate elevation measurements are also presented on the hydrograph. The piezometer water level and spring-pool elevation are generally comparable and the spring-pool elevation appears to represent the shallow water table at the site.

The general fluctuation of the water level of Blind Spring, cool water temperature, similarity of the stable isotopic composition to that of modern day precipitation, lack of flow from the spring, and hydrogeologic conditions indicate that the spring is local and most likely a reflection of the shallow water table in the vicinity of the site.

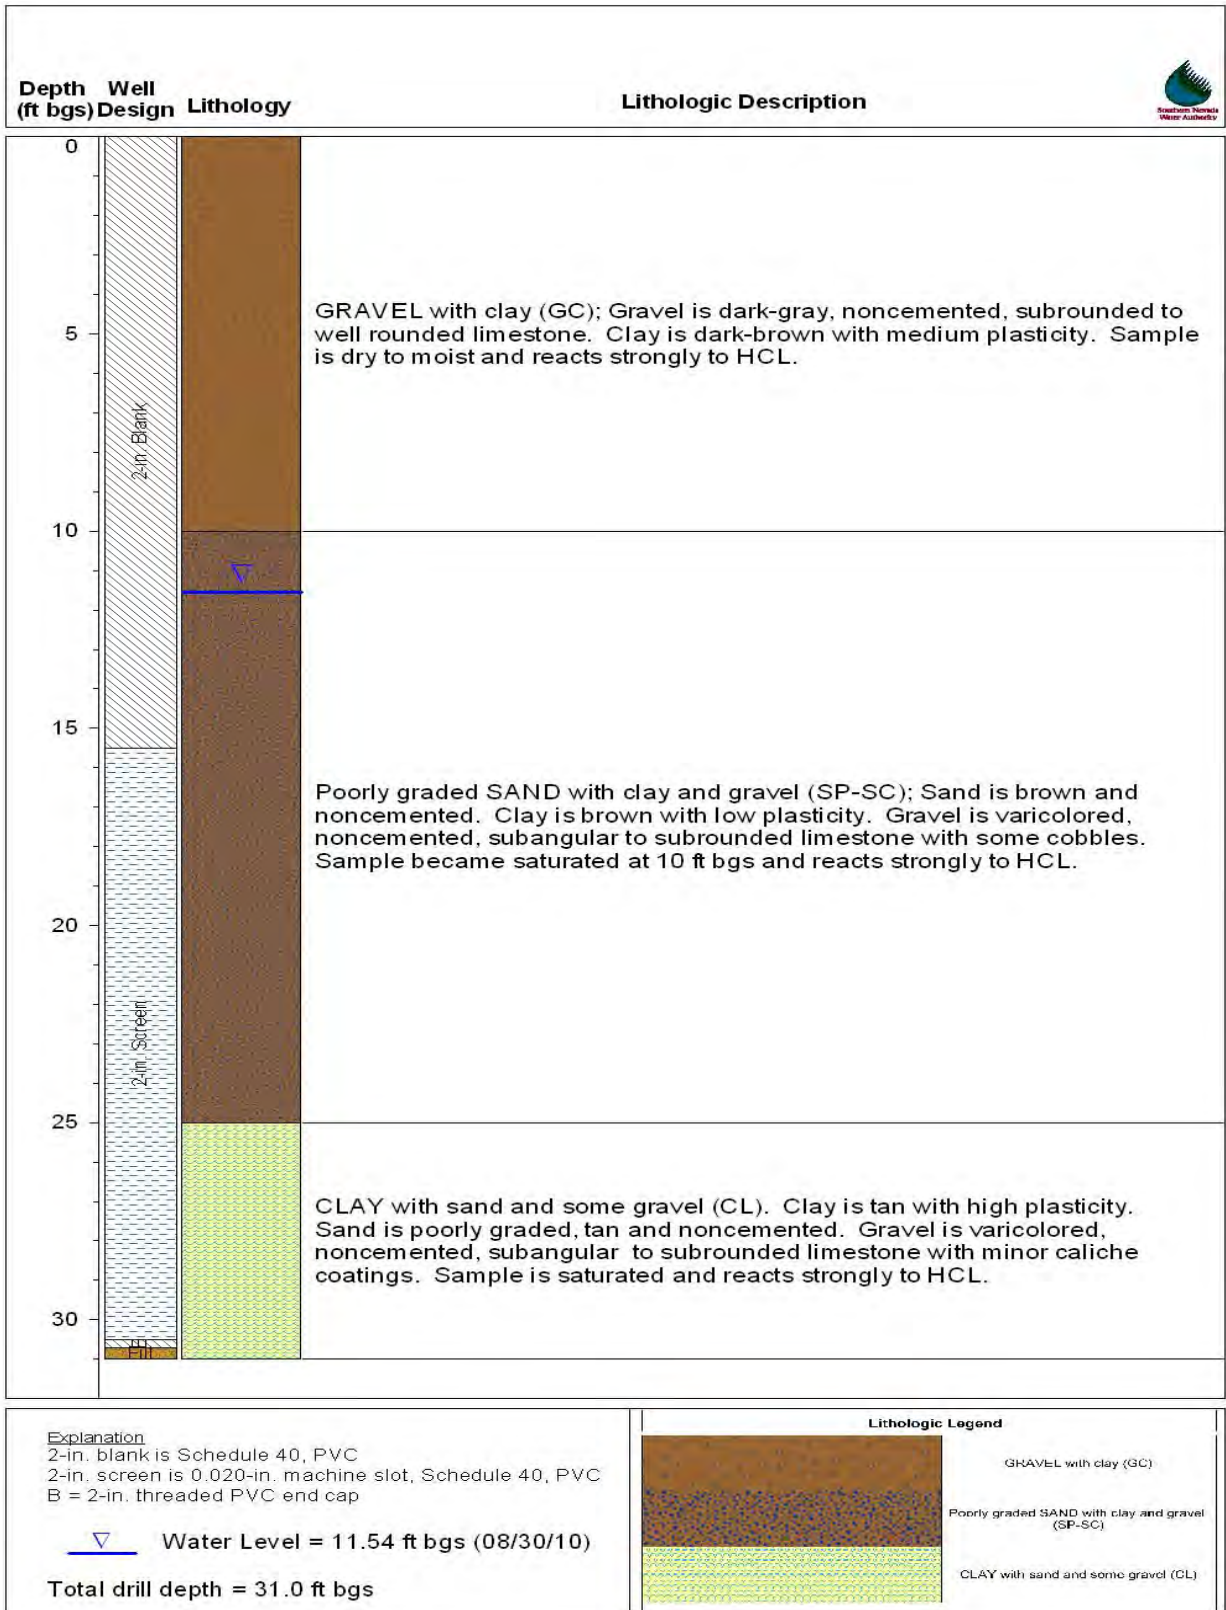
Figure 4-5
The Seep Spring Piezometer Lithologic Log

Lithologic soil samples were collected for piezometer SPR7014Z at 5-ft intervals during the drilling process. The borehole was advanced within surficial sediments to 30.7 ft bgs. The soils encountered consist of gravel with clay and sand with clay, underlain by clay with sand. The gravels encountered

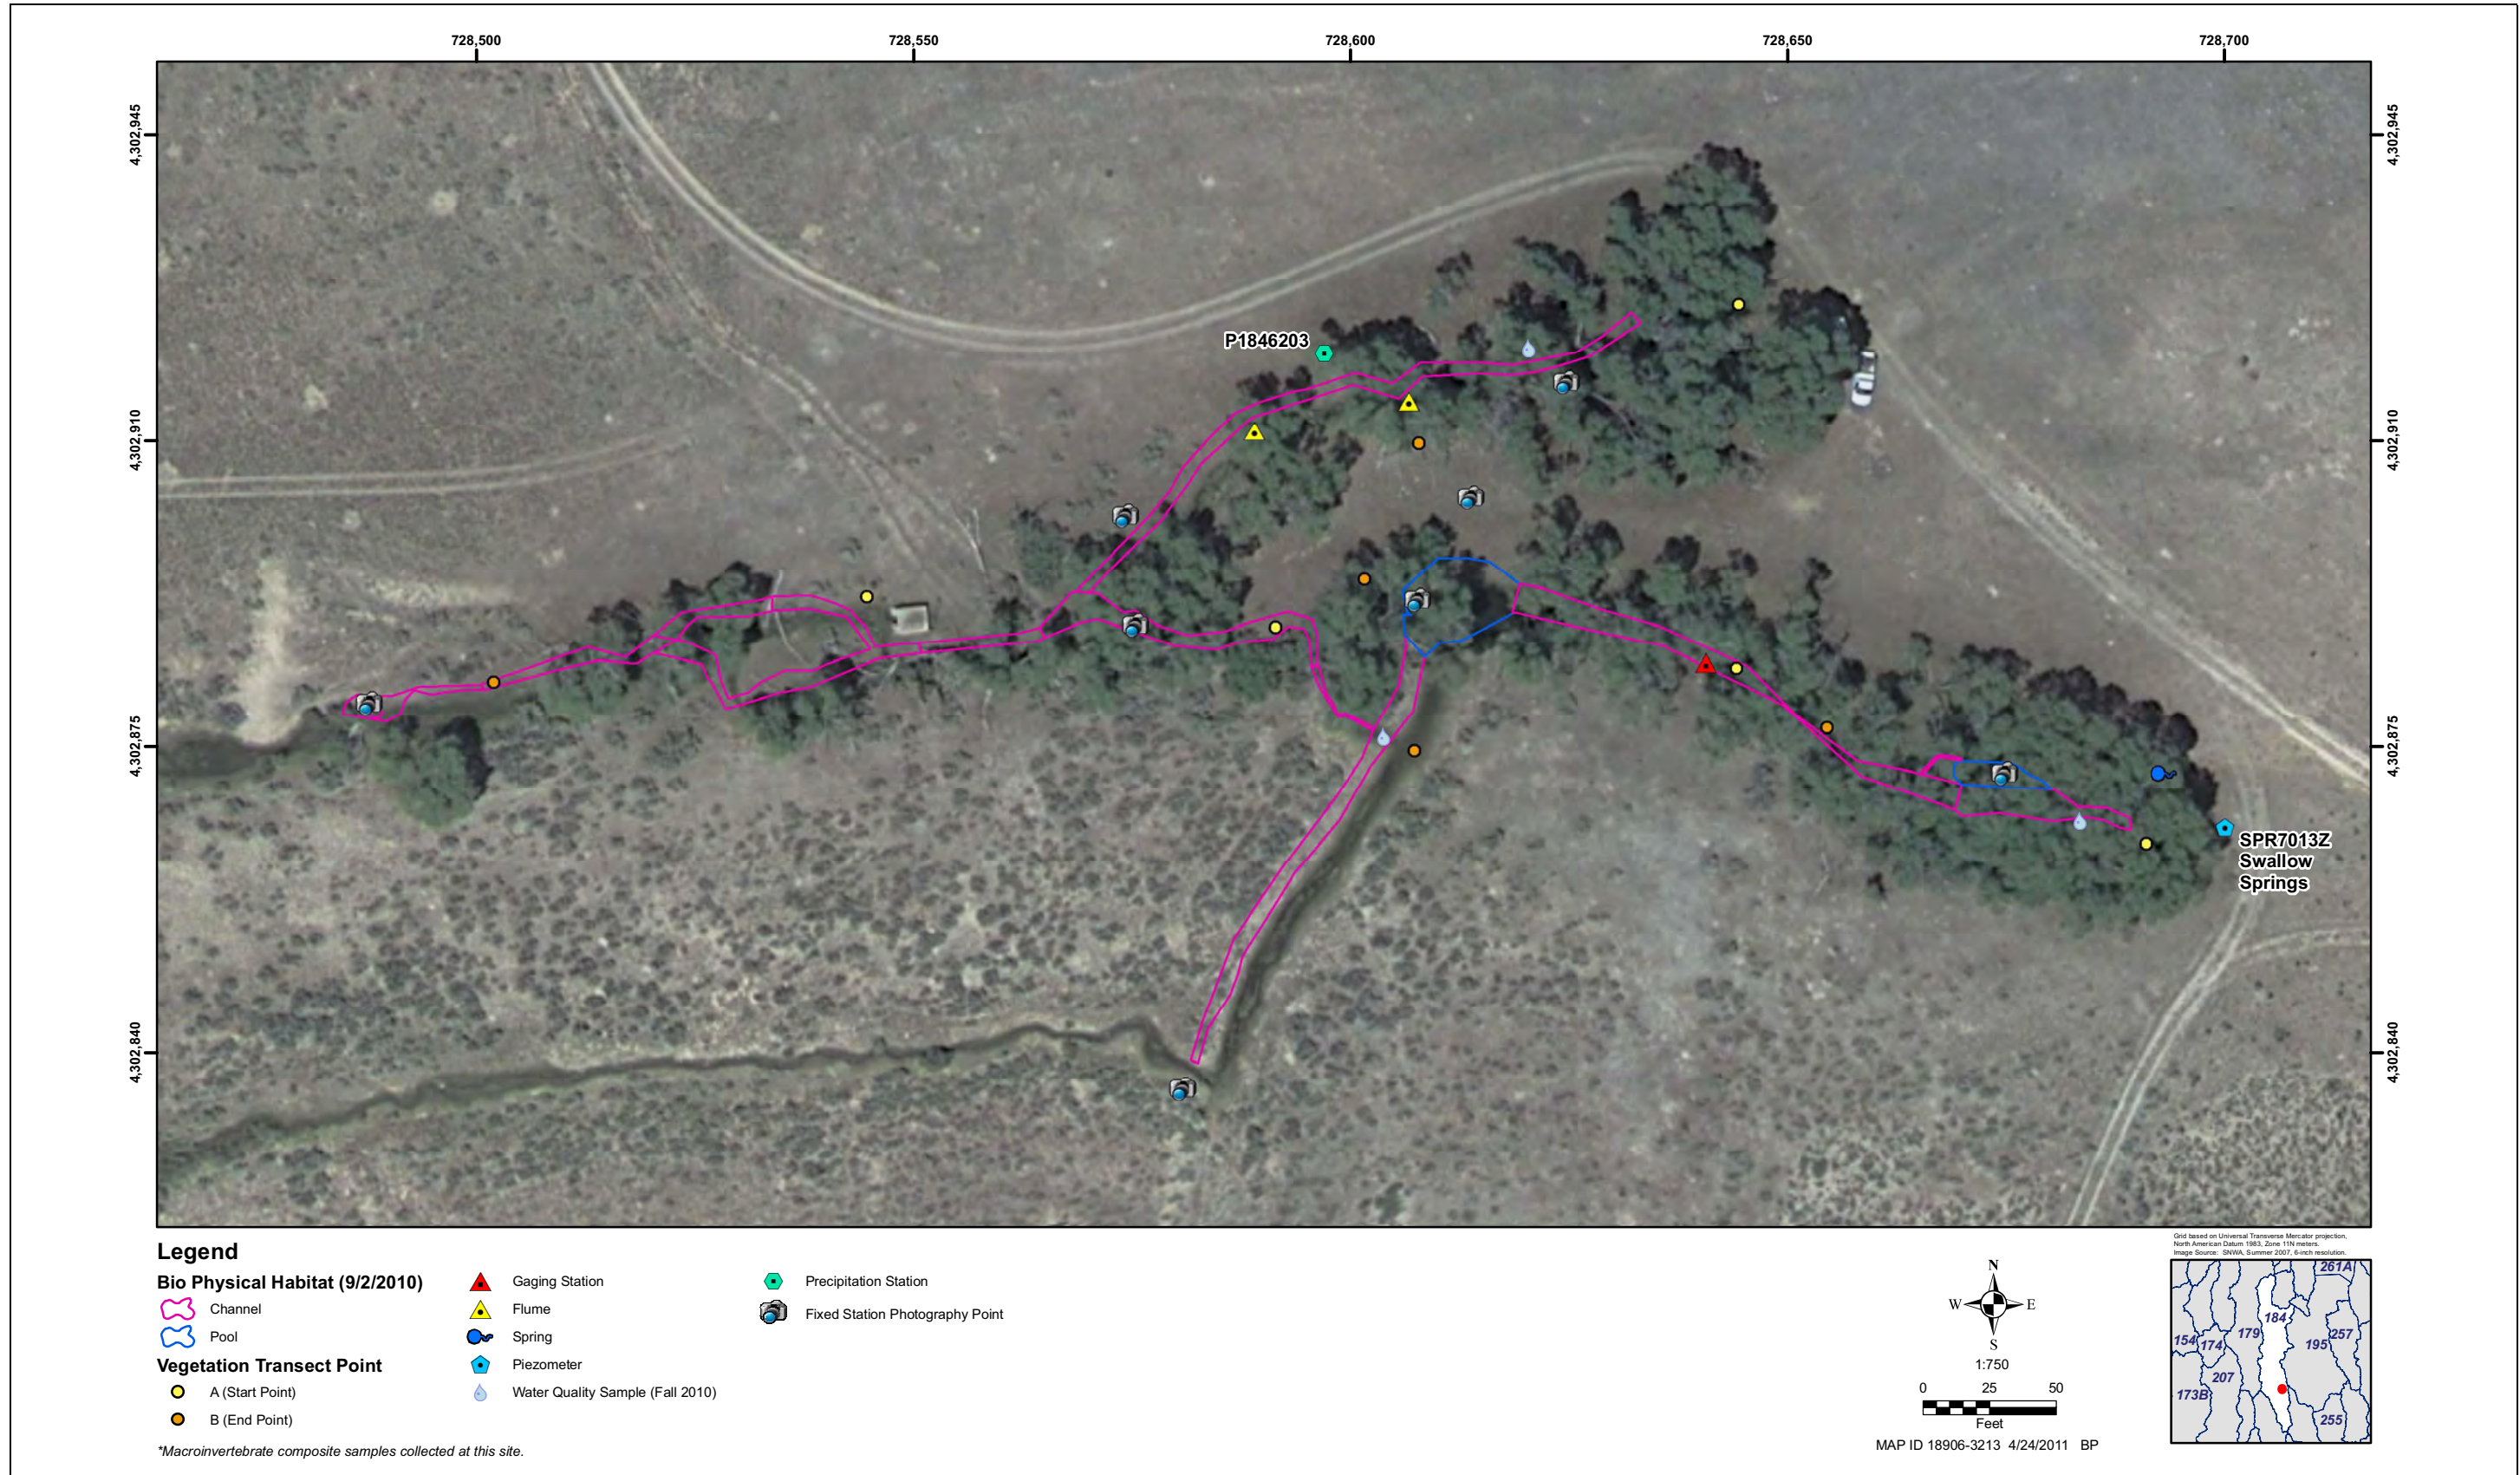
Figure 5-2
High-Resolution Aerial Photo of Swallow Springs and Hydrologic and Biologic Monitoring Locations

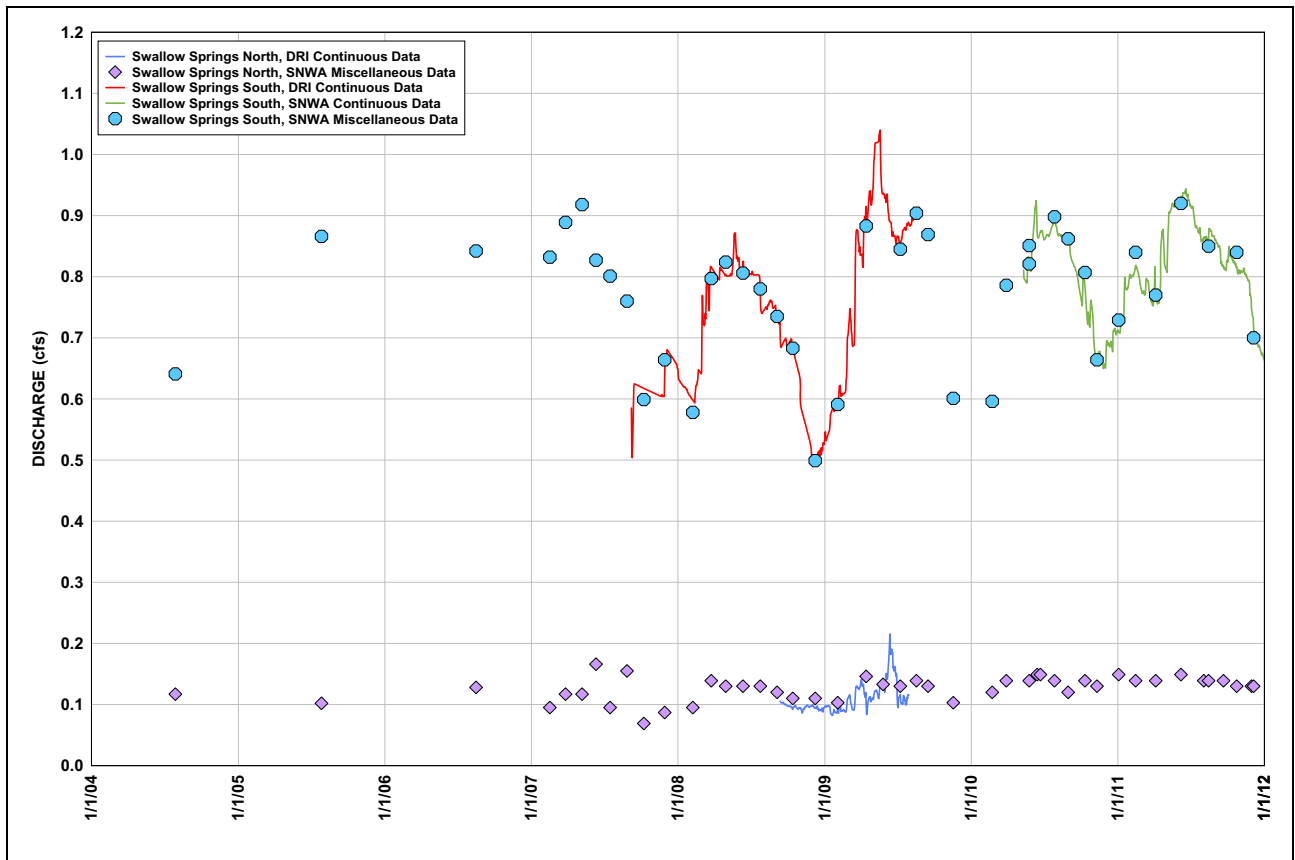
Figure 5-7
Hydrograph of Swallow Springs North and South Discharge

The spring discharge is monitored with a gaging station at the 6-in. Parshall flume located in the southern channel downstream of the orifice. The northern channel is measured periodically at two flume locations. A piezometer was constructed to a depth of 65 ft near the south spring orifice. There does not appear to be a direct hydraulic connection between the shallow groundwater and the springs because the depth to groundwater in the piezometer is greater than 50 ft. Therefore, discharge monitoring is more effective in documenting spring conditions. The flumes have been surveyed to determine elevation and planar coordinates. In addition to the gaging station and piezometer there is a tipping bucket and bulk gage which is used to measure precipitation duration, intensity, and volume.

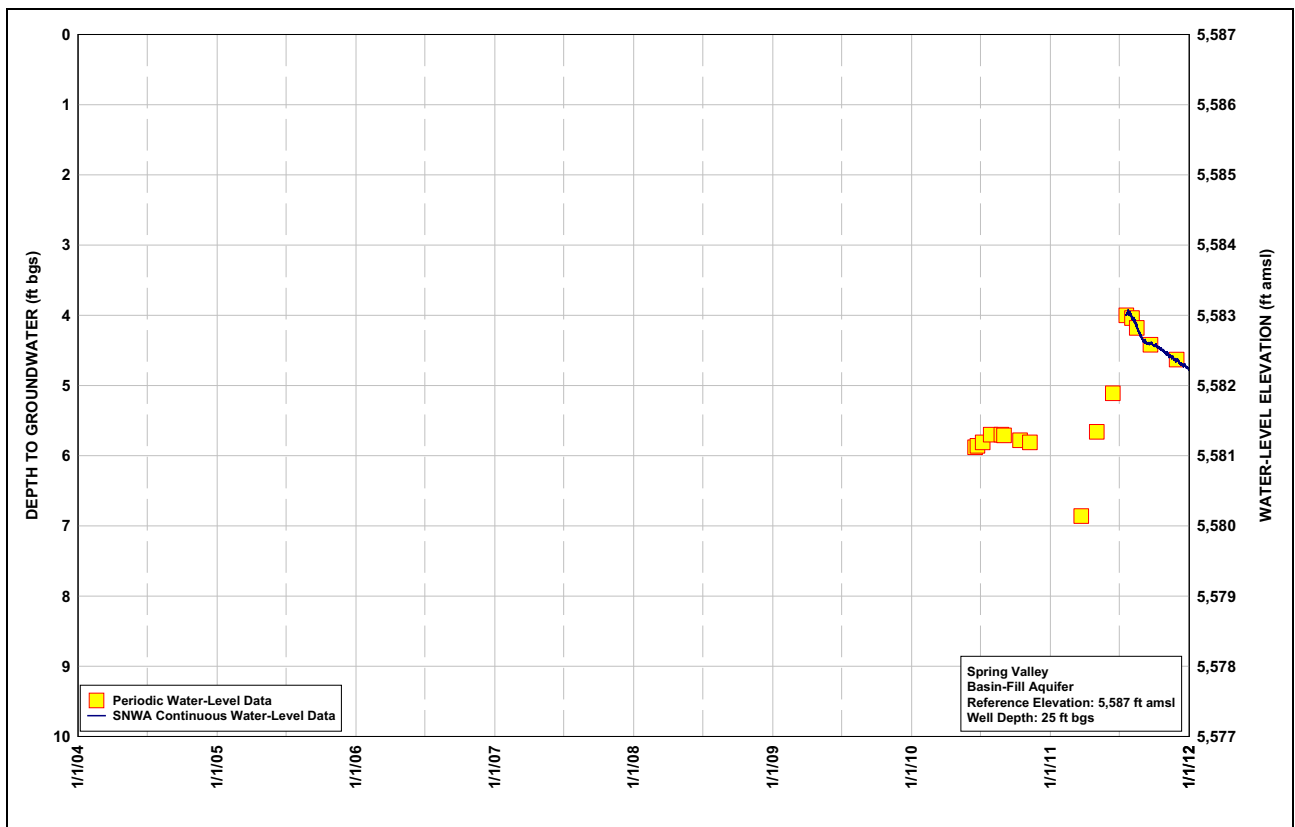
Figure 9-8
Hydrograph of South Millick Spring Piezometer

A hydrograph of periodic and continuous water-level data collected at the piezometer is presented on [Figure 9-8](#). A hydrograph of the spring discharge measured at this site is presented in [Figure 9-9](#).

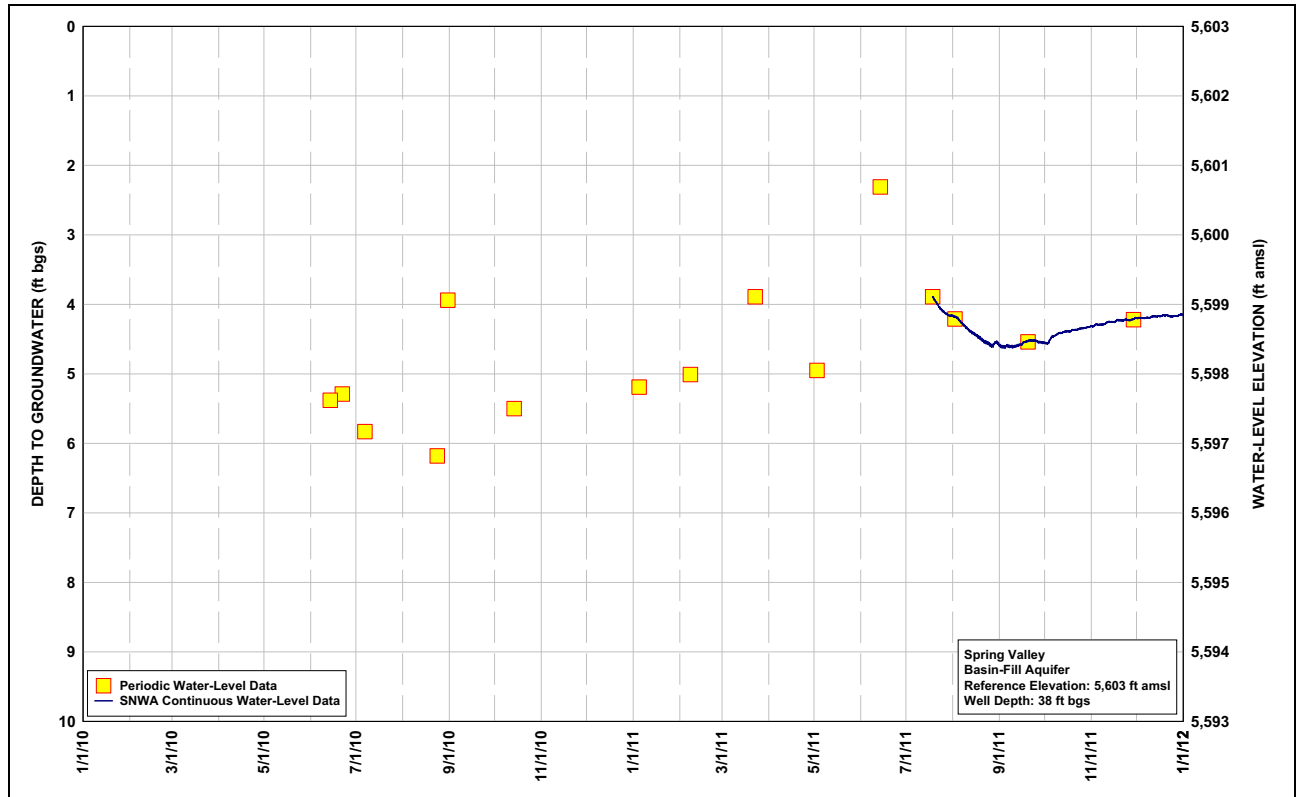
Figure 10-8
Hydrograph of West Spring Valley Complex 1 Piezometer

A hydrograph of periodic and continuous water-level data collected at the piezometer is presented on [Figure 10-8](#).

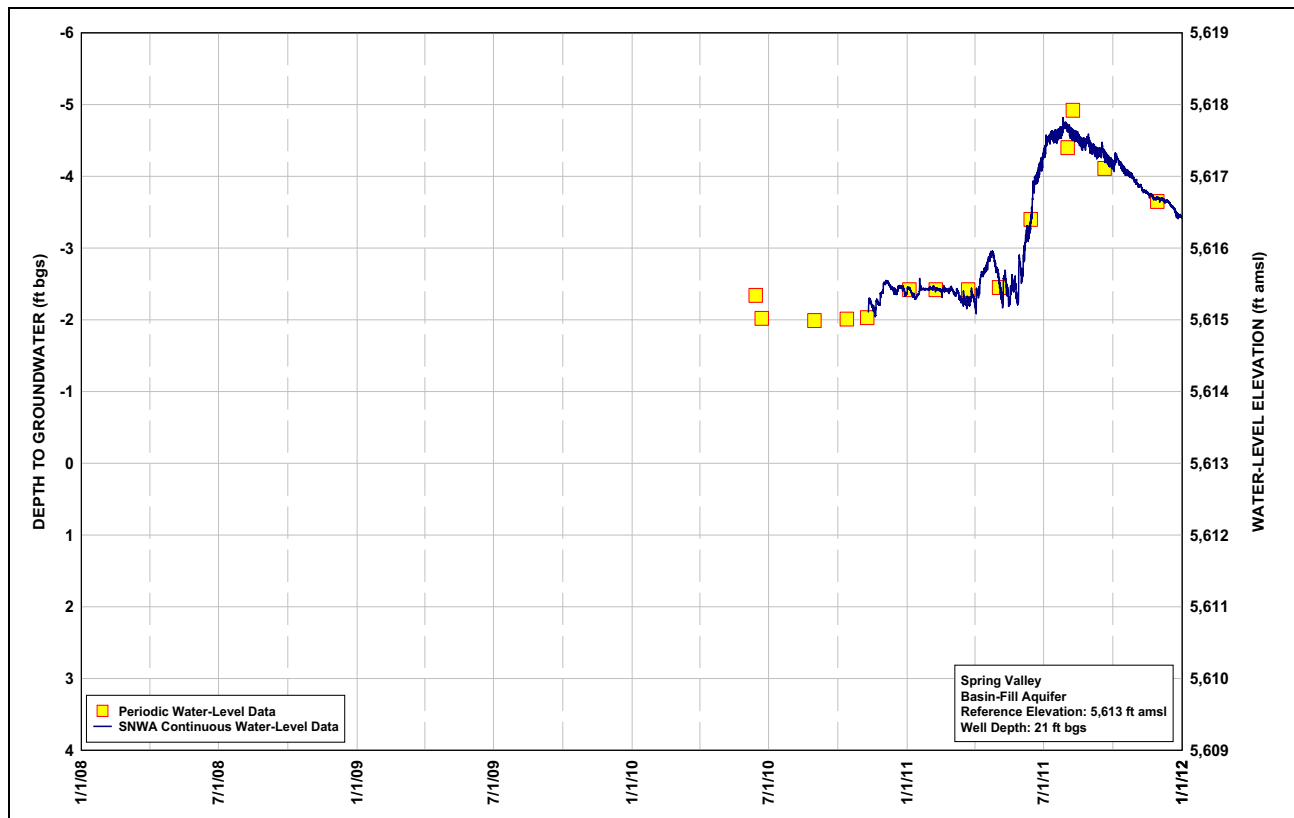
Figure 11-8
Hydrograph of Keegan Spring Piezometer

A hydrograph of periodic and continuous water-level data collected at the piezometer is presented on [Figure 11-8](#). A hydrograph of the spring discharge measured at the permanent flume is presented in

Figure 11-9. The piezometer water level and spring discharge observations have similar trends. The hydrograph and site hydrogeologic conditions indicate a direct hydraulic connection between the spring and shallow groundwater system.

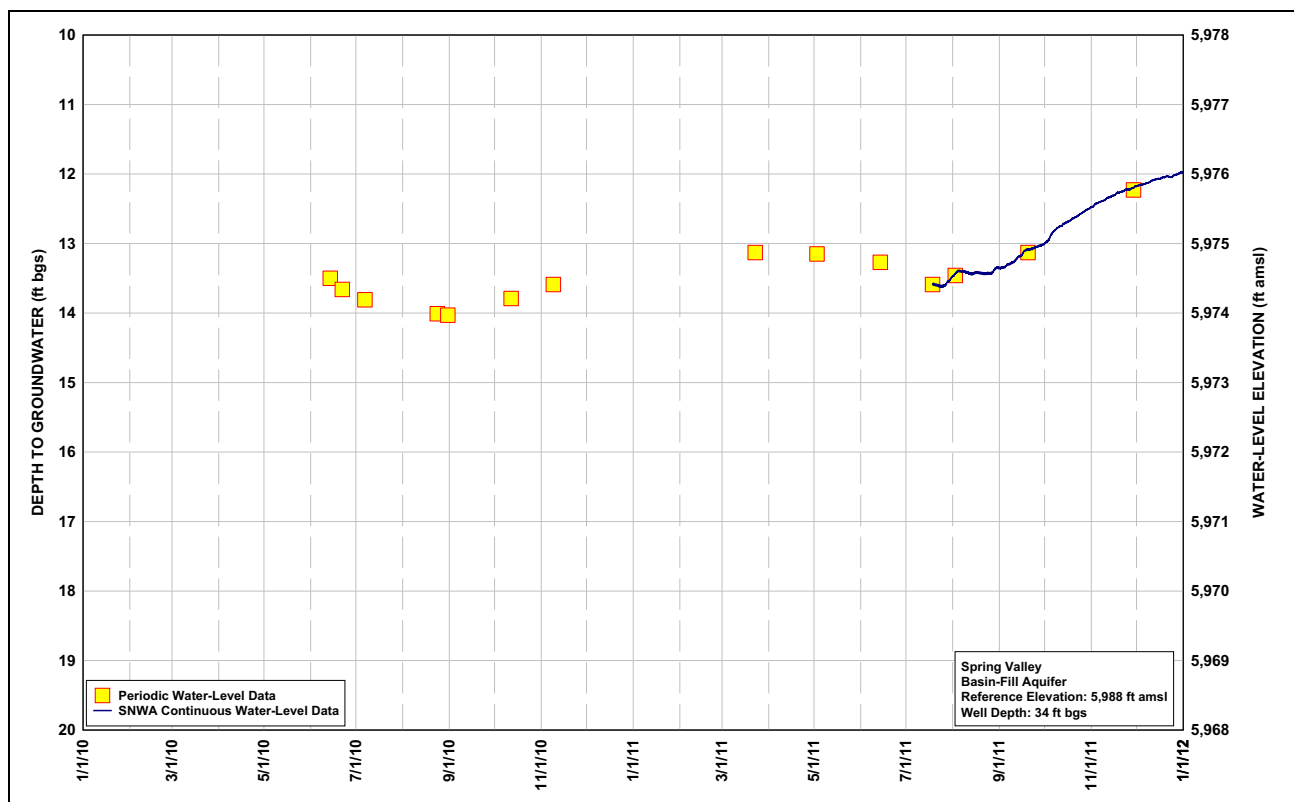
Figure 12-8
Hydrograph of Willow Spring Piezometer

A hydrograph of periodic and continuous water-level data collected at the piezometer is presented on [Figure 12-8](#). A hydrograph of the spring discharge measured at the combined channel using a temporary flume is presented in [Figure 12-9](#). The piezometer water level and spring discharge observations have similar trends.

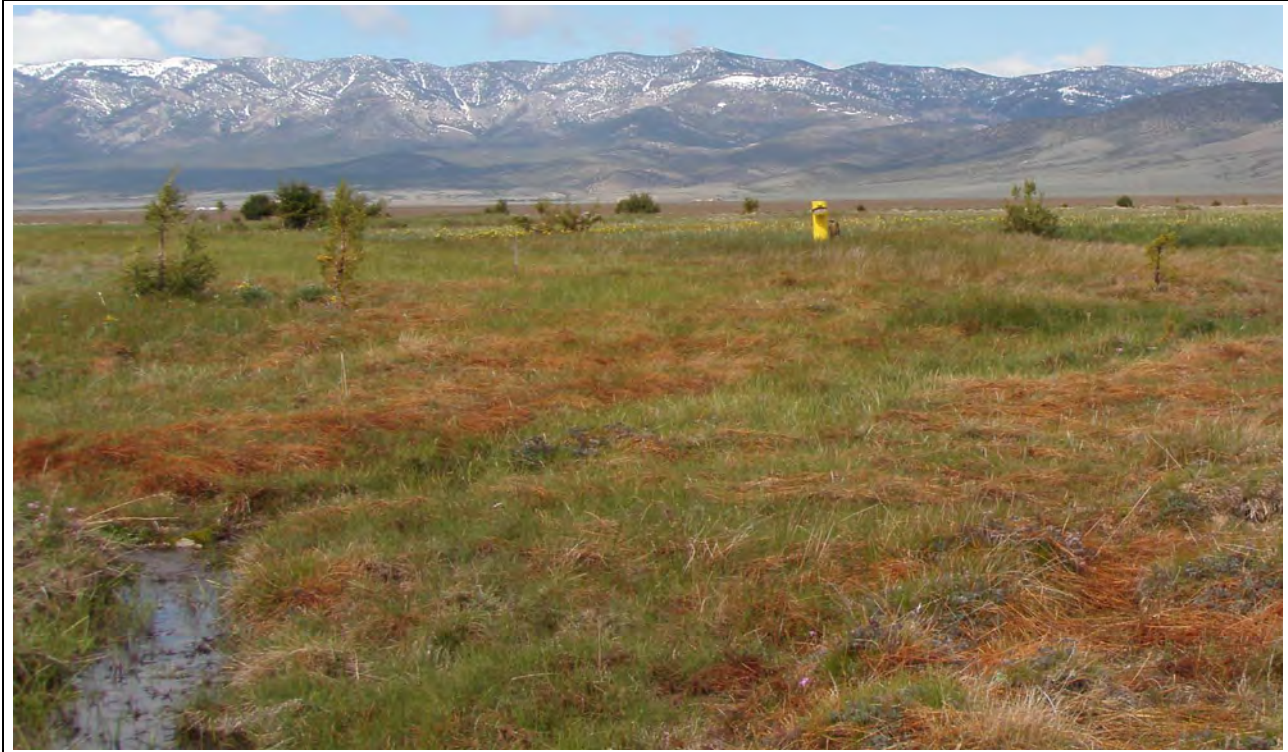
Figure 16-6
Spring Discharge Channel and Piezometer Cleveland Ranch Spring North

Cleveland Ranch Spring North is located on the valley floor in unconsolidated basin-fill sediments. The spring is situated in an area of multiple diffuse springs and surrounded by moderately dense vegetation coverage consisting of grass, shrubs, and Swamp Cedar trees. A high-resolution aerial photo depicting the spring area, hydrologic monitoring locations and biological monitoring transects are presented in [Figure 16-3](#). LANDSAT 5 satellite imagery for the region around Cleveland Ranch Spring North for a dry period (2002), wet period (2005), and last year (2011) is presented in [Figure 16-4](#). Field photos of the spring are presented in [Figures 16-5](#) and [16-6](#).

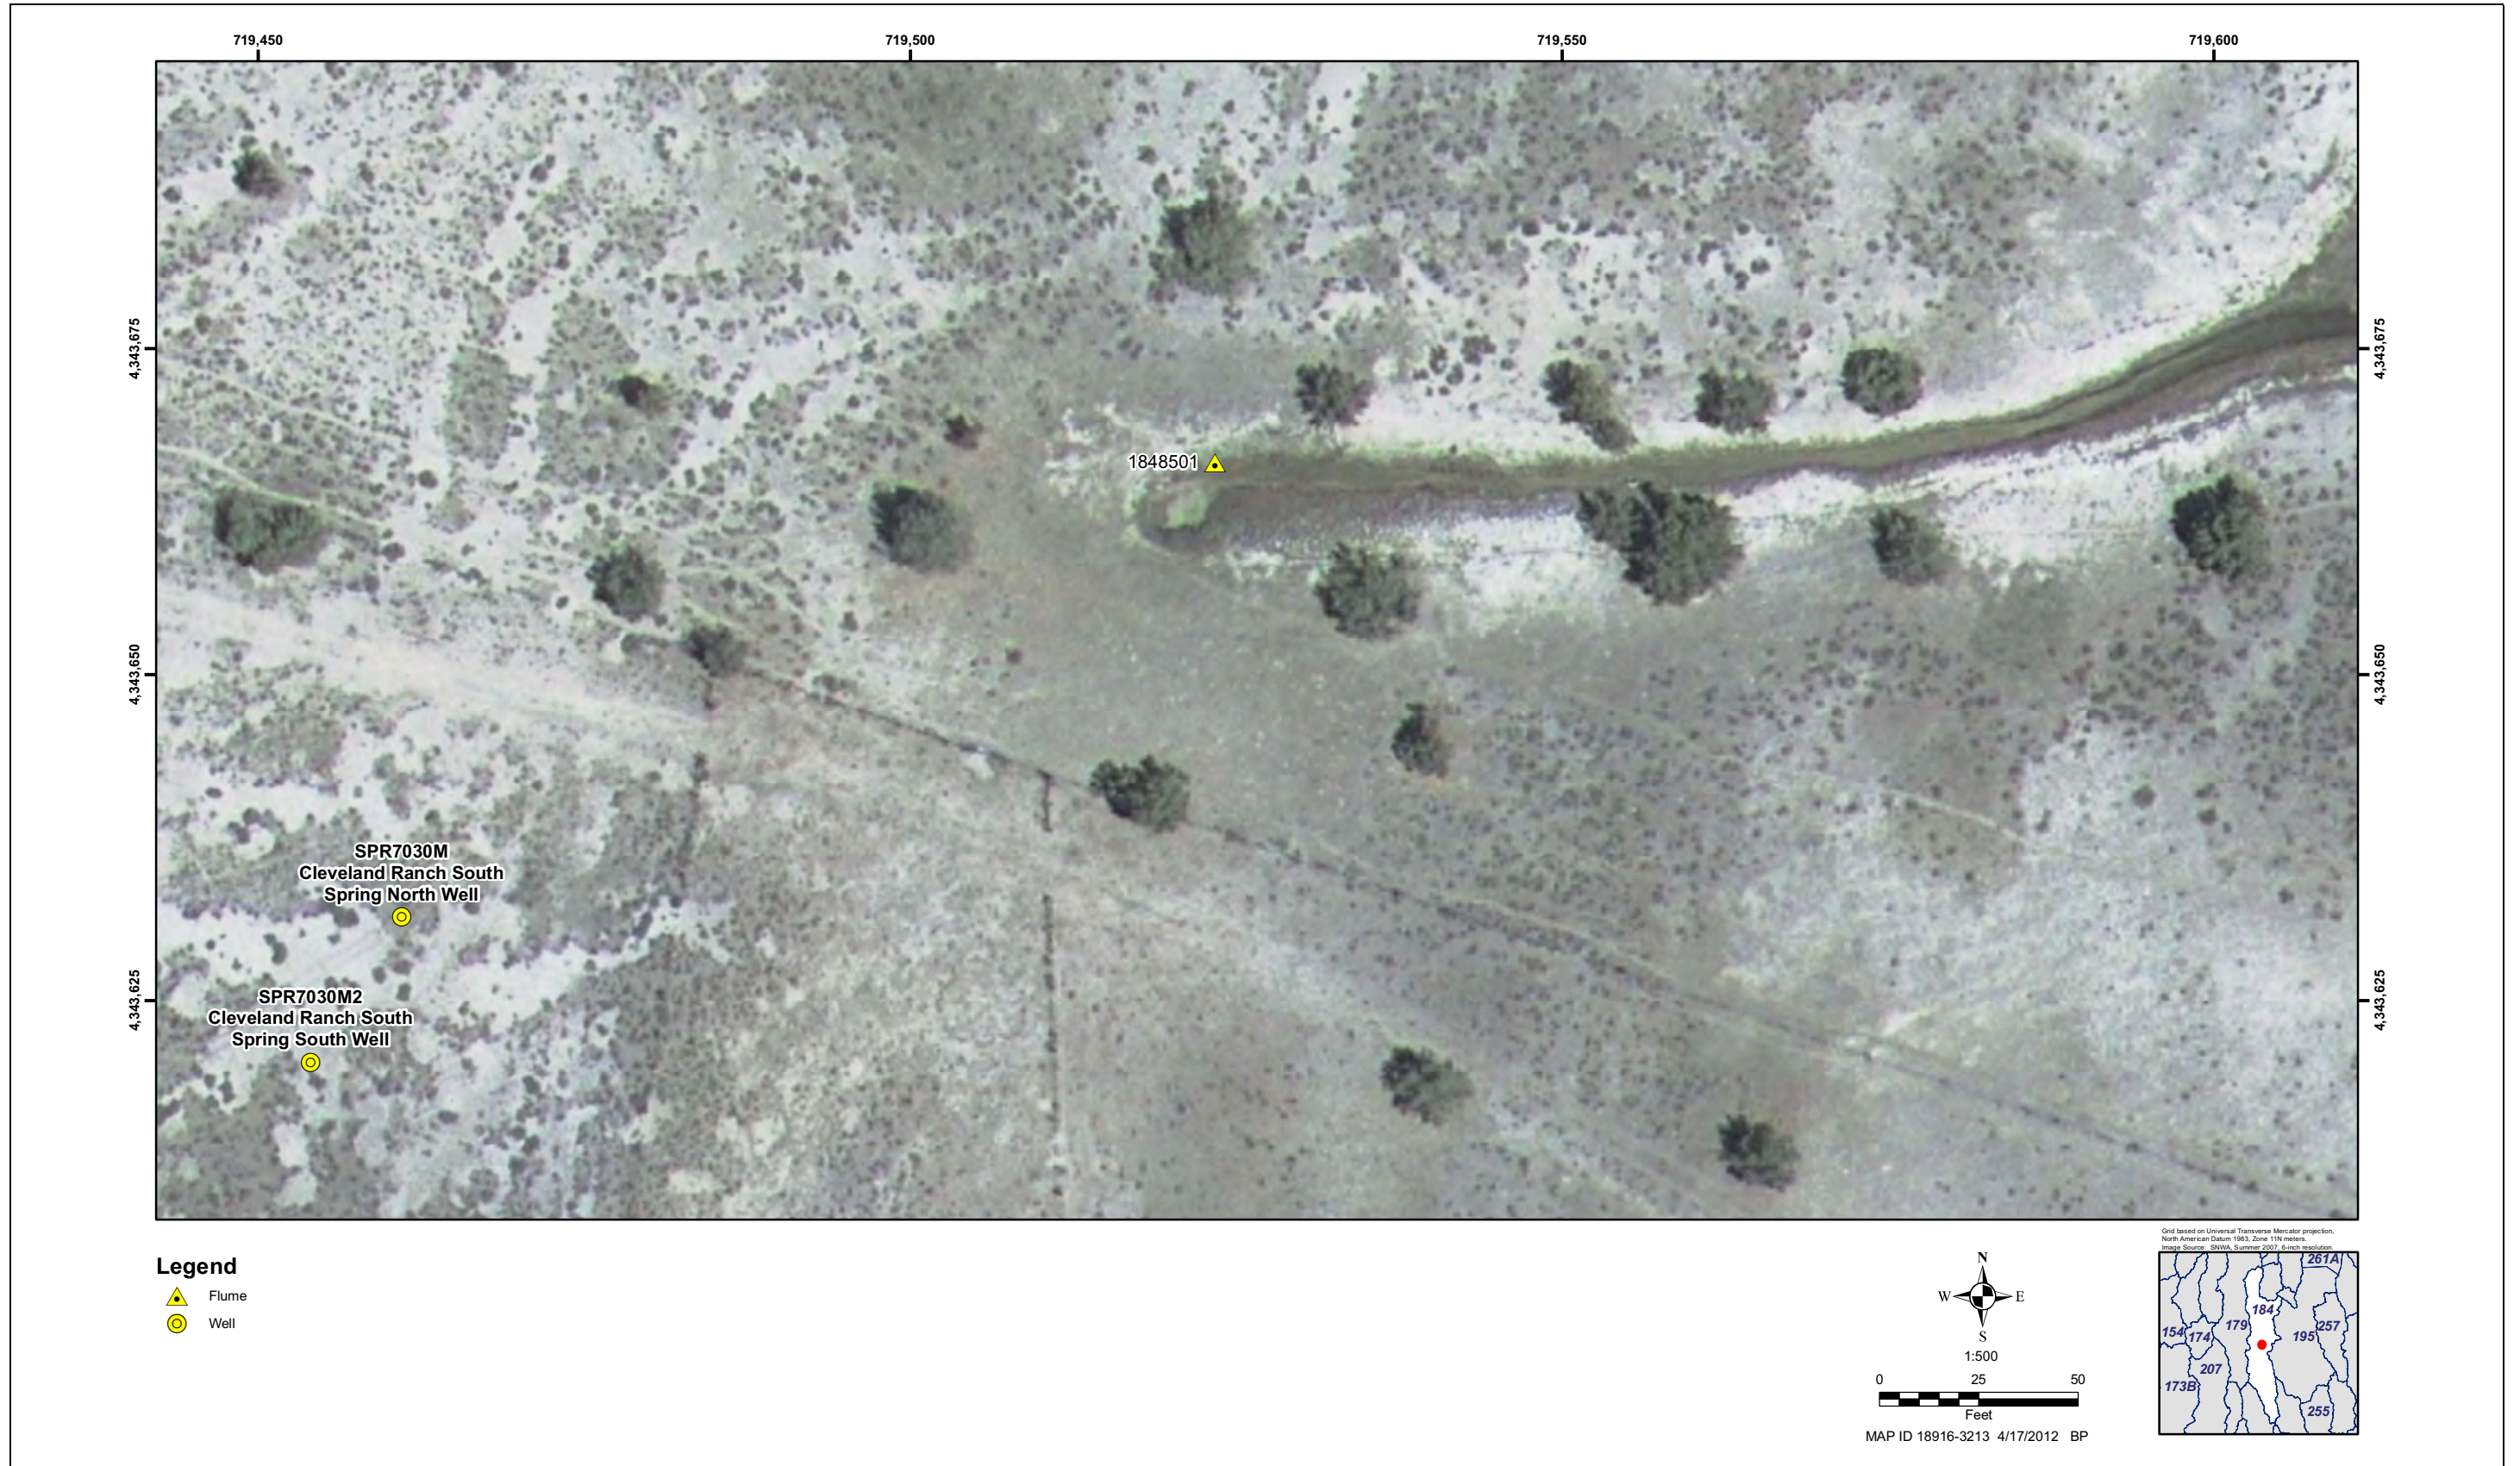
Figure 17-1
High-Resolution Aerial Photo of Cleveland Ranch Spring South

Cleveland Ranch Spring South is located on the valley floor in unconsolidated basin-fill sediments. The spring emits from a spring pool approximately 15 ft in diameter and is located in an area of multiple diffuse springs and surrounded by moderately-dense vegetation coverage consisting of grass, shrubs, and swamp cedar trees. A high-resolution aerial photo depicting the spring dimensions, hydrologic monitoring locations and biological monitoring transects are presented in [Figure 17-1](#). LANDSAT 5 satellite imagery for the region around Cleveland Ranch Spring South for a dry period (2002), wet period (2005), and last year (2011) is presented in [Figure 16-4](#). Field photos of the spring are presented in [Figures 17-2](#) and [17-3](#).

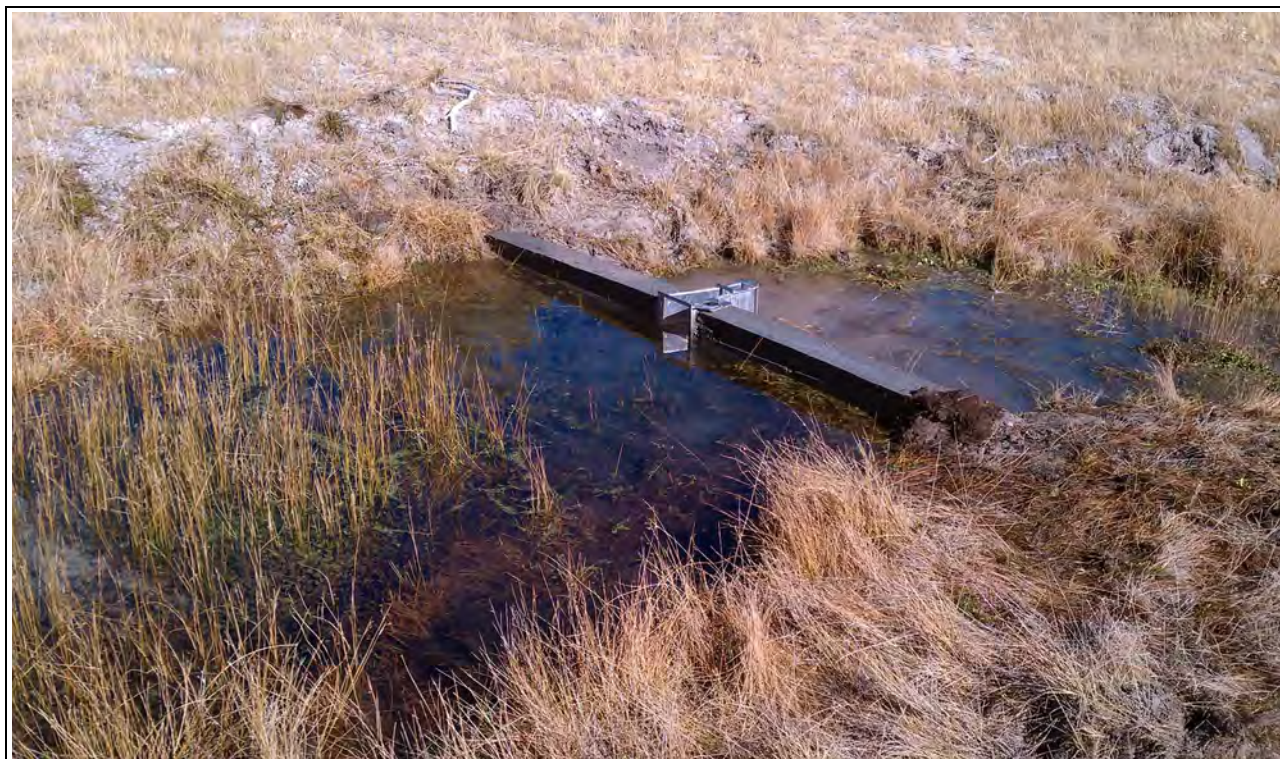
Figure 17-2
Cleveland Ranch Spring South November 11, 2010

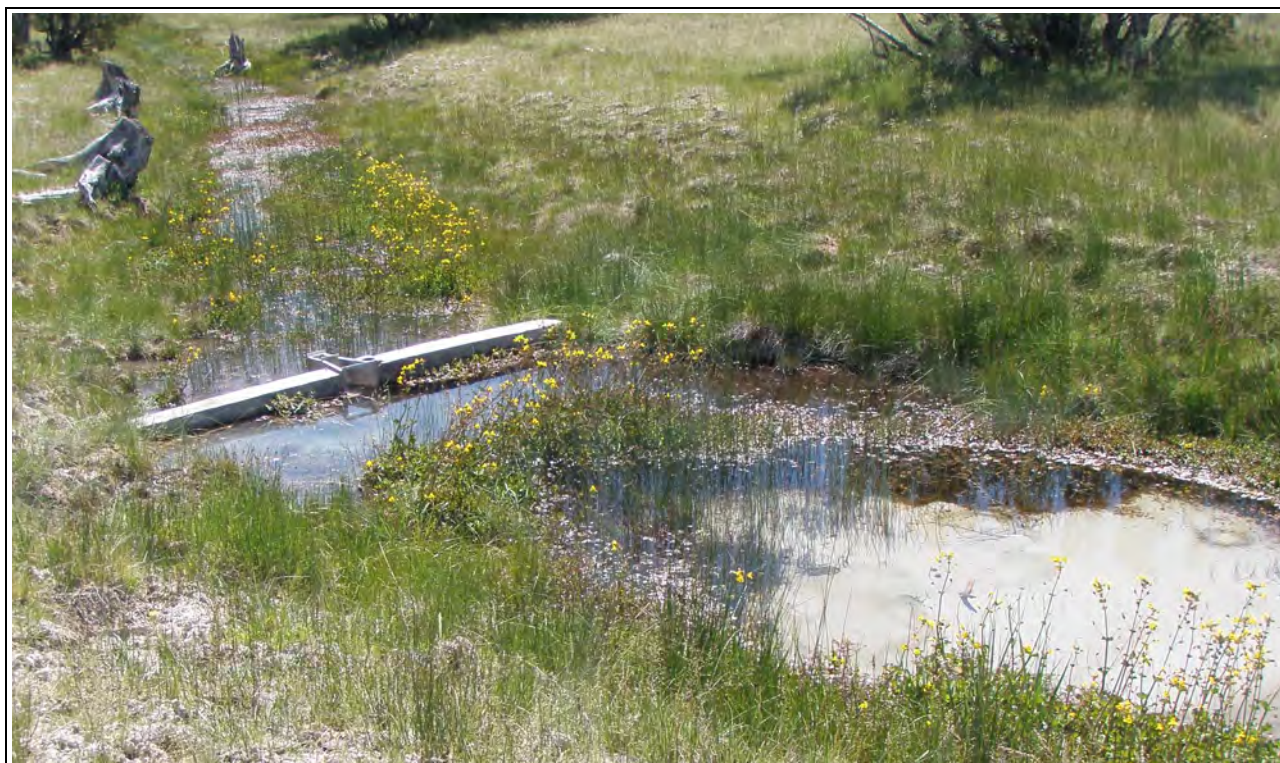
Figure 17-3
Cleveland Ranch Spring South June 30, 2011
