Dale C. Bugenig, Consulting Hydrogeologist,
In the Matter of
Adjudication of Claims of Public Water Reserves in Diamond Valley, Nevada

January 29, 2019

Prepared for
Eureka Board of County Commissioners

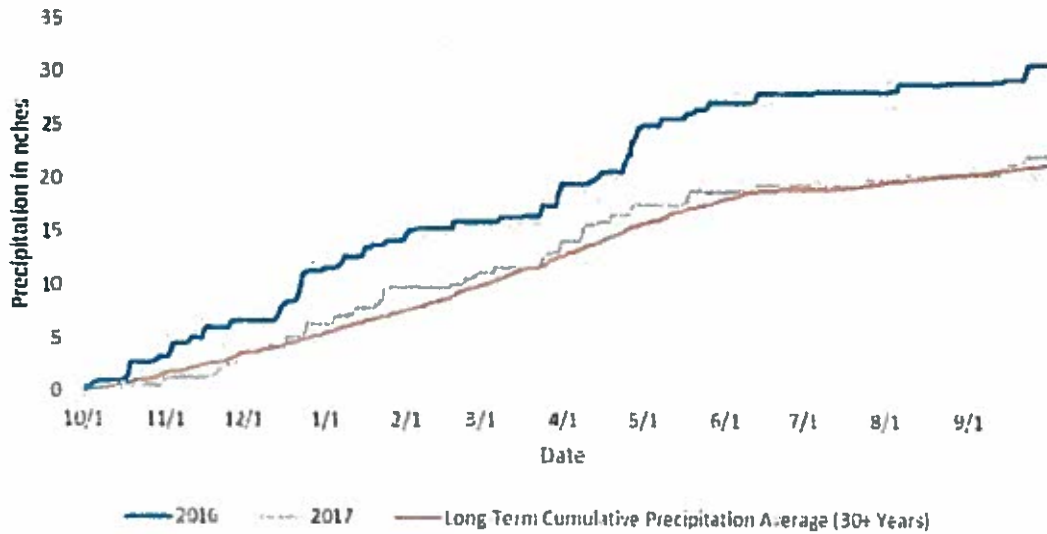
and during the timeframe of BLM's measurements was well above average. See the figures below:

Water Year Precipitation Diamond Peak SNOTEL

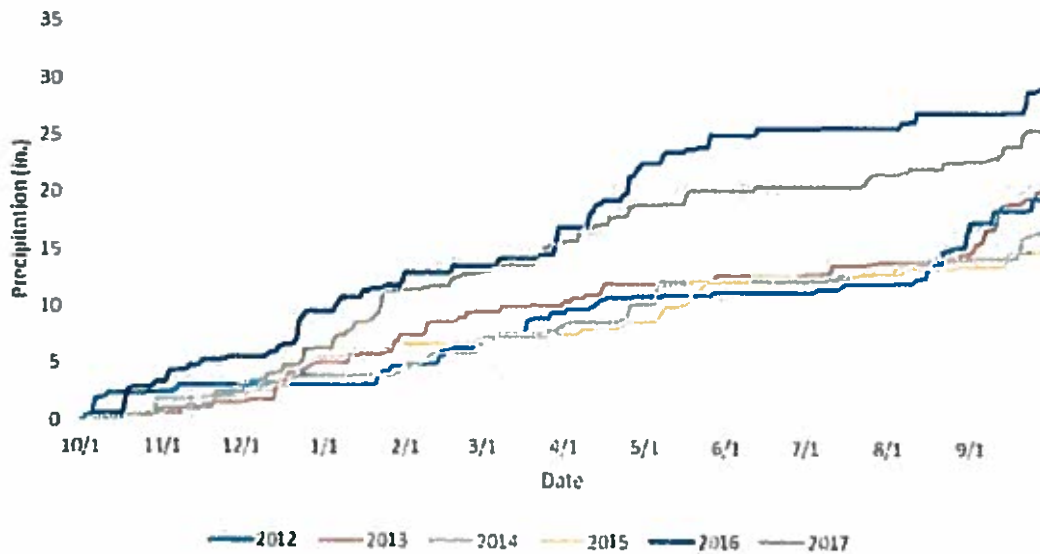
**Water Year Precipitation
Vacarro Springs SNOTEL**

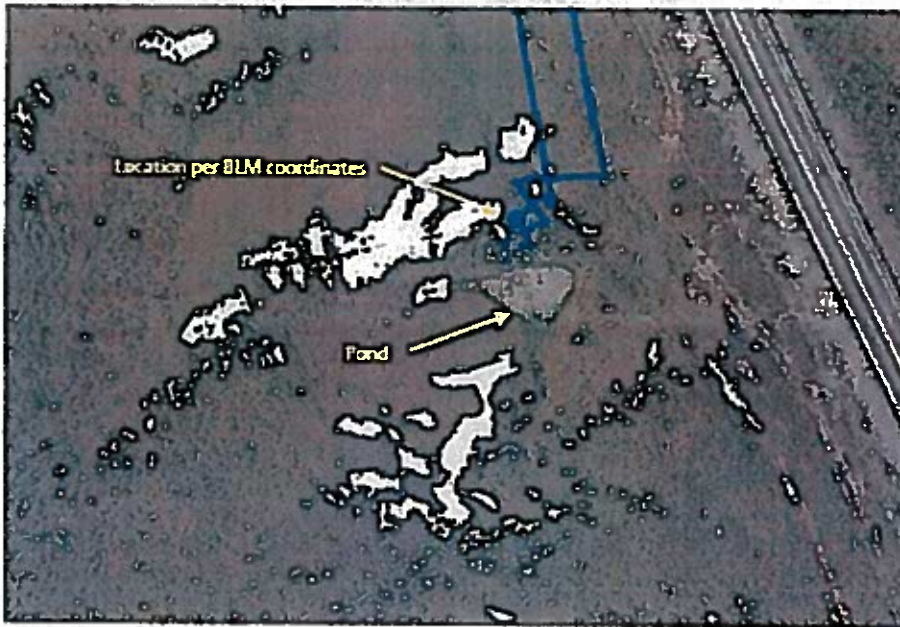
BLM description: "Spring Complex, at least 3 springs expressions, all flow into a stock pond. There is a trough but it is nonfunctional."

Aerial image of R04233.

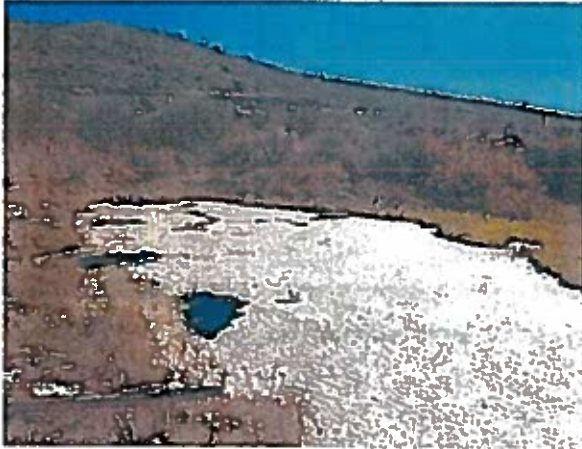
The discharge from the R04233 was determined from the combined measurements of the surface discharge at the spring pond and the discharge from the pipe from the pond made during the October 16, 2016 field visit. Overland discharge from the pond was measured at 0.75 gpm, discharge from the pipe was measured at 1.0 gpm, for a total of 1.75 gpm. By comparison, BLM reported the spring low to be 11 gpm on April 12, 2016. The spring discharge appears to be variable, depending on the time of year with higher flows when runoff is occurring. The recent measurement made on behalf of Eureka County may be more representative of base flow conditions.

Pond at source of R04233.

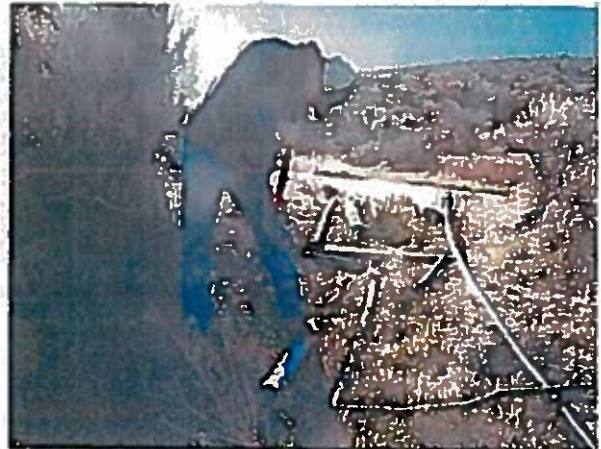
Installing a pipe in order to measure surface outflow from R04233 pond.

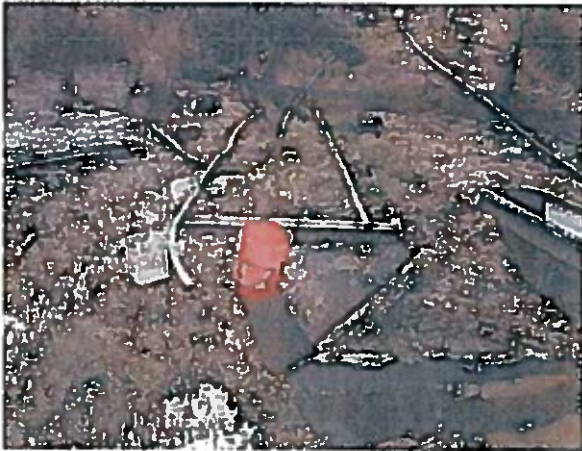
Additional outflow from R04233 via pipe.

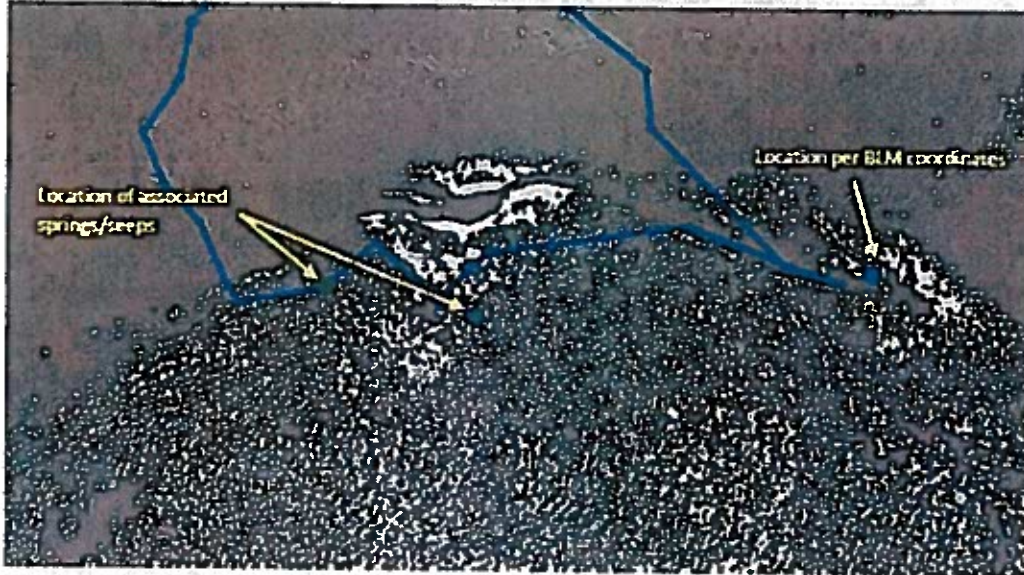
BLM description: "Large spring complex with 4-5 seeps and 2 meadows, all leading to an intermittent stream. Several troughs, one functional and one no longer functioning."

Aerial Image of R04236.

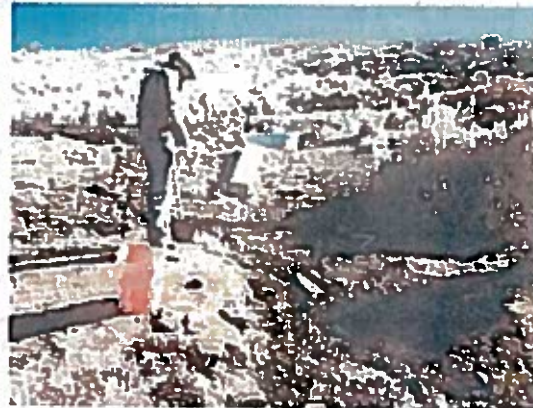
Hillside spring 460 feet west of R04236 site. Pipe placed in spring discharge channel to measure flow.

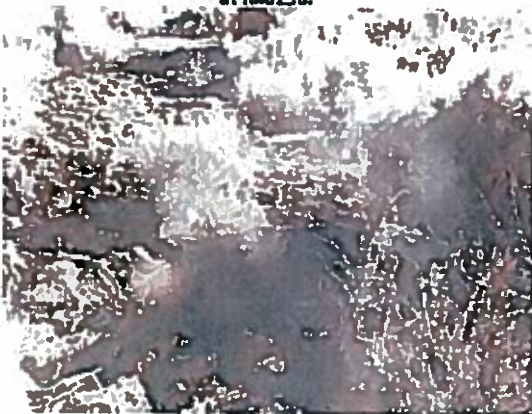
Seep 633 feet west of R04236. No measurable flow.

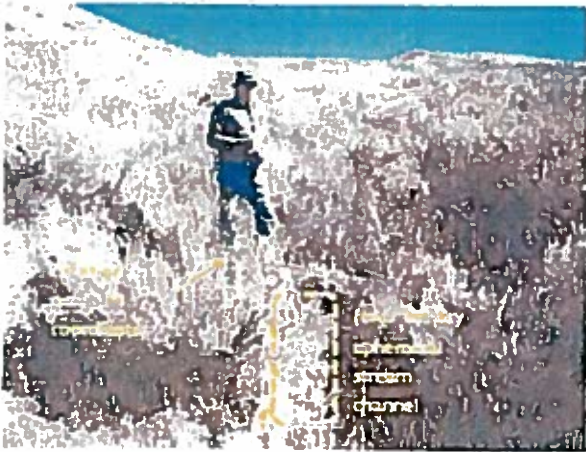
R04237 location.

No spring flow was observed at R04237 on 10/16/18 and the site was dry. By comparison, the BLM reported 1.75 gpm on April 13, 2016. The difference between the two measurements is likely explained by the different sampling dates and spring runoff. From all appearances, the source is ephemeral with flow limited to the springtime.

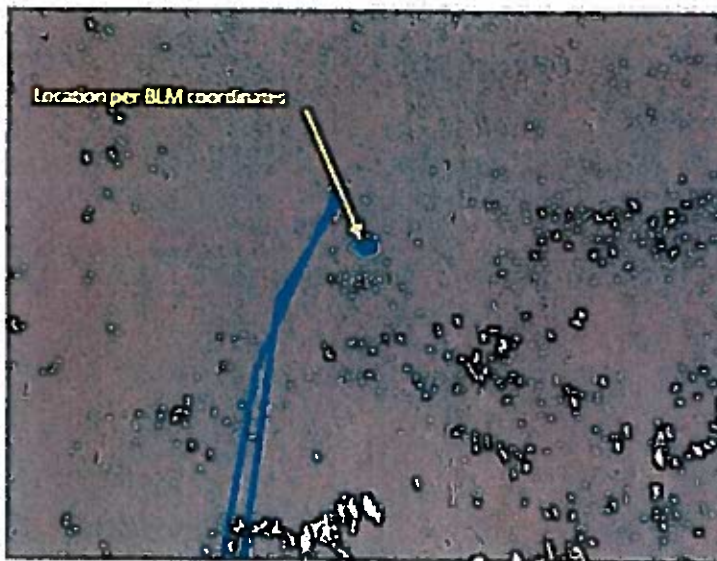
BLM description: "Spring maybe part of a larger complex, expresses from side of a channel."

Aerial Image of R04238

The conditions at R04238 are similar to R04237. Except that the vegetation suggests there may be some seepage earlier in the year, but there is no evidence of continuous, year-round flow.

No flow was observed during the visit on 10/16/18 and the site was dry. In contrast, the BLM reported a flow of 1.25 gpm on April 13, 2016. The source apparently is ephemeral and only may provide a source of supply during runoff periods.

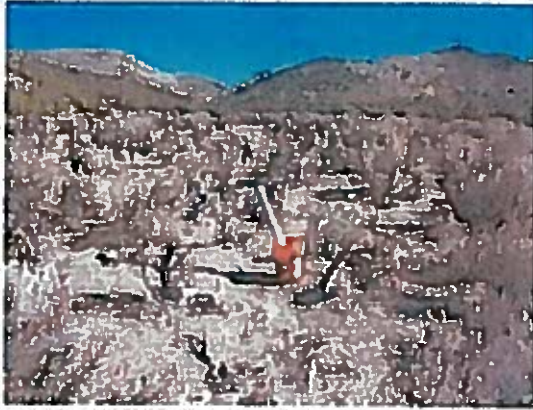
The discharge from the spring was determined from the combined measurements of the surface discharge at the spring site and the discharge from the pipe where it flows into the trough made 10/16/18. Discharge at the source that bypasses the collection system was measured at 0.26 gpm. Discharge to the trough was measured at 1.0 gpm, for a total of 1.26 gpm. By comparison, the BLM reported a flow of 6 gpm on 4/13/16 and the State Engineer Field Investigation Report reported the flow in 2017 "of 12 gpm discharging from a...pipe...along with an estimated unmeasured 3 gpm from the nearby immediate area near the pipe." This was at the exact same location where Eureka County measured the 0.26 gpm in October 2018. It would not be surprising if there were more water in the springtime when both BLM and State

Engineer staff measured flow, but the area is dry later in the year and only Bennett Spring which has been developed, not the meadow area, provides a continuous, year-round source of water.

R04239 Location per BLM coordinates

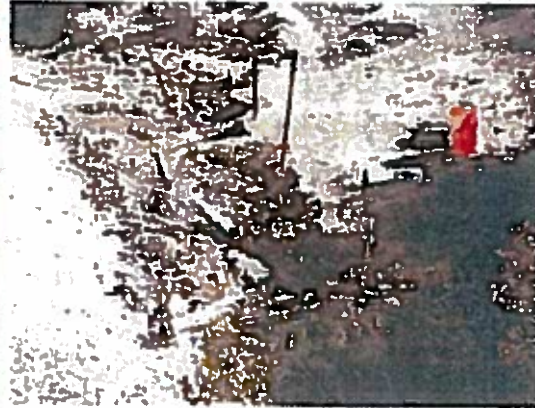
Location of Spring 217 feet northwest of BLM location.
Water is piped to trough.

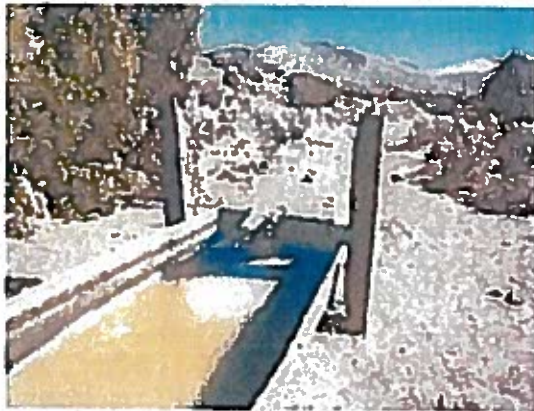
Water from Bennett Spring is piped to this trough.

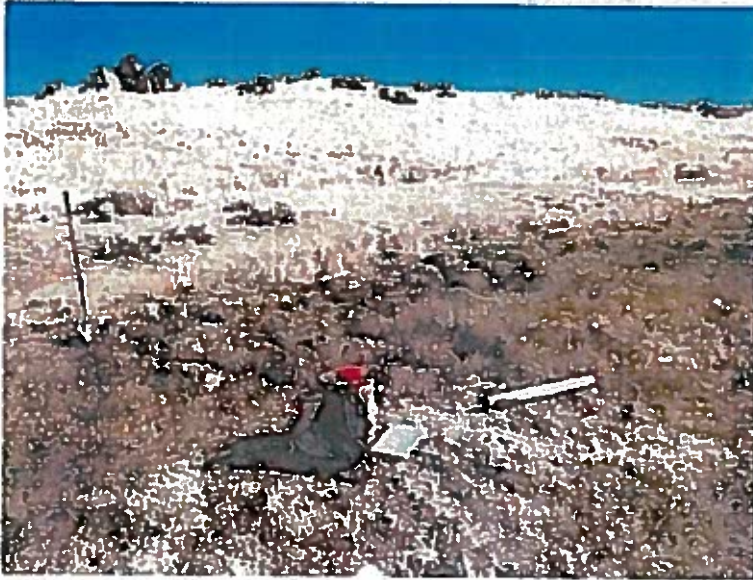
Although standing water is present, there was no measureable or observable flow on 10/16/18. In contrast, the BLM reported a flow of 2.5 gpm on April 13, 2016. Apparently, the flow measured by BLM during the spring of the year is not available continuously, year-round.

Hillside seep at R04243.

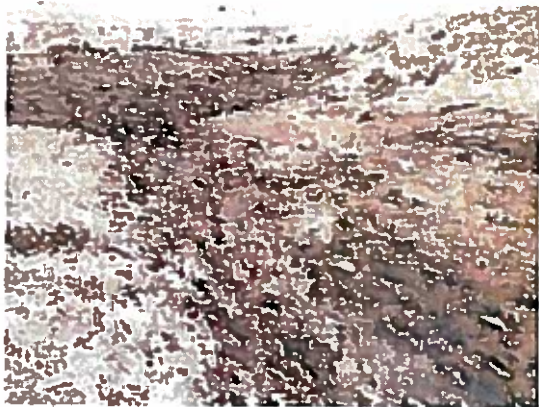
The spring has excavated resulting in a low earthen embankment. Water is piped 120 feet to the northwest to a trough. No flow to the trough was observed. There is a small overland flow from the spring source.

The discharge for R04244 was measured 10/16/18 in the channel below the spring source at 0.25 gpm. There was no flow to the trough at this time. In contrast, the BLM reported a flow of 1.25 gpm on 4/13/16. The spring flow apparently is variable, with the measurement made 4/13/16 potentially affected by springtime soil moisture conditions or runoff from the hillside above the spring, but the spring does not flow year-round at 1.25 gpm.

Spring at R04244.

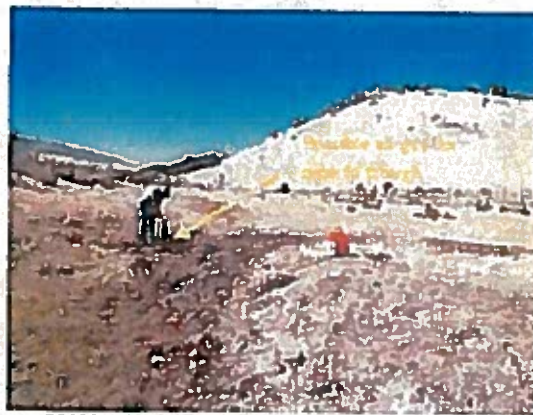
R04244 Discharge Channel, viewed in a downstream direction from the source area.

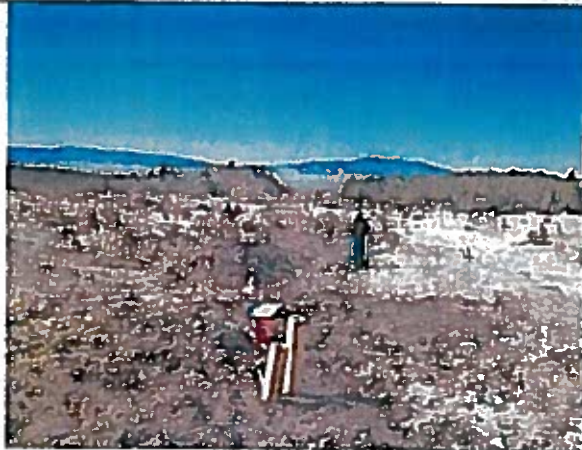
The discharge from the spring was measured at two locations – in the channel approximately 250 feet west of the location depicted by the BLM and at the outfall of the pipe at the pond approximately ¼ mile to the west-southwest. Flow was measured at 3.5 gpm in the channel near the source and 20 gpm at the outfall to the pond, for a total of 23.5 gpm. In contrast, the BLM reported a flow of 3 gpm on May 16, 2016. Clearly, the spring development has captured flow in excess of the spring's natural discharge.

R0429 location based on BLM coordinates. Spring has been extensively developed to deliver water to pond ¼ mile to west-southwest.

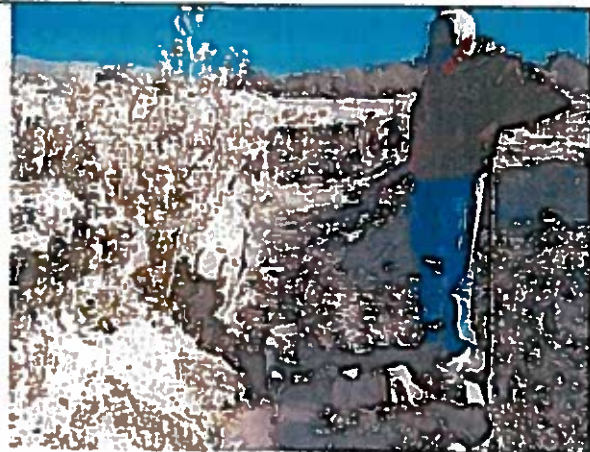
Measurement of Spring flow not captured by pipe to pond.

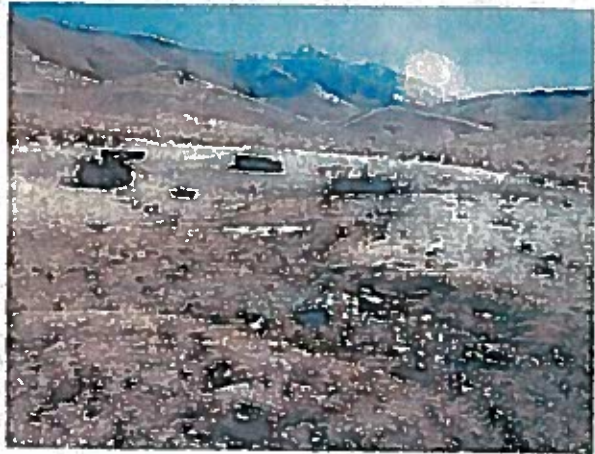
Overflow from tank flows to the north-northwest.

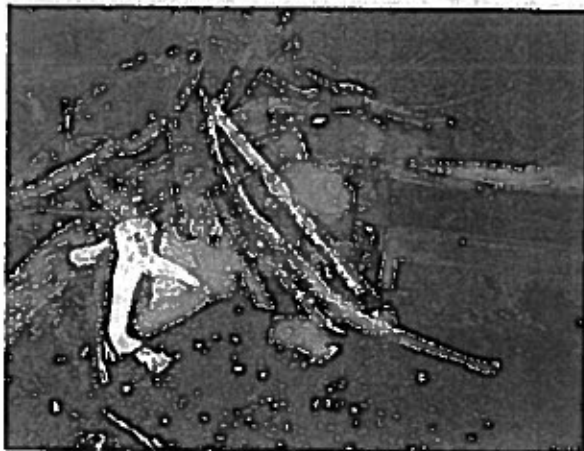
The spring flow measurement on 10/18/18 of 0.75 gpm was taken in the stream channel below the trough such that it includes the overflow from the trough as well as the spring discharge that is not collected and conveyed to the trough. This measurement contrasts with reported flow of 12 gpm reported by the BLM on 5/16/16. It seems likely that the BLM measurement was affected by seasonal recharge or runoff.

Spring at R04251.

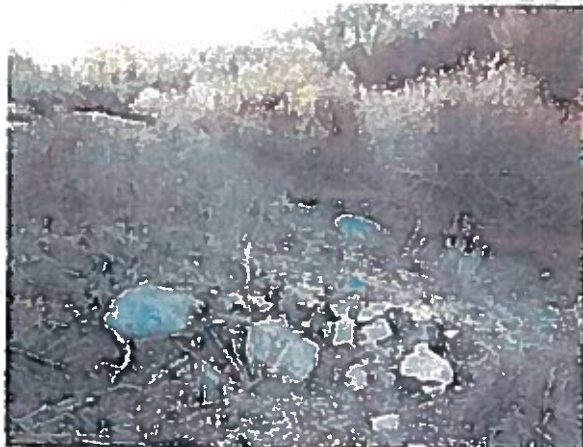
Spring discharge was measured at 11.5 gpm on 10/18/18 downstream of the location indicated by the BLM in order to capture the combined discharge at this location. This compares to a flow of 47.3 gpm reported by the BLM on 5/16/16. The large difference suggests that spring runoff may have contributed to the high flow measured by the BLM and 11.5 gpm may be more representative of the base flow from this spring.

Source of spring at R04252

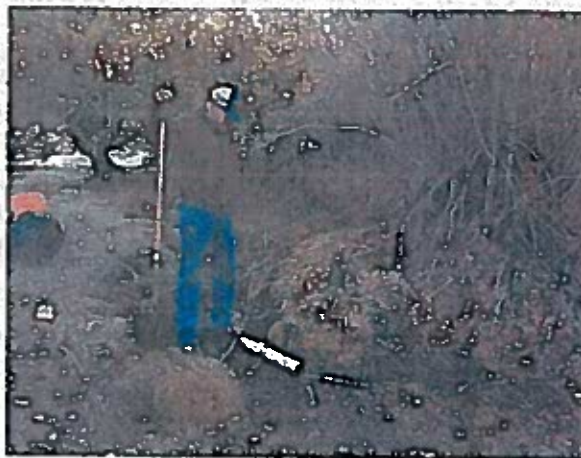
Location of measurement downstream of R04252.

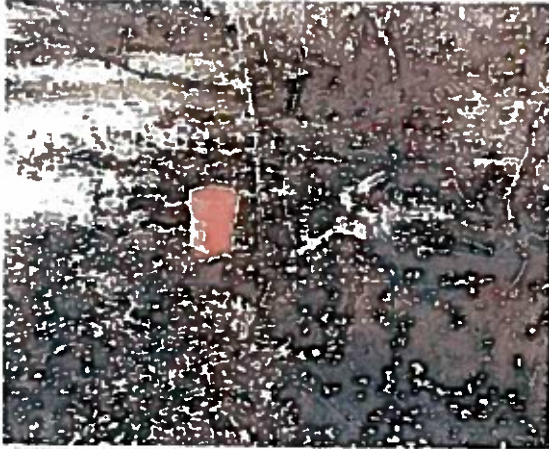
Spring discharge was measured in the stream channel below the seeps at 1.01 gpm on 10/18/18. This compares to a flow of 2.35 gpm reported by the BLM on 5/13/16. The flow measured 10/18/18 is more representative of base flow from this complex and indicates the flow measured by the BLM is not available continuously.

Location of seep at coordinates provided by BLM for R04253. Site is wet, but no measureable flow.

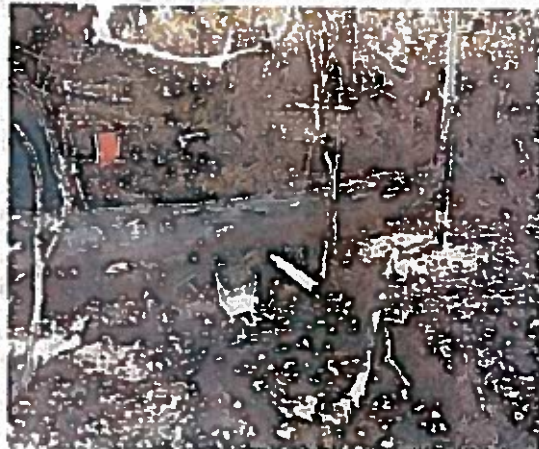
Location where measurement was taken in stream channel below seeps.

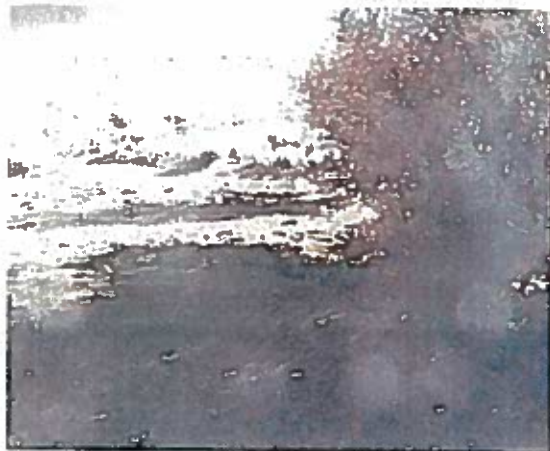
The spring flow measurements were taken at two locations in the stream channel - one located approximately 50 feet downslope of the source, the second at the lower trough approximately 1,000 feet downstream of the source – to obtain the combined flow of the spring complex. Total spring discharged measured 10/18/18 was 4.01 gpm. This rate is greater than the measurement of 2.5 gpm reported by the BLM April 14, 2016.

R04254 source as described by BLM.

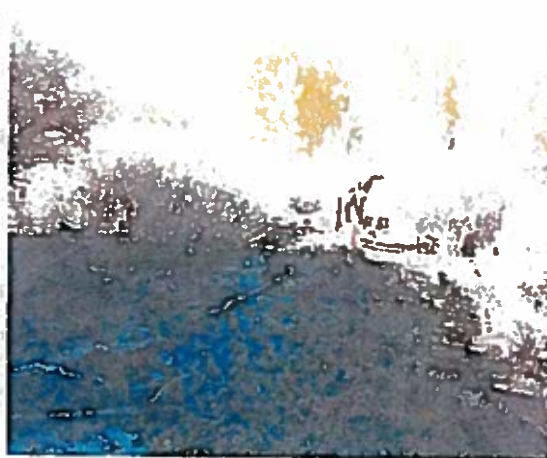
Location of measurement from channel located approximately 50 feet downslope of source.

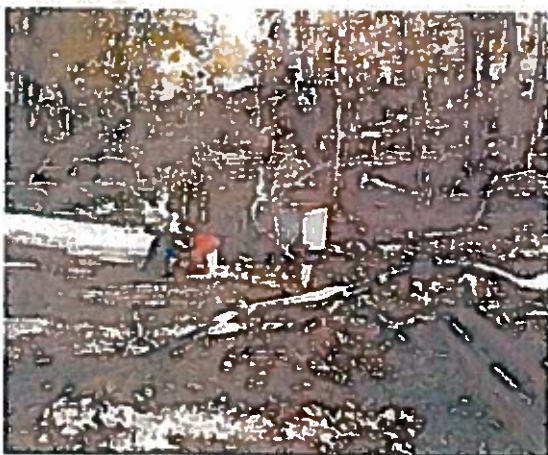
Lower trough where 2nd flow measurement was collected.

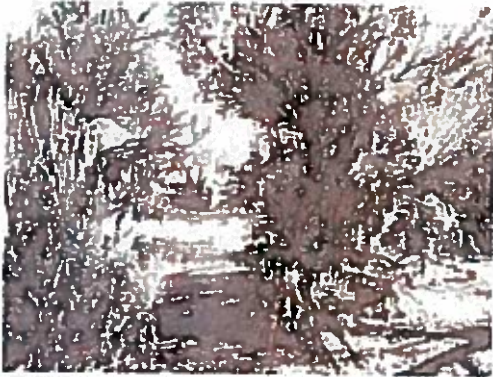
Spring discharge was measured at the outflow from the pond at 0.50 gallon per minute. No flow was observed from the pipe to the troughs. In contrast, BLM reported the flow was 9.4 gpm May 13, 2016. The flow from the spring appears to be variable, with the October 2018 measurement more representative of base flow conditions.

R04256 location based on BLM coordinates.

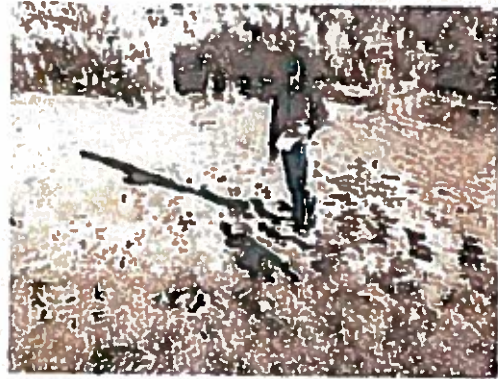
Hummocky ground at the likely location of R04256, west of the location suggested by BLM coordinates.

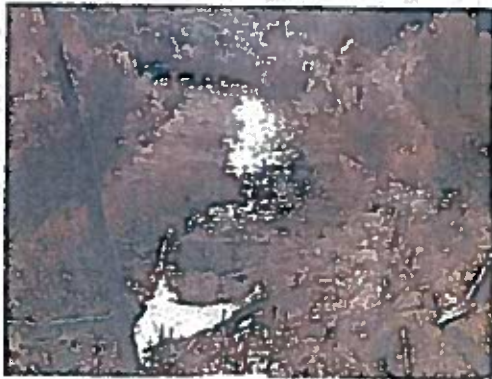
Flow in channel below pond west of R04256.

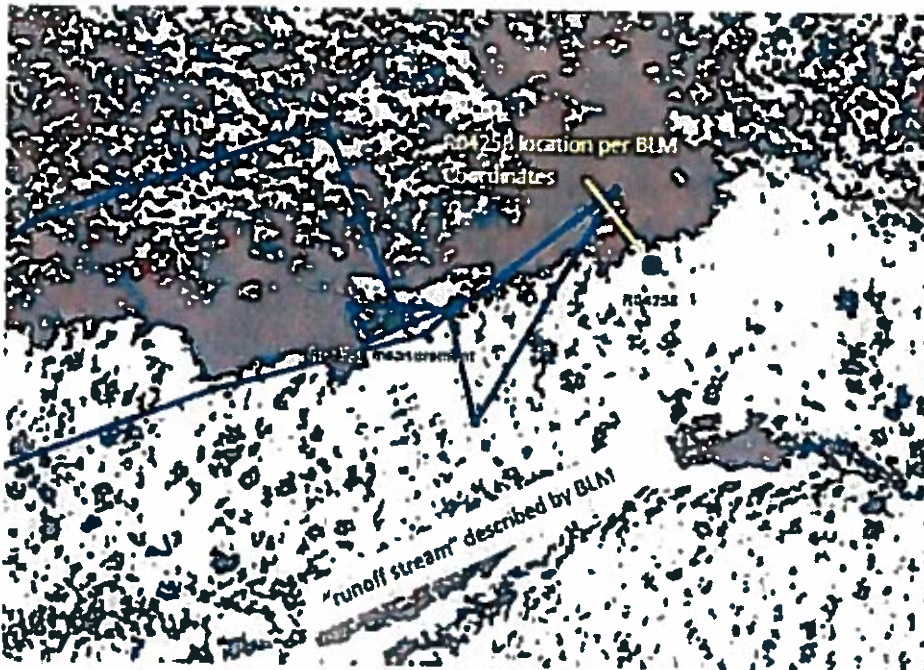
BLM description: "Spring head with several expression creating a large tributary, stream runs for approximately 0.5 miles before meeting with runoff stream."

Aerial image of R04258 site.

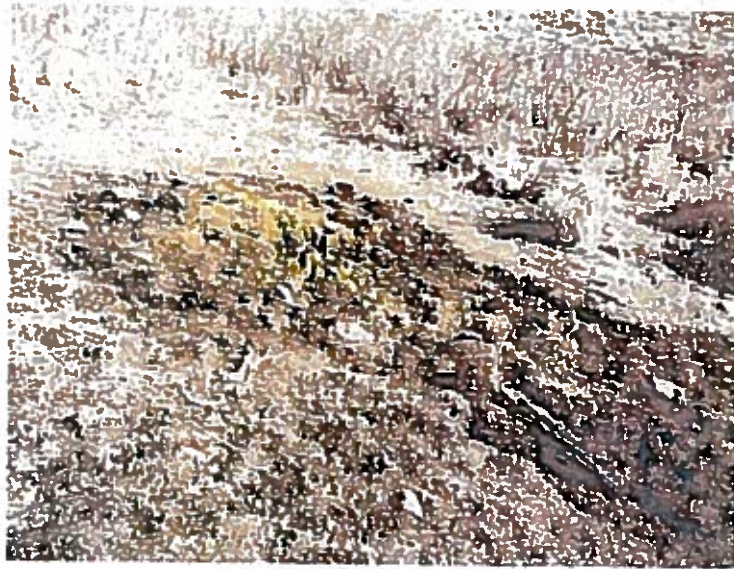
Spring discharge was measured in the channel downstream (southwest) of the spring at 0.03 gpm on 10/19/18. In contrast, BLM reported a flow of 109 gpm on 5/17/16 that likely was affected by runoff given the huge discrepancy in flow. Based on BLM's description, it appears that flow may have been measured where the spring flow met the "runoff stream." The October 2018 measurement is more representative of base flow from the spring.

Spring identified in R04258.

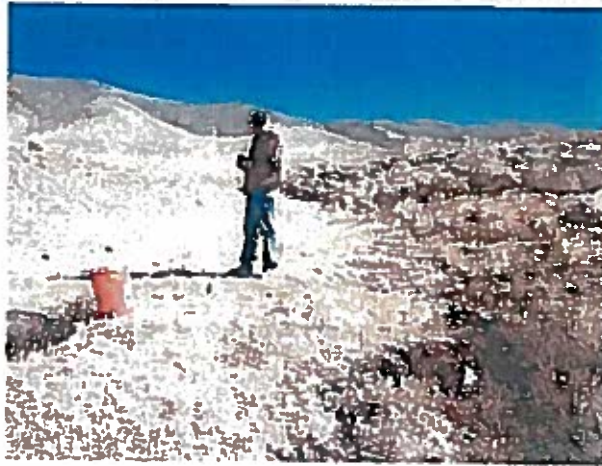
Location of R04259.

No spring flow was observed at the site during the October 2018 site visit, nor was there any evidence of recent flow in the stream channel immediately below the spring site. In contrast, BLM reported a flow of 3 gpm on May 17, 2016. The spring flow apparently varies seasonally, with some flow during the spring runoff period, drying up later in the year.

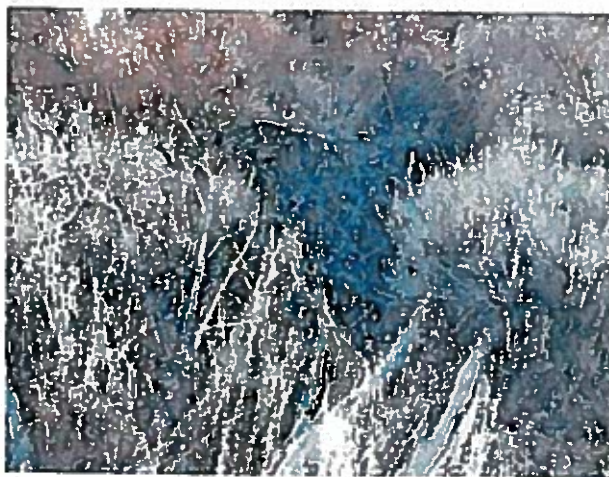
No spring was observed at the coordinates provided by the BLM, although a seasonal spring likely exists at this location. The stream described by the BLM was dry for a distance of more than 200 feet downstream of the spring location.

No spring flow was detected at Potato Spring (R04260) in October 2018. SRK measured a flow of 0.46 gpm in October 2007. In contrast, BLM reported a flow of >2 gpm on May 17, 2016. Clearly, the flow of the spring varies seasonally and is dry in the fall some years.

No spring flow observed at the BLM Location for R04260 spring.

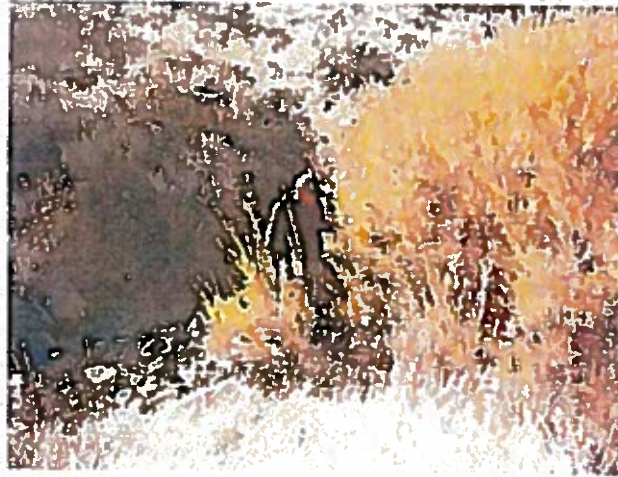
No spring flow was observed October 20, 2018. The stream above and below the willows was dry. In contrast, BLM reported a flow of >2 gpm on May 17, 2016. The spring flow is apparently seasonal and it dries up later in the year.

Location of spring identified in R04261. No observed flow from the spring.

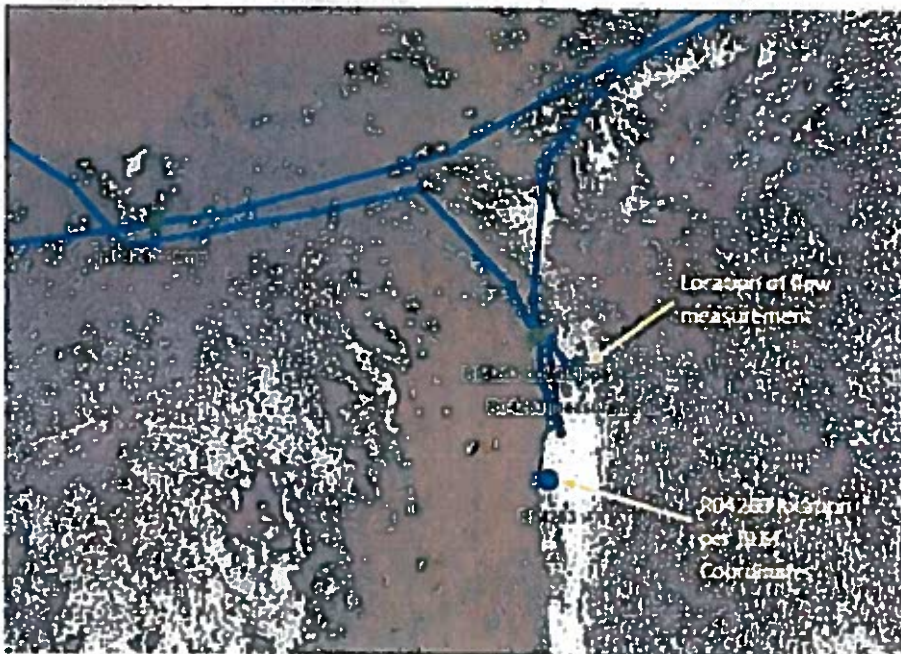
BLM description: "Spring near an intermittent stream expresses to form tributary. There is a sheep trough below the spring head at the bottom of the stream."

Aerial image of R04263 site.

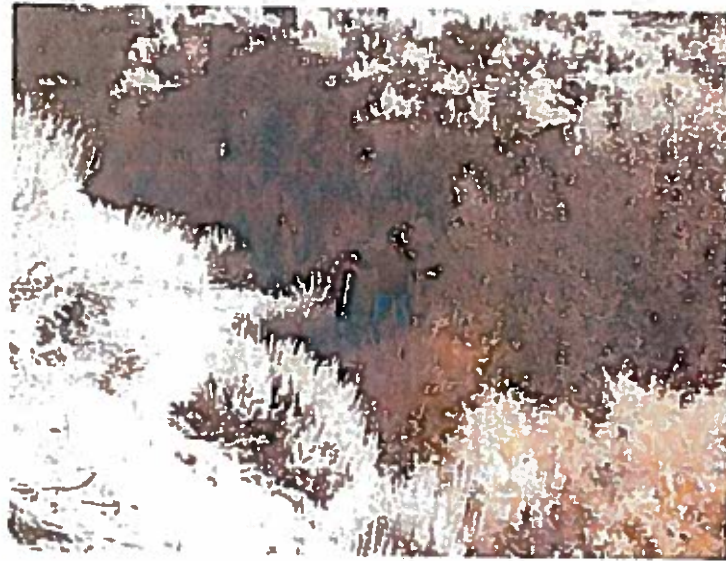
No spring flow was observed during the October 2018 site inspection. BLM reported a flow of >2gpm on May 17, 2016. As seems to be the case for many of the BLM's claims for Public Water Reserves, the small flow measured by BLM is not available year-round.

Location of R04270.

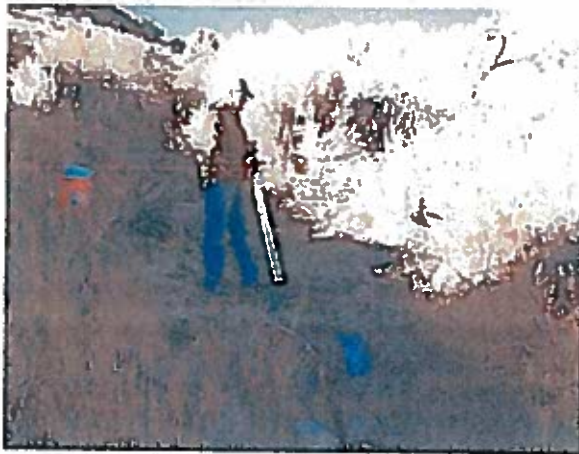
No flow was observed at the location given by the BLM's coordinates. At the nearby seep, water was observed in the depression but there was no measureable flow observed during the October 2018 site inspection such that the flow is likely less than 0.1 gpm. In contrast, the BLM reported a flow of 42 gpm on May 18, 2016. Given the location provided for R-04277 that places it in an ephemeral stream channel, the flow measured by the BLM was very likely affected by runoff.

Location of R04277.

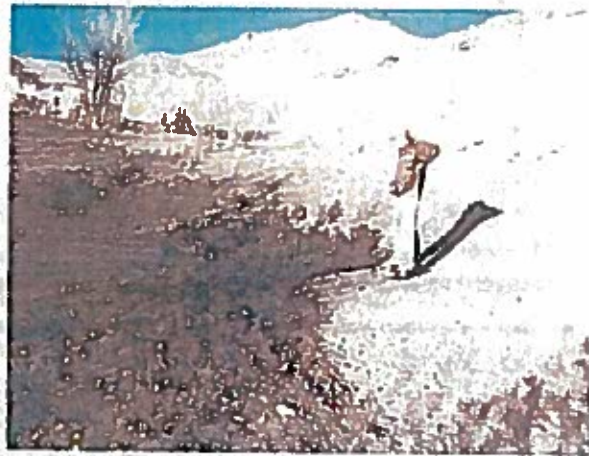
Seep located approximately 180 feet north-northeast of R04277.
