Appendix F3.15

Visual Resources

- **Visual Resource Inventory Summary**
- **Compliance with Visual Resource Objectives by KOP for Proposed Action**
 - **Photographic Simulations**
 - **Contrast Rating Forms**

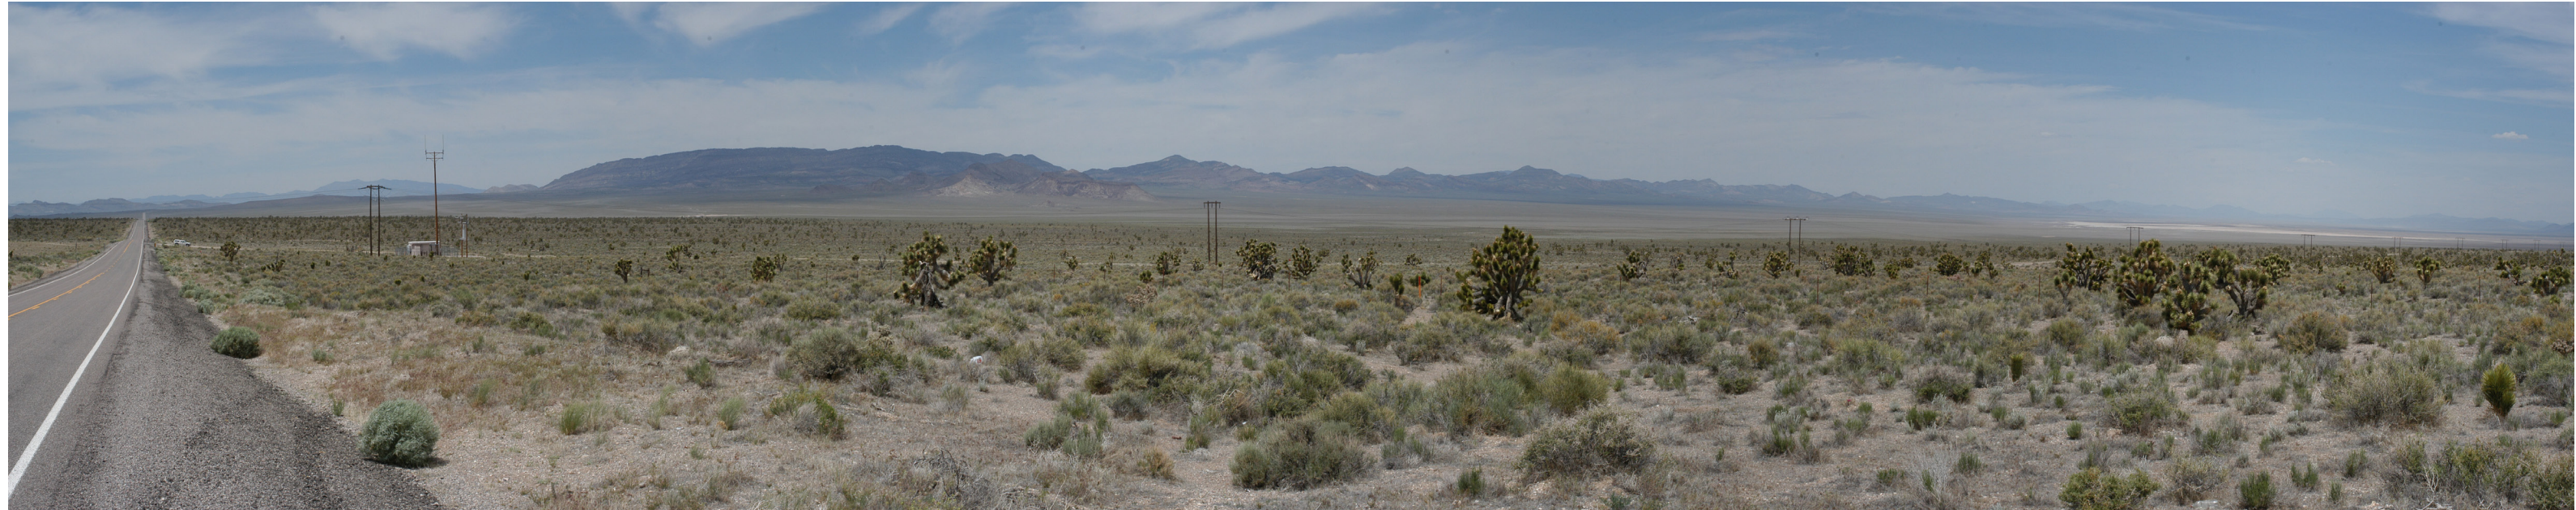
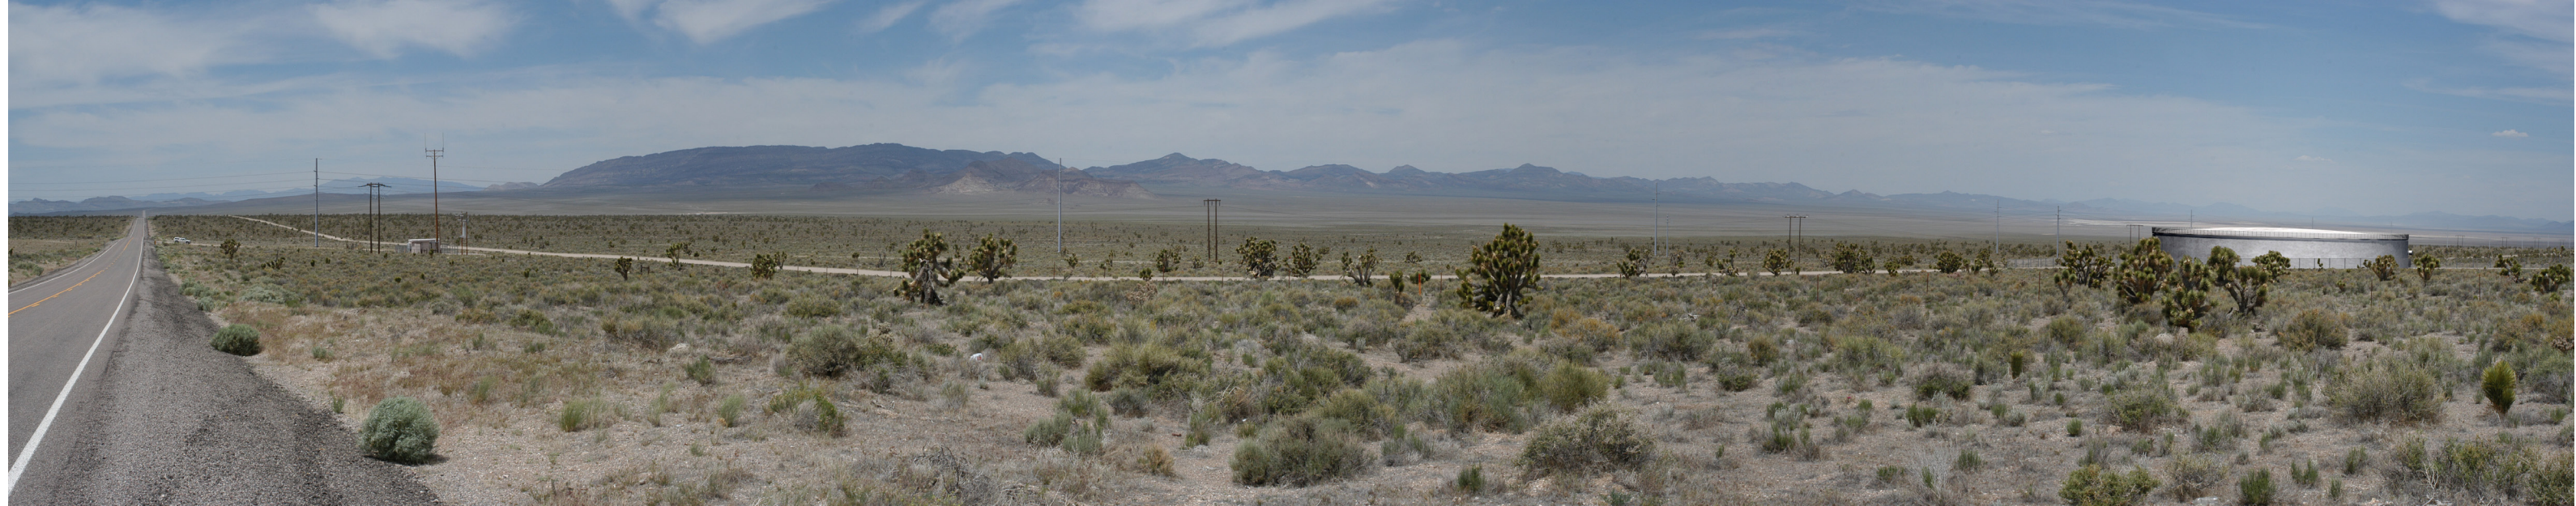
Photo taken along US 93, approximately 17 miles west of Caliente, NV - looking Northwest

Simulation (No Mitigation Measures Applied)

Proposed Action

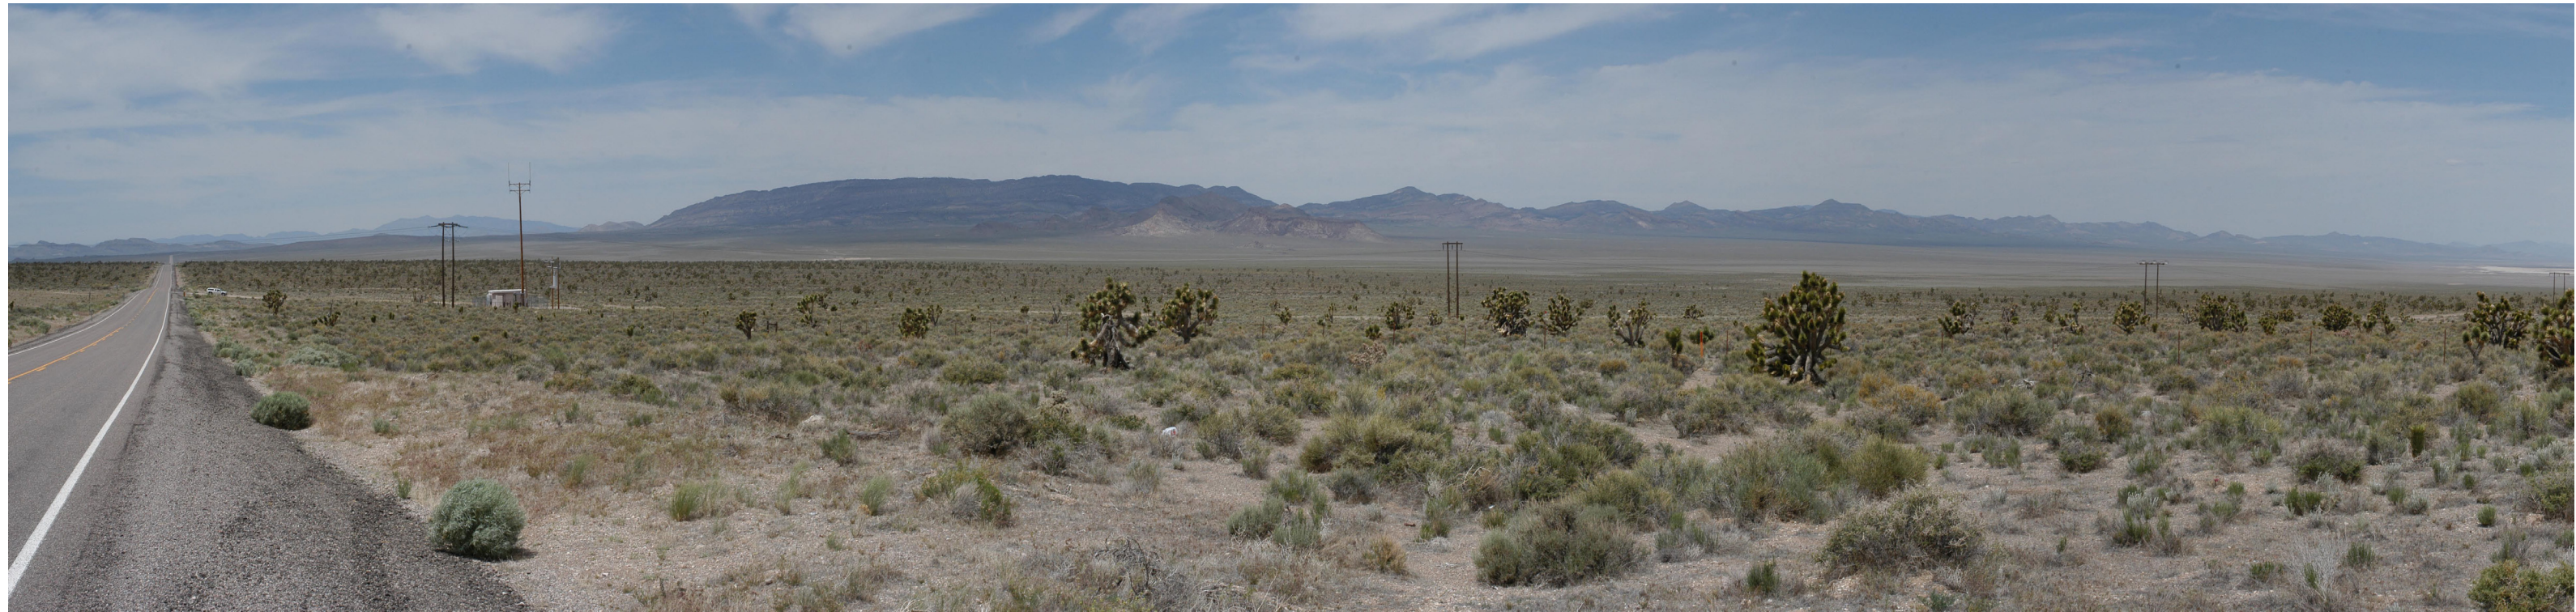
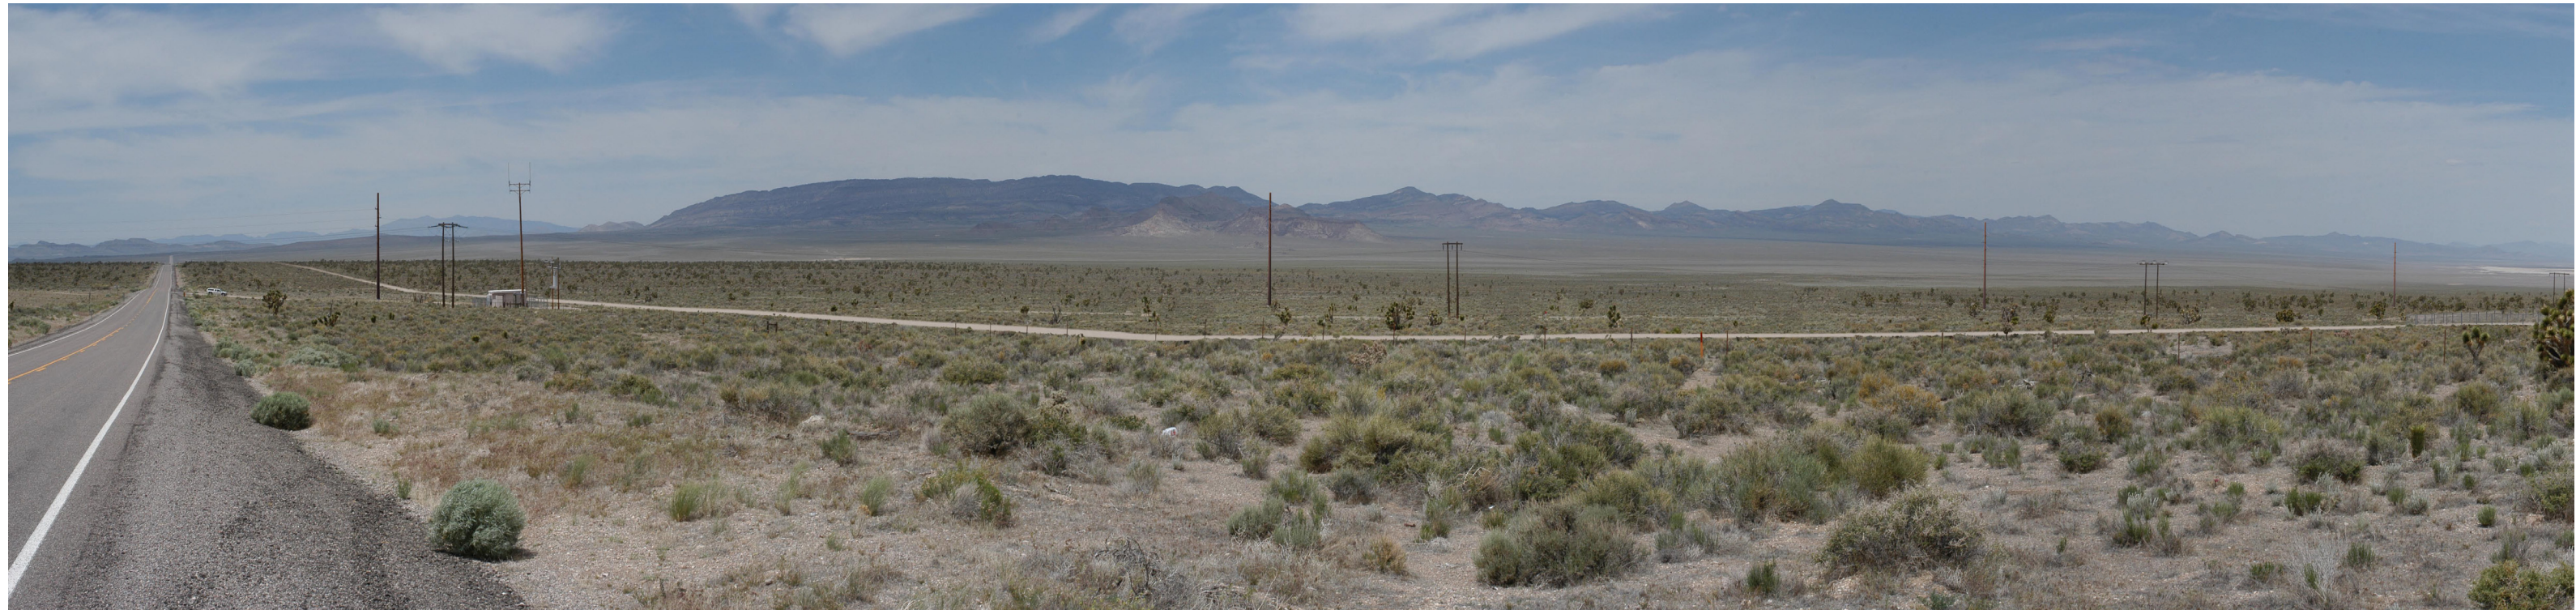
Photo taken along US 93, approximately 17 miles west of Caliente, NV - looking Northwest

Simulation (Mitigation Measures Applied)

Proposed Action

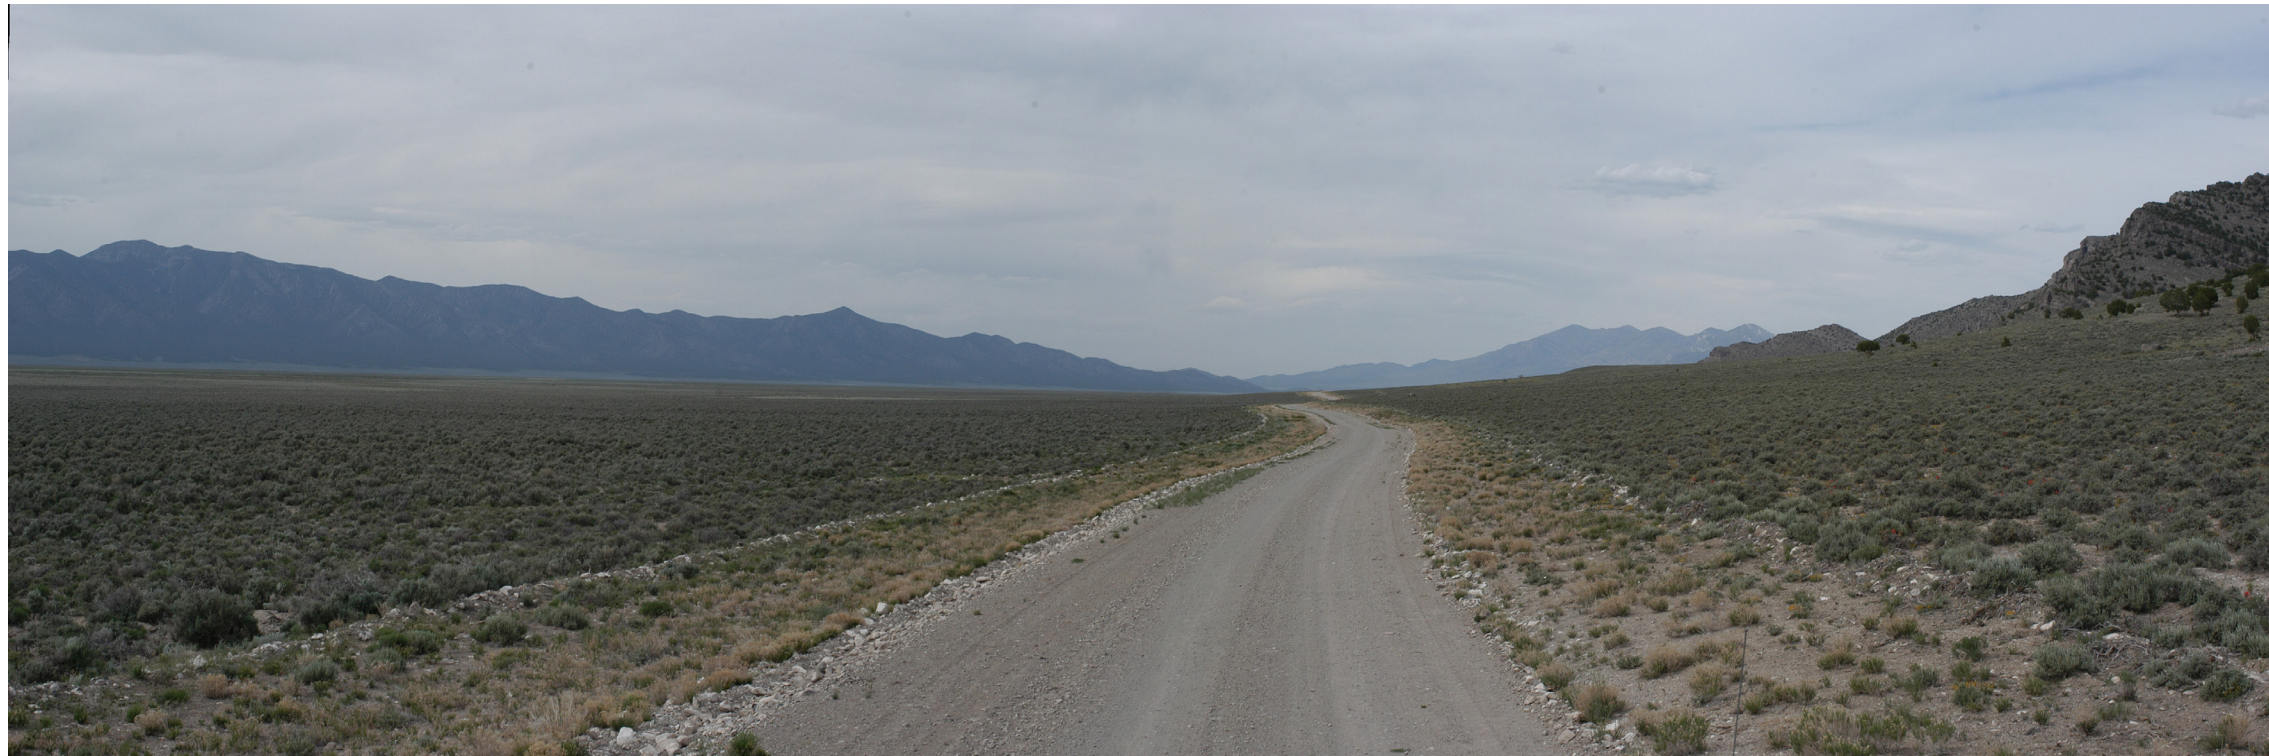
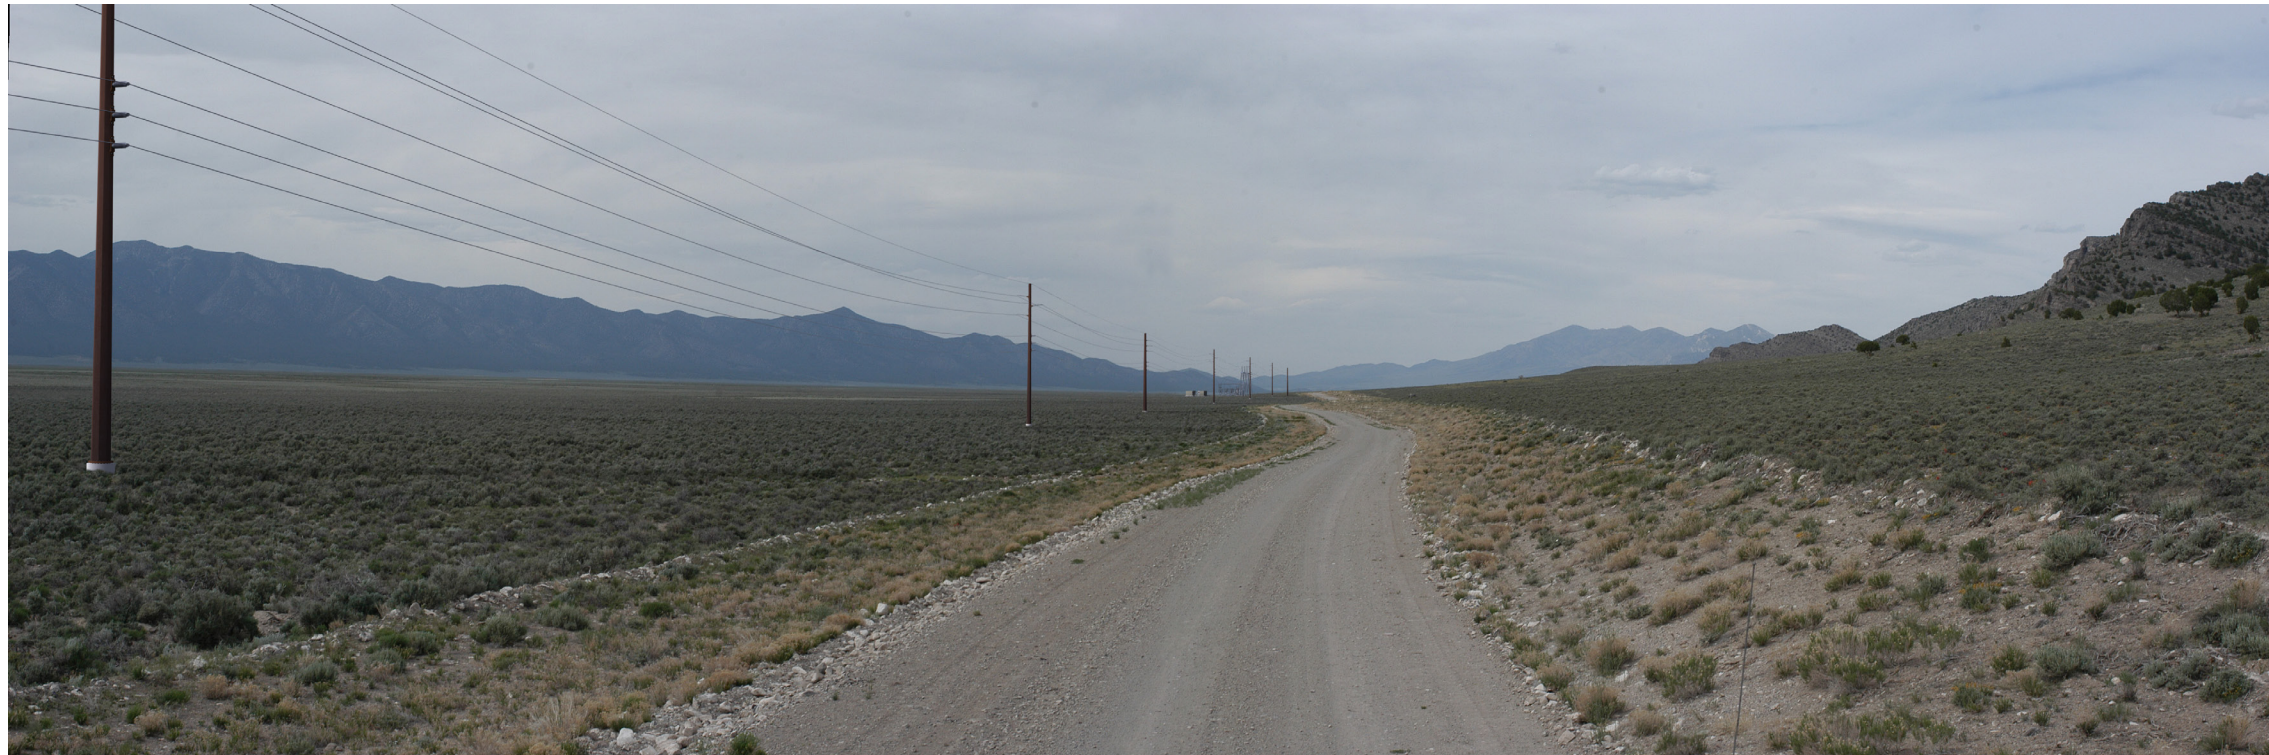
Photo taken along South Cave Valley Road, looking North

Simulation (Mitigation Measures Applied)

- 69 kV + 25 kV Transmission Line: Single steel poles, core-ten steel
- Pipeline Diameter: 16" - 30"
- Pipeline ROW Width: 75' (reduced from 200')
- Existing Improved Road
- Cave Valley Secondary Substation Site with buildings painted with colors from BLM color palette

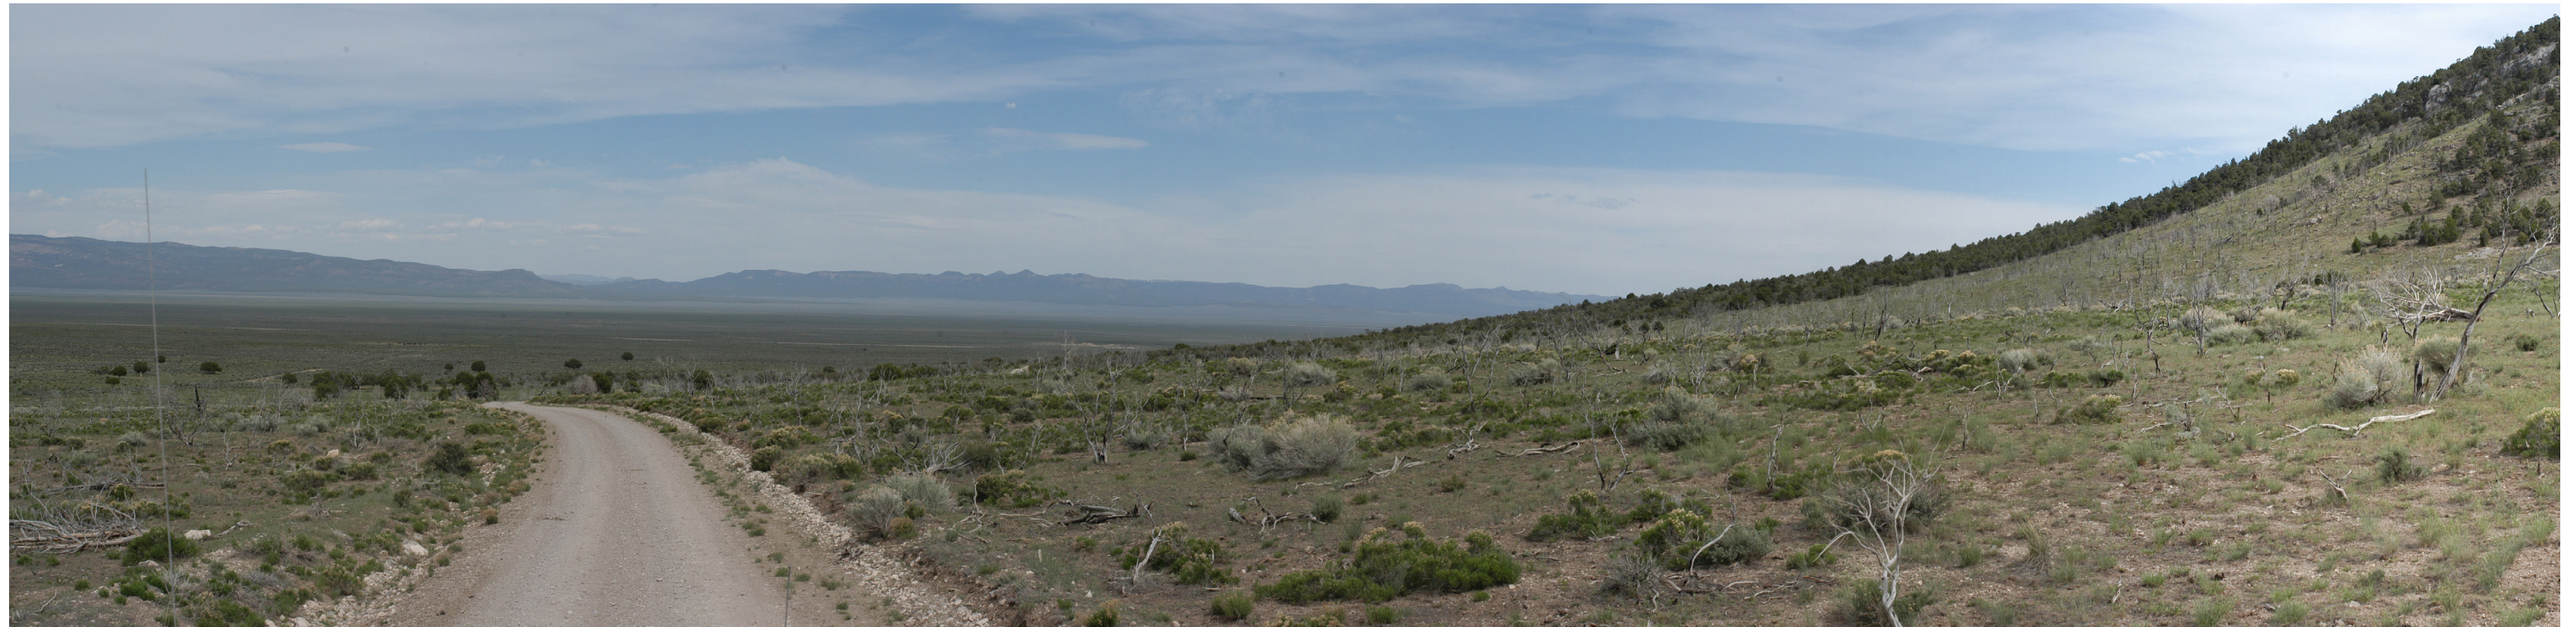
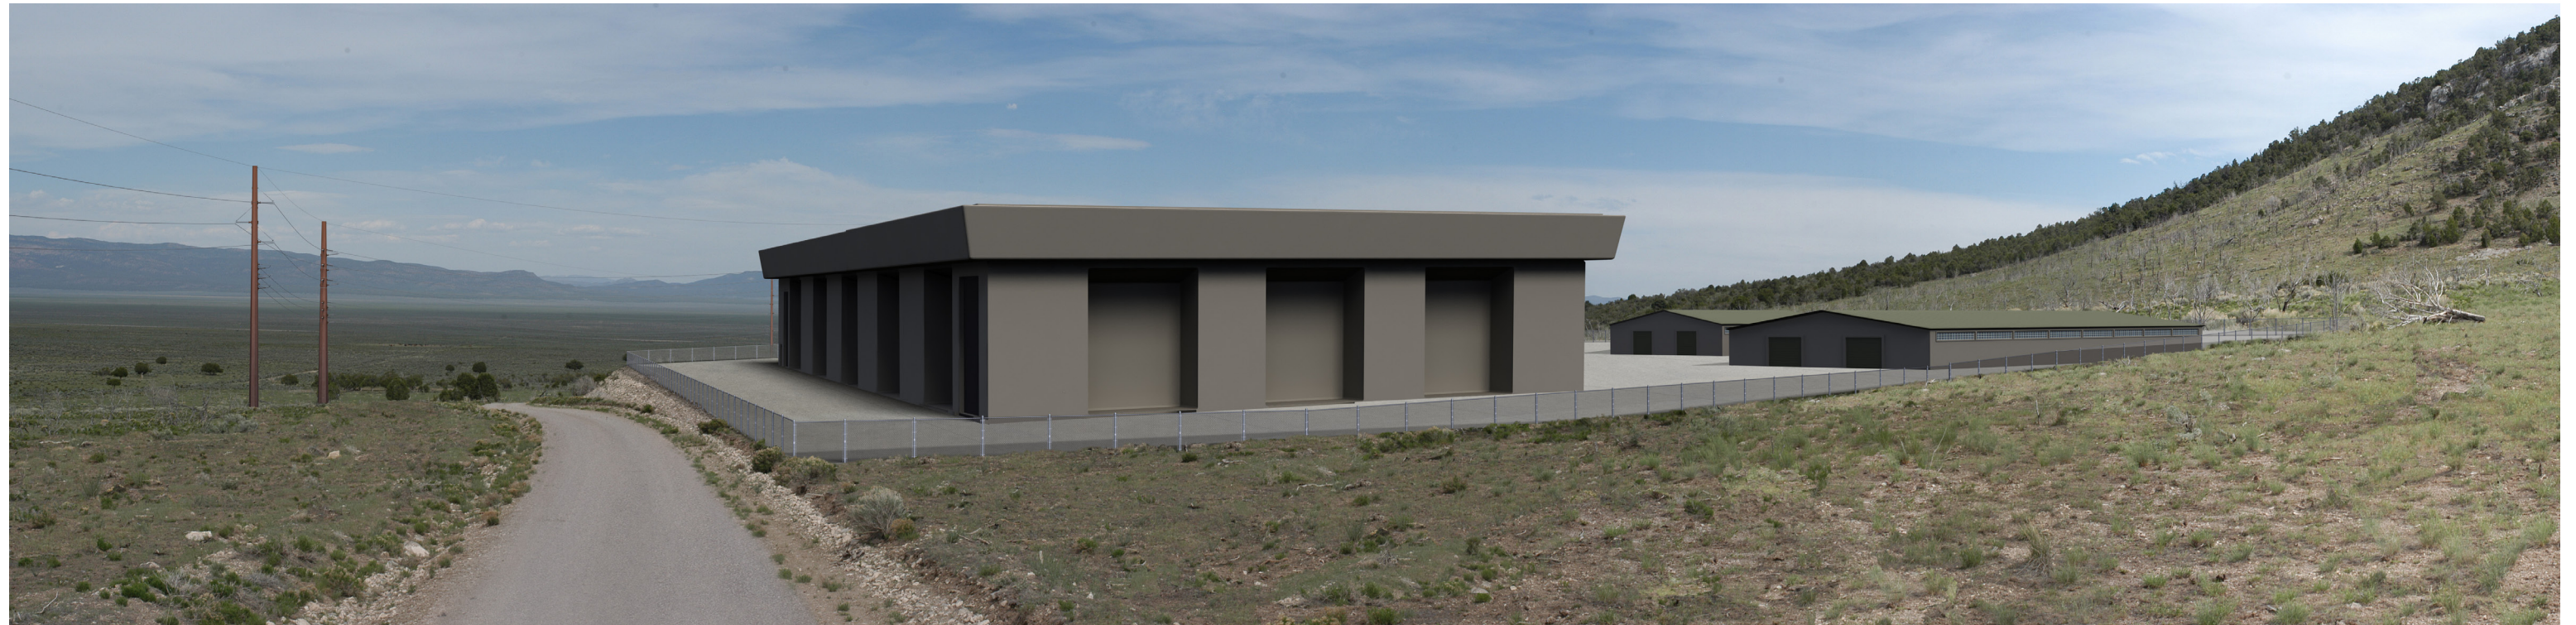
Photo taken along OHV trail, approximately 4 miles west of US Hwy 93 - looking East

Simulation (Mitigation Measures Applied)

Proposed Action

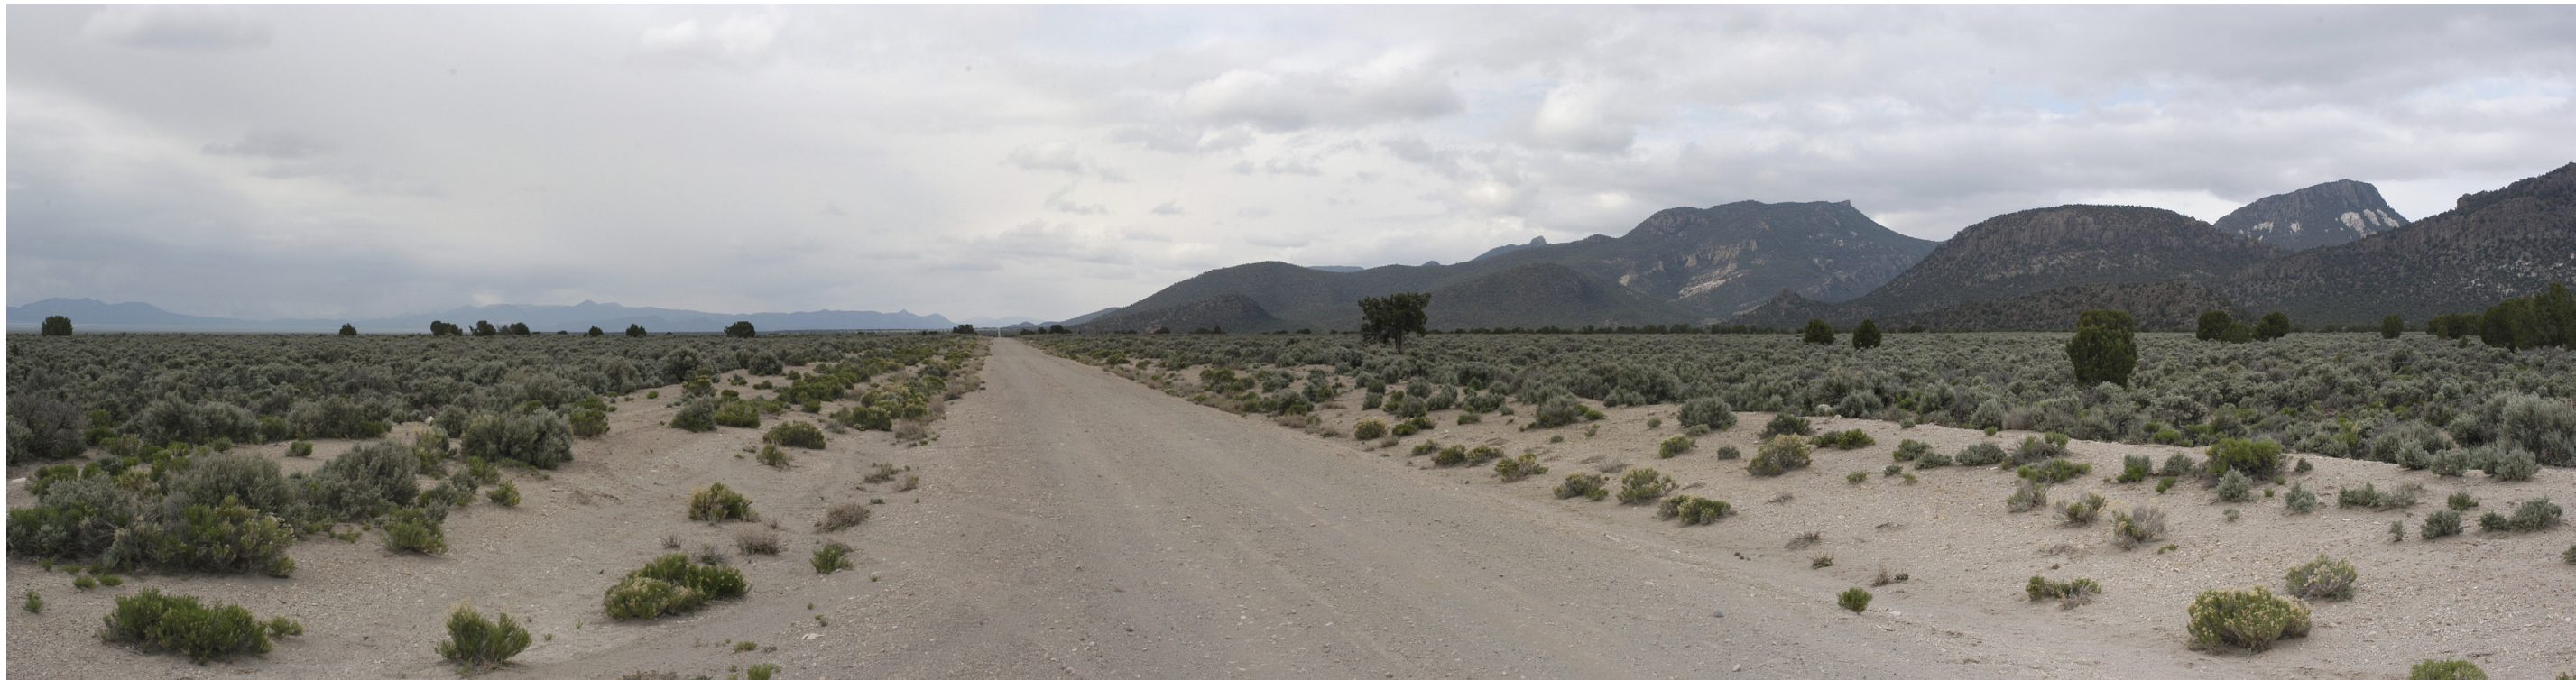
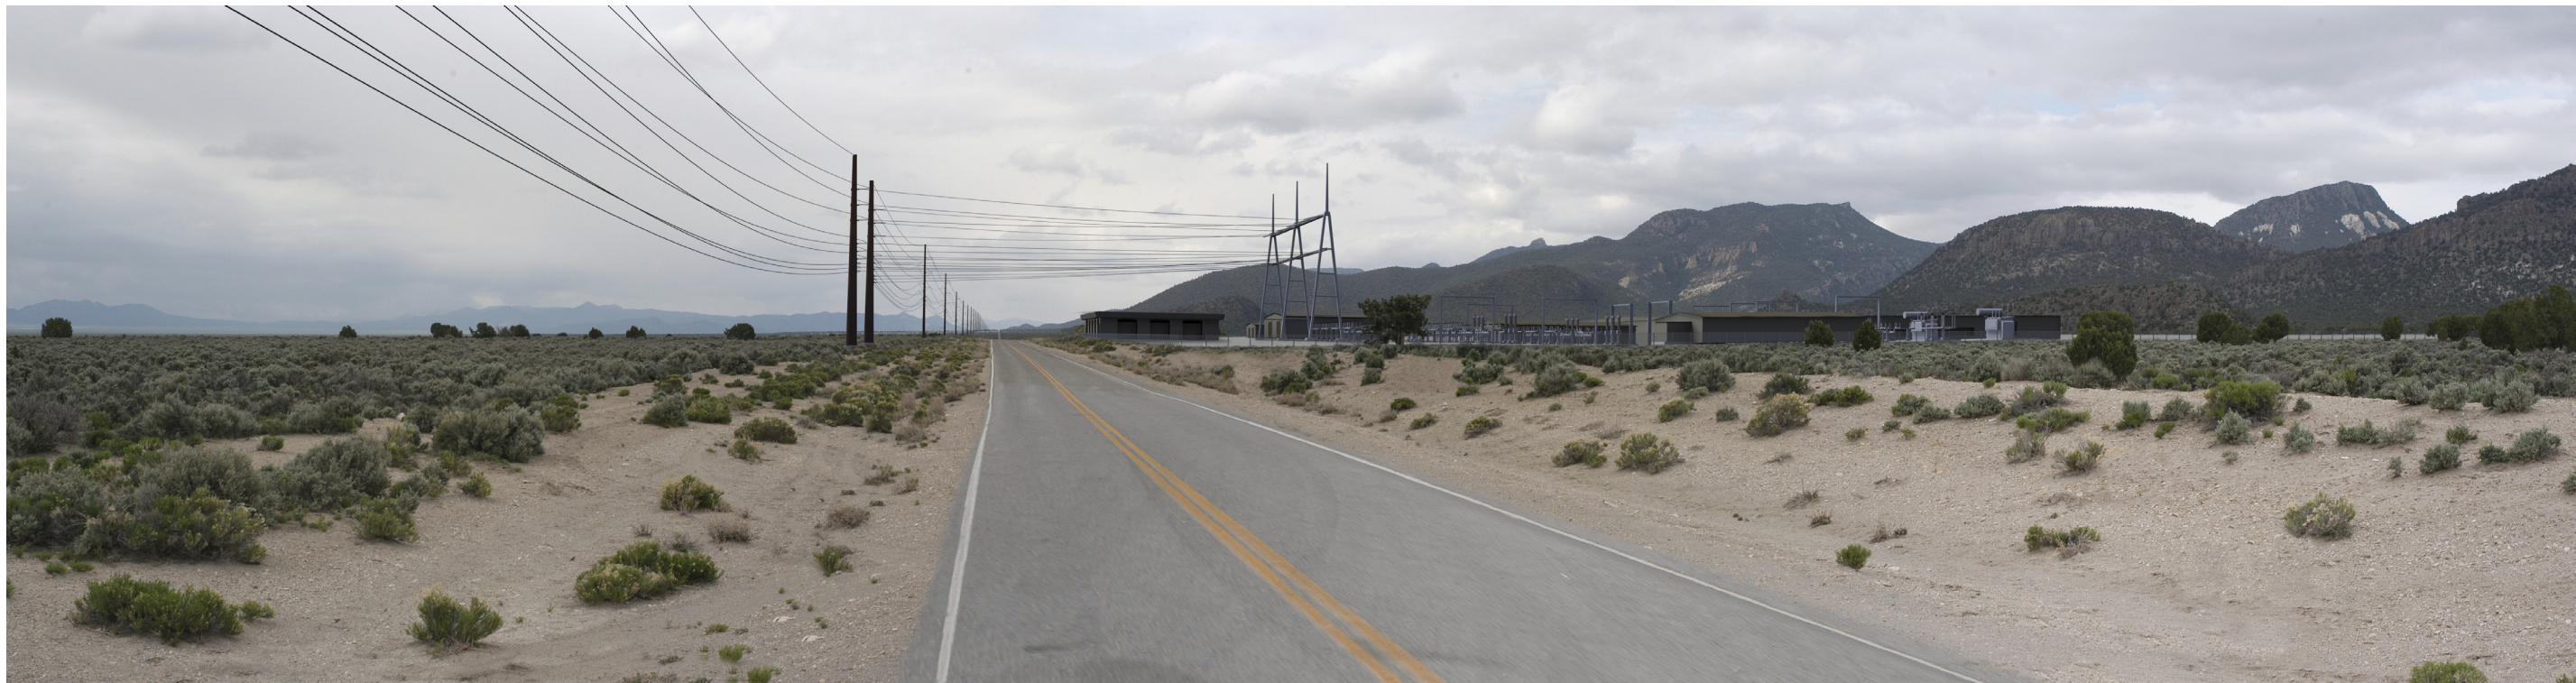
Photo taken along White Pine CR 47, approximately 10 miles southeast of US Hwy 93 - looking South

Simulation (Mitigation Measures Applied)

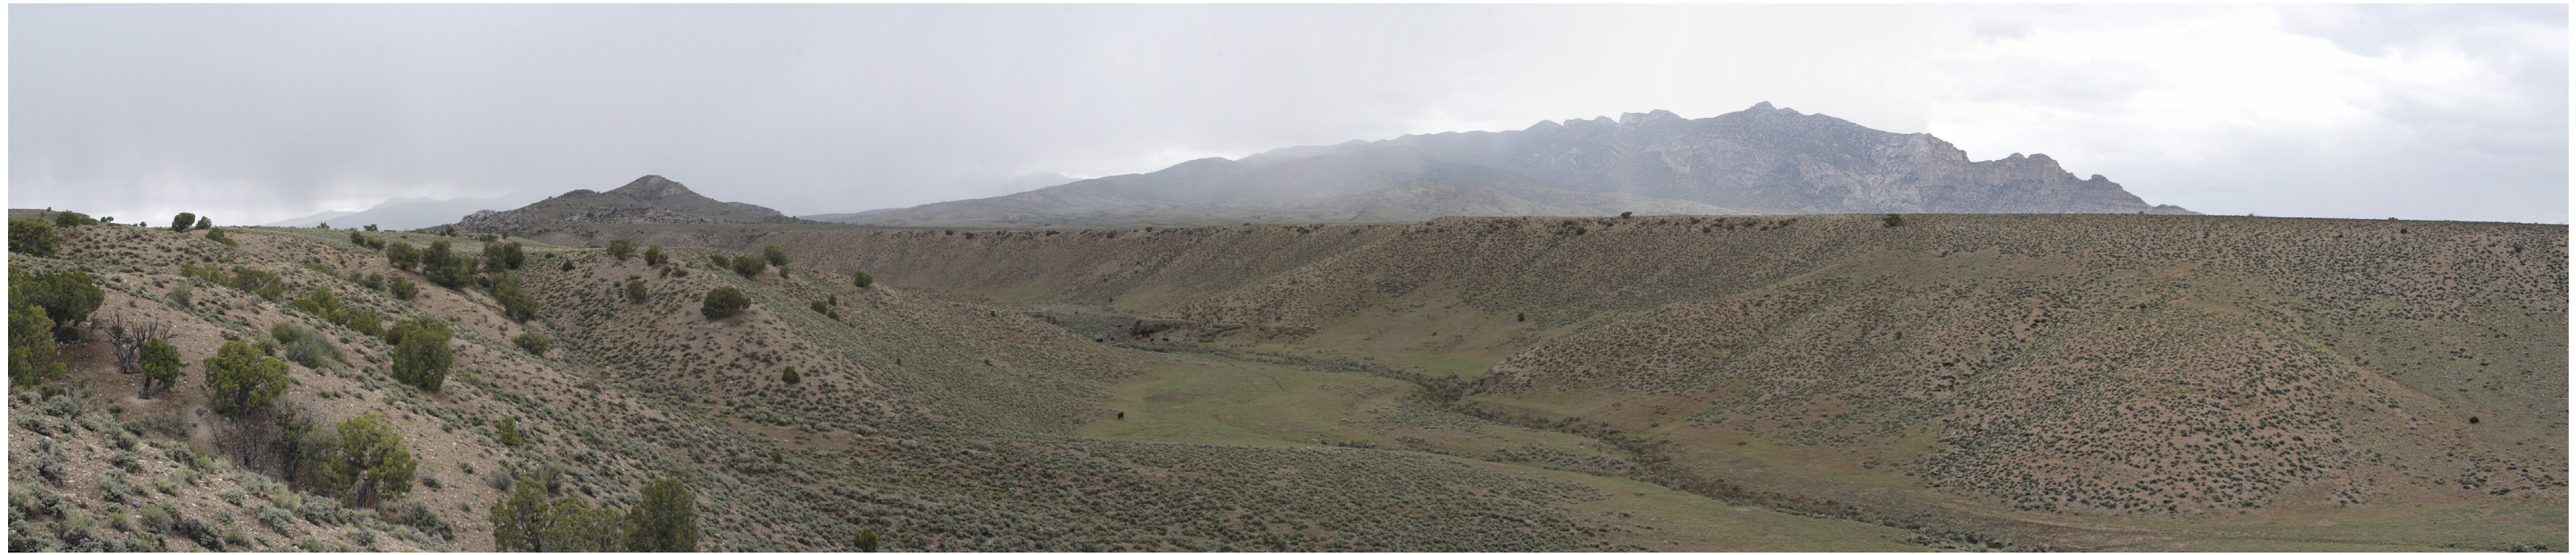
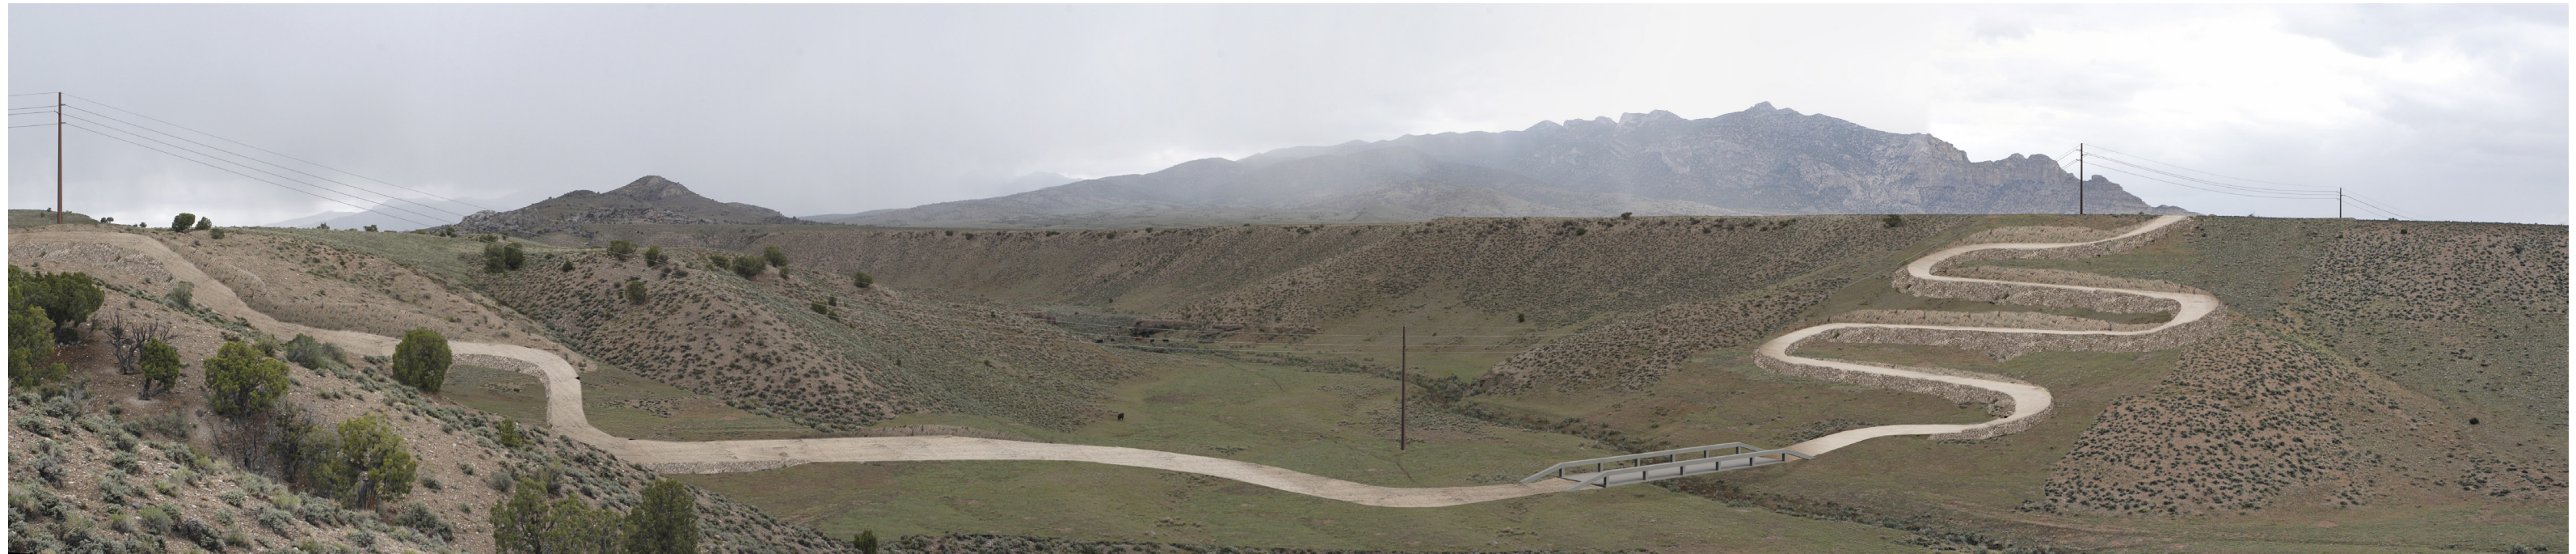
Photo taken at Big Spring Wash crossing, looking Northwest

Simulation (Mitigation Measures Applied)

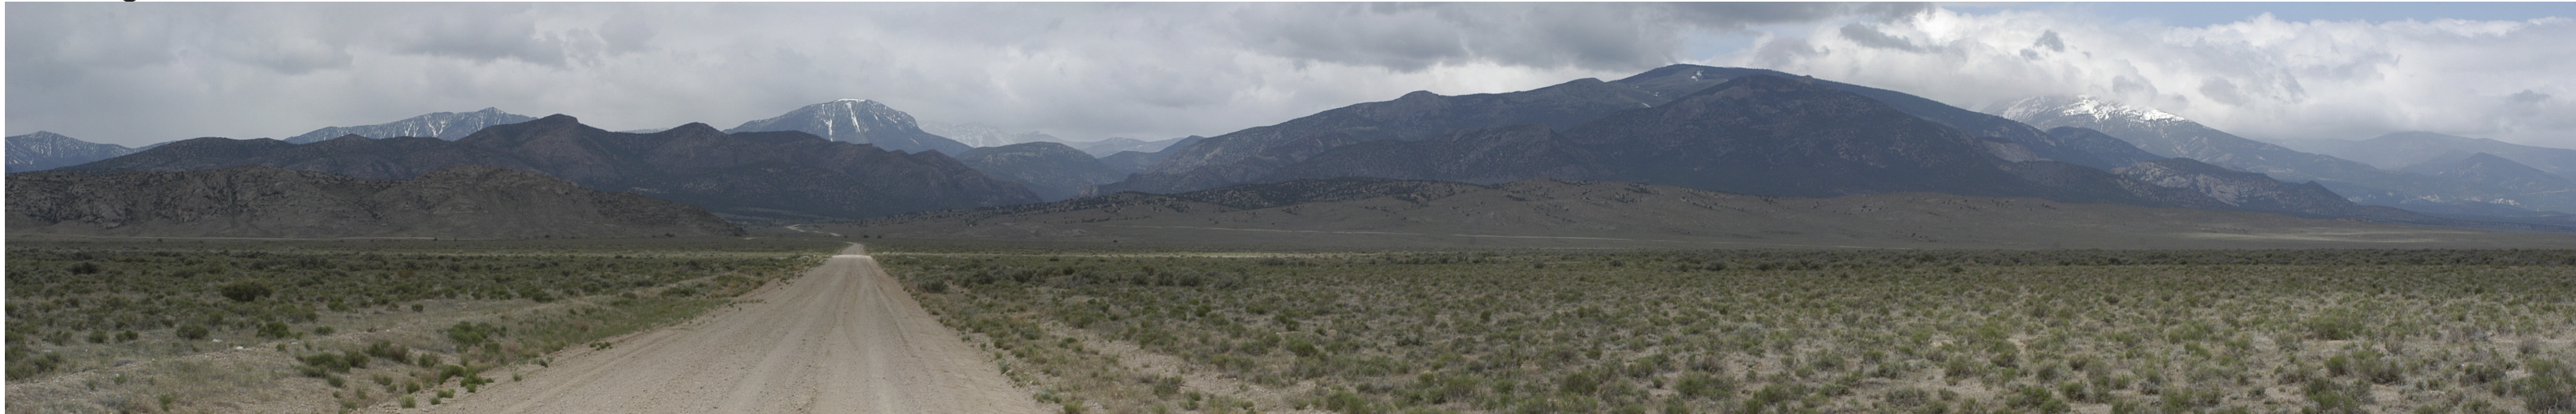
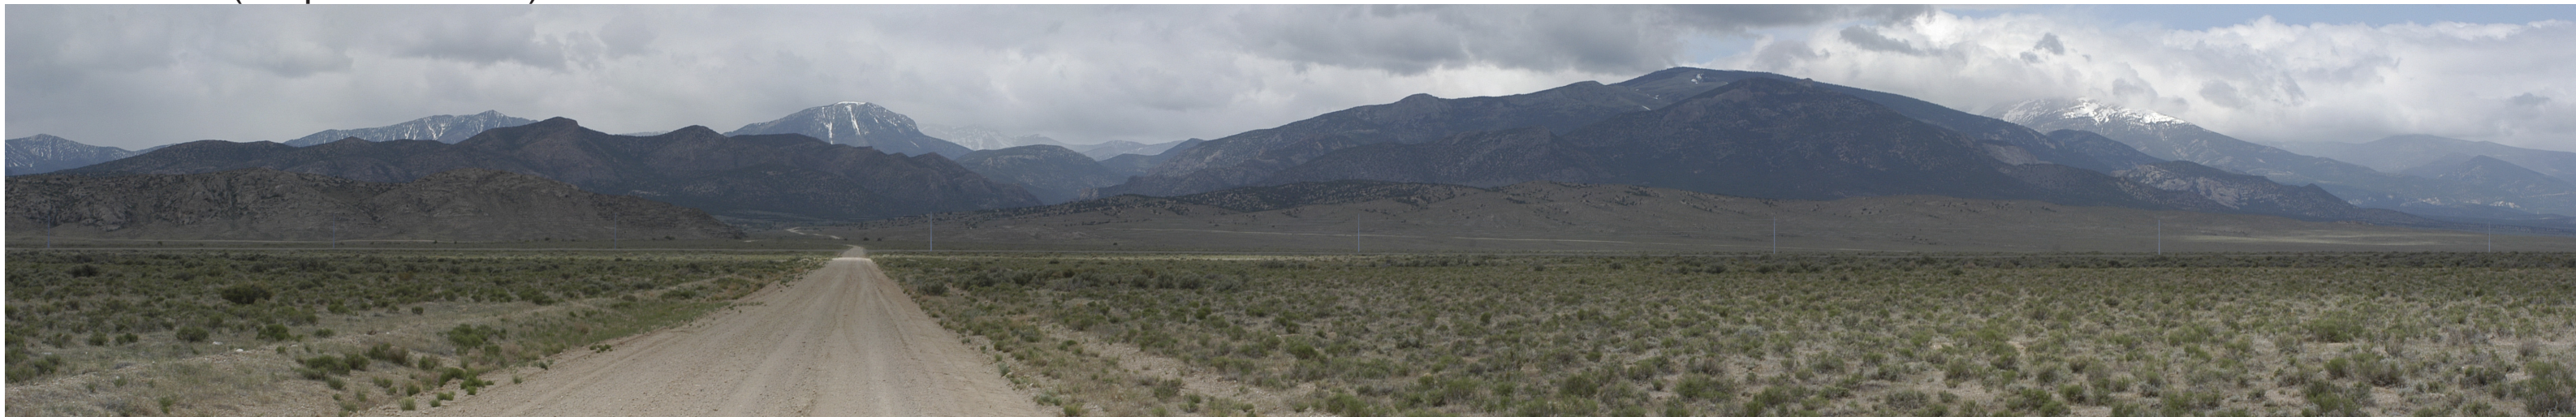
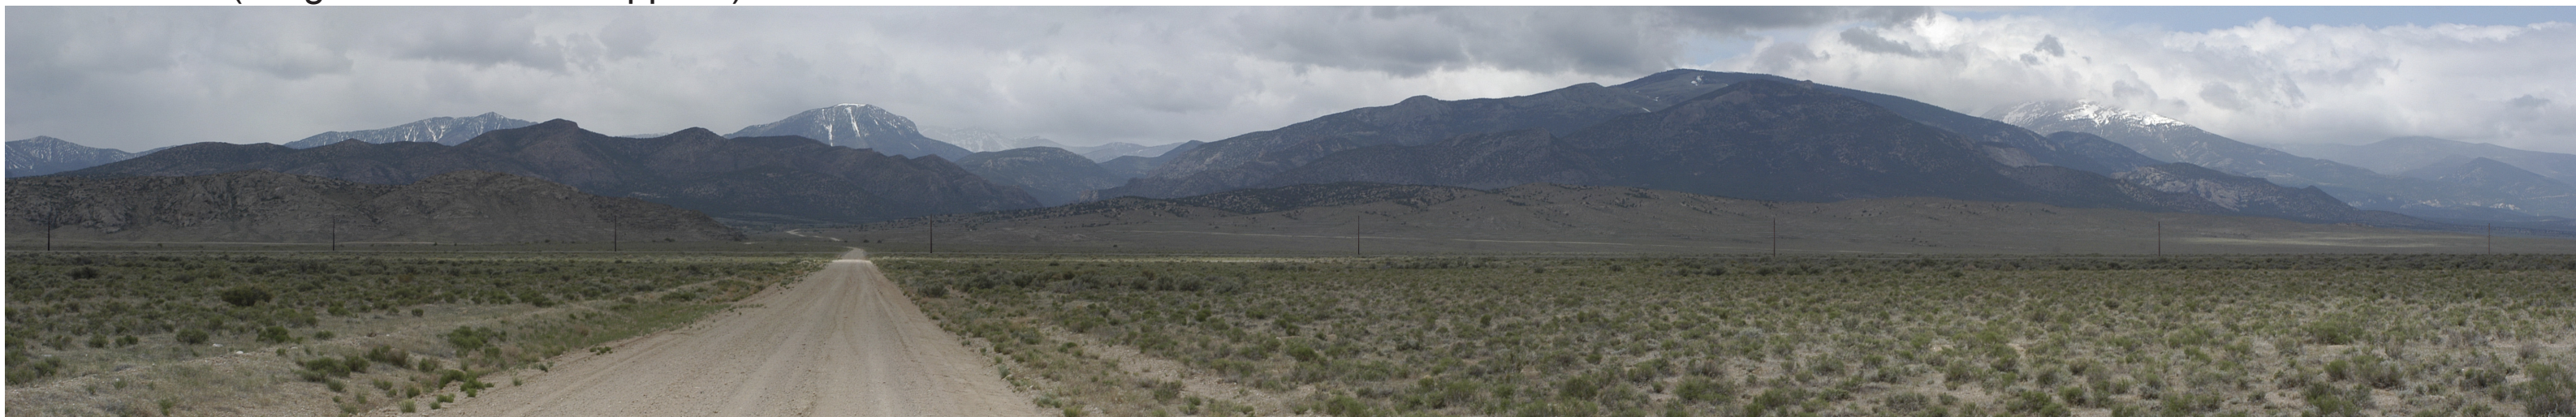
Simulation 1 (Proposed Action)

Photo taken along White Pine County Road 42, approximately 1 miles west of Garrison, Utah – looking west to Great Basin National Park (4.5 miles away).

Simulation 2 (Mitigation Measures Applied)
