Appendix F3.15

Visual Resources

- **Visual Resource Inventory Summary**
- **Compliance with Visual Resource Objectives by KOP for Proposed Action**
 - **Photographic Simulations**
 - **Contrast Rating Forms**

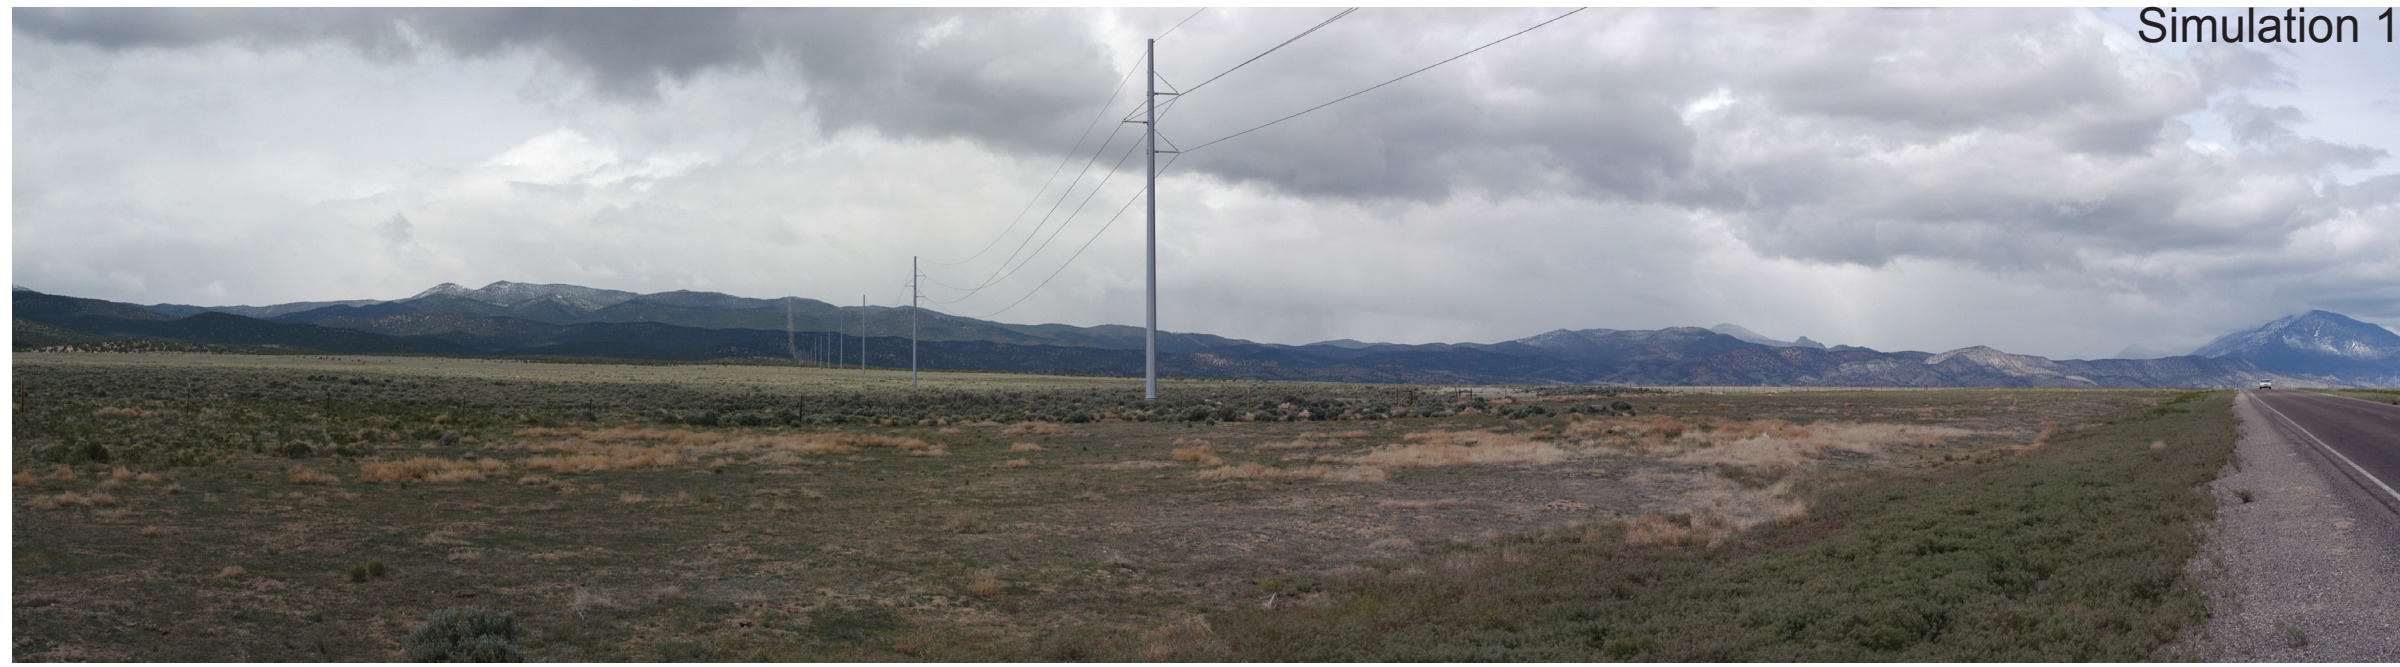
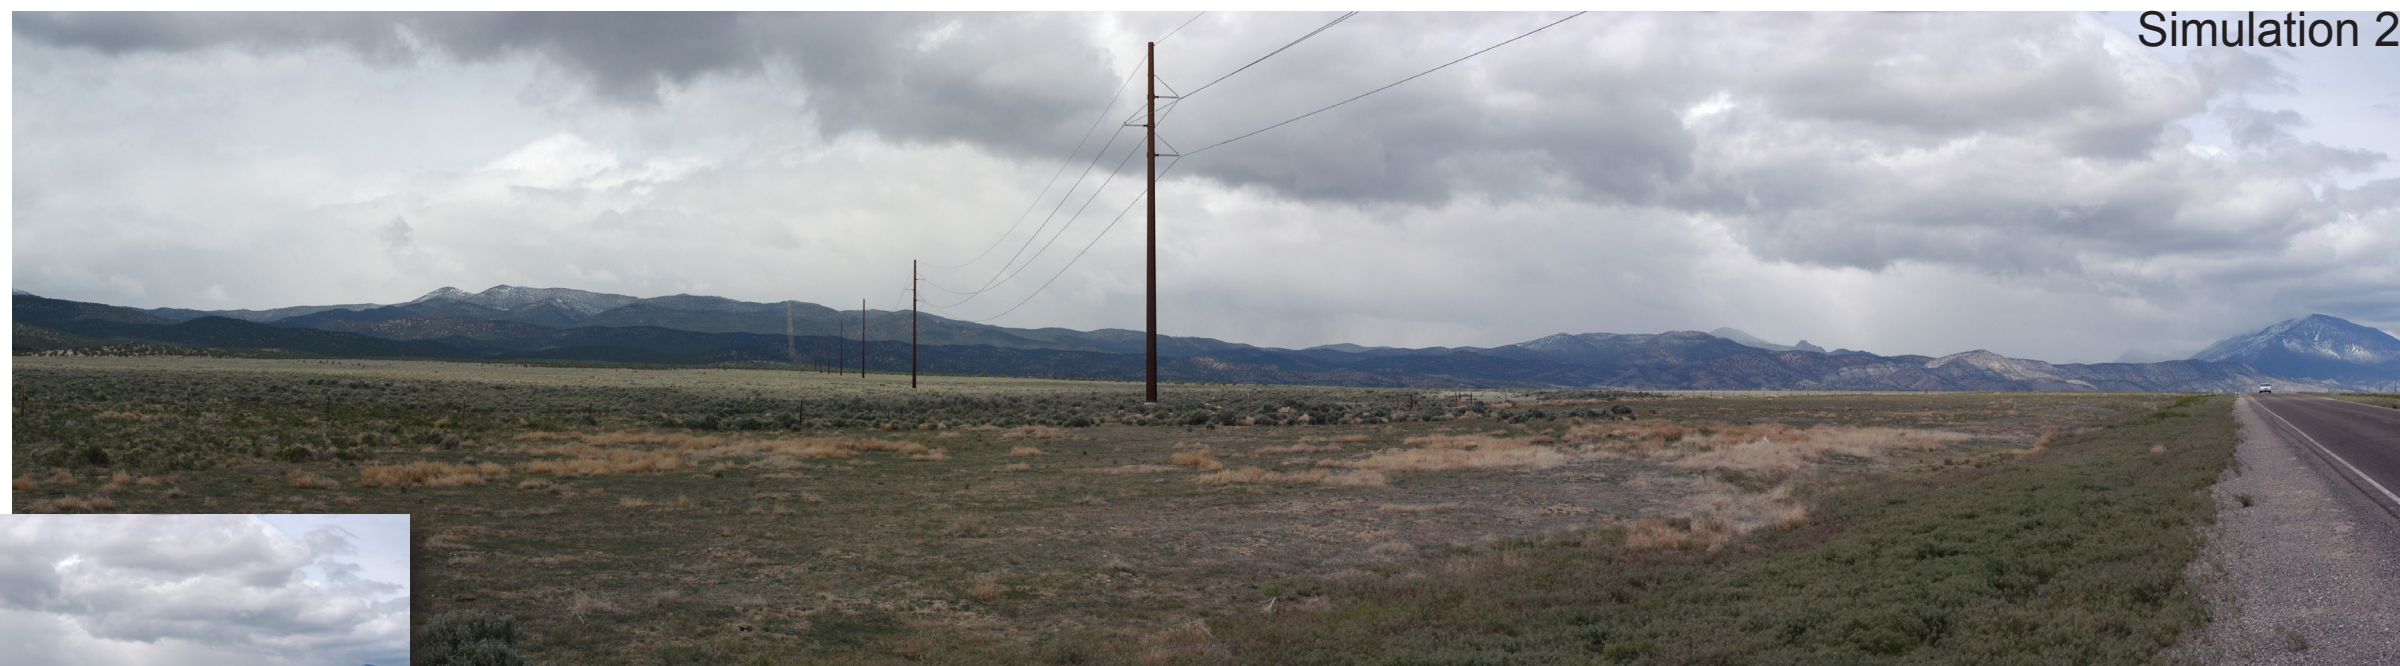
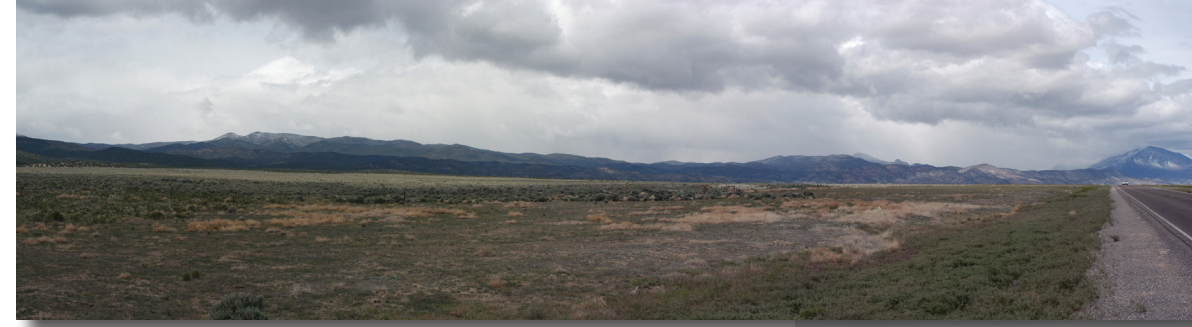
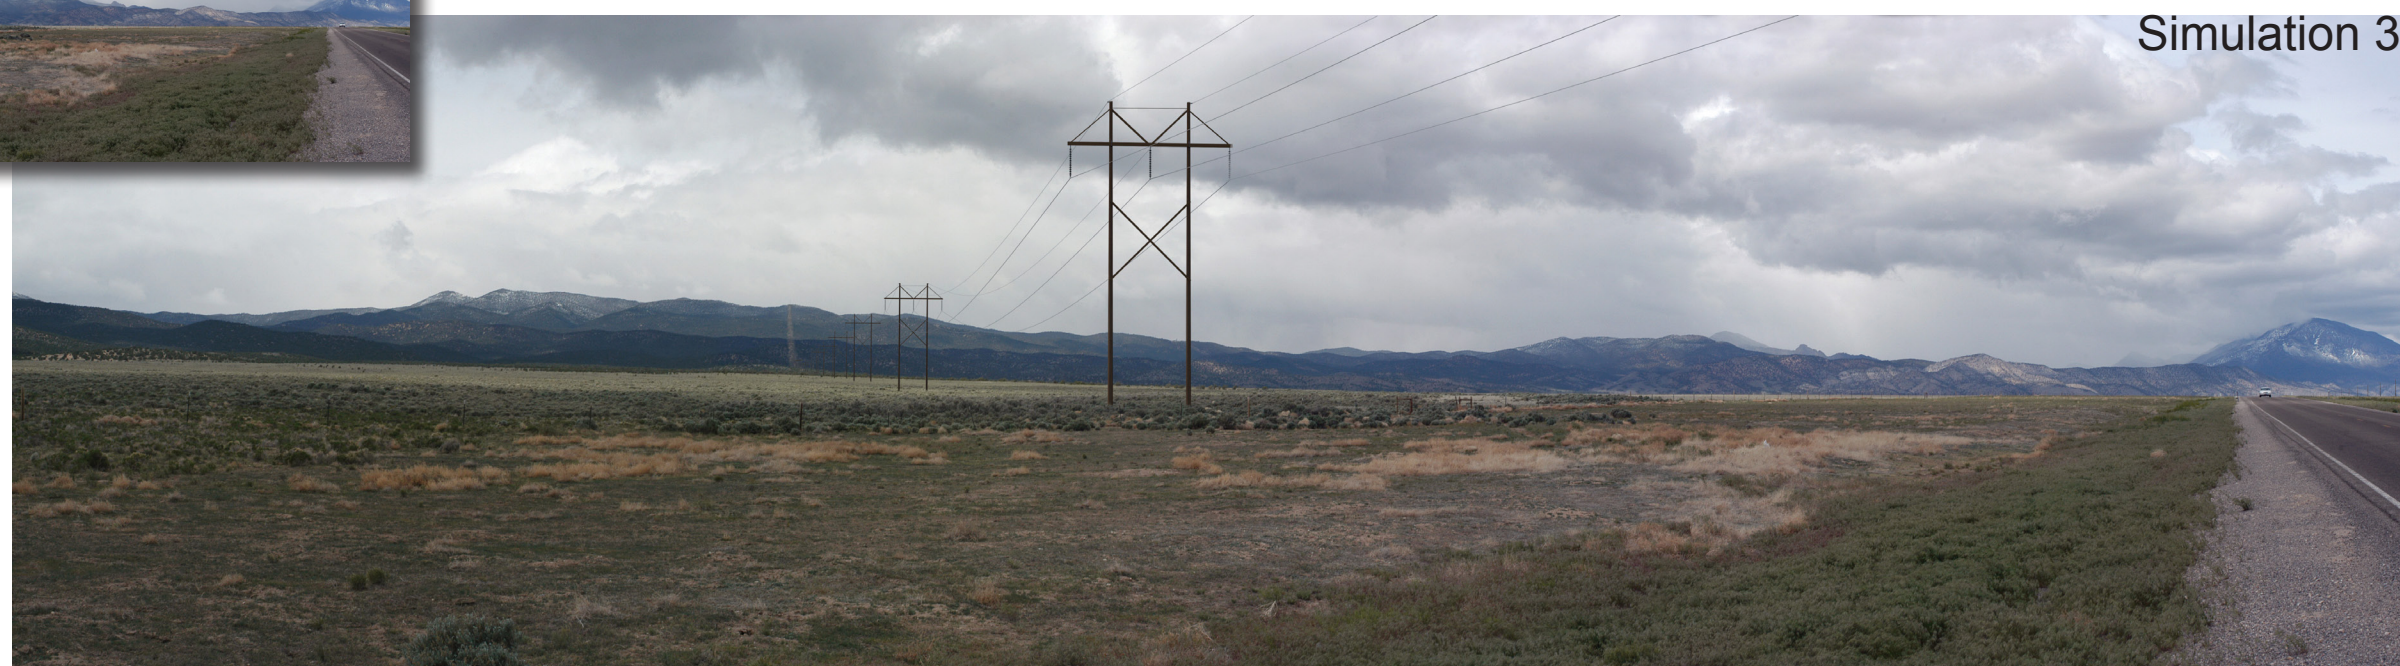
KOP 34

Simulation 1

Simulation 2

Photo taken along US Hwy 93, approximately 4.5 miles south of intersection of US Hwy 6/50, looking northwest

Simulation 3

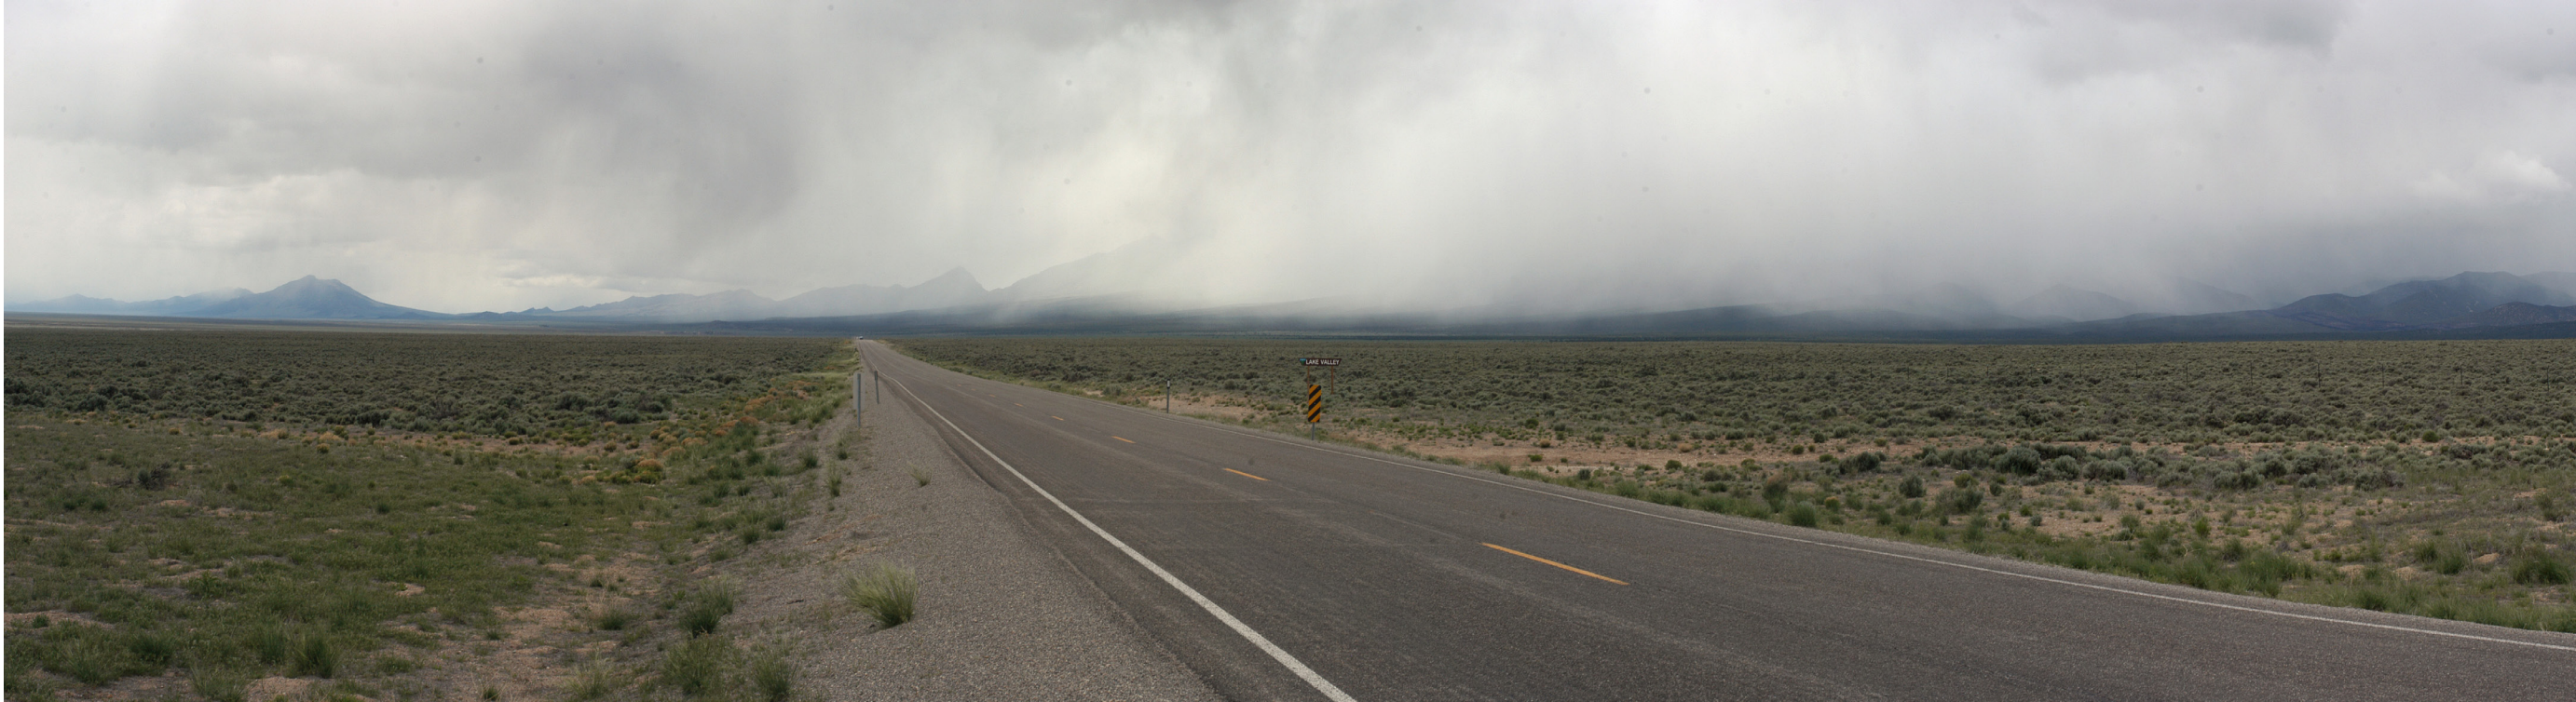
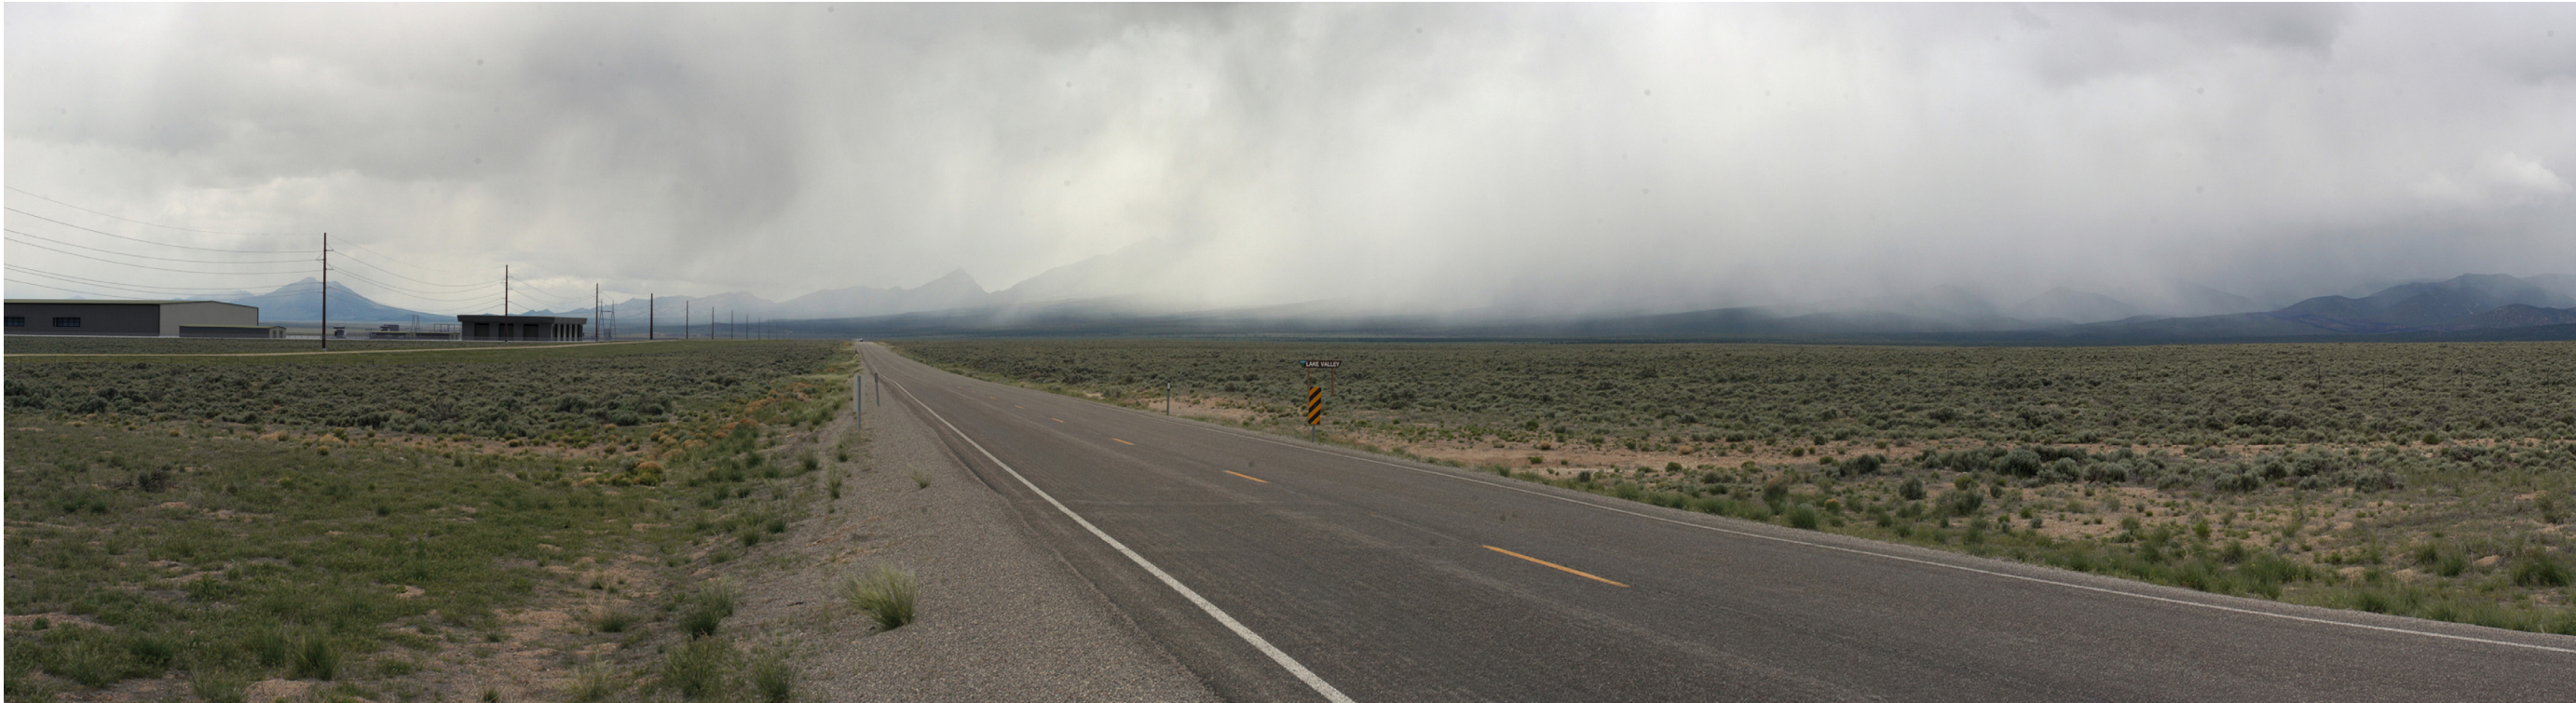
Photo taken along US Hwy 93, approximately 0.25 miles south of Lake Valley summit - looking South

Simulation (Mitigation Measures Applied)

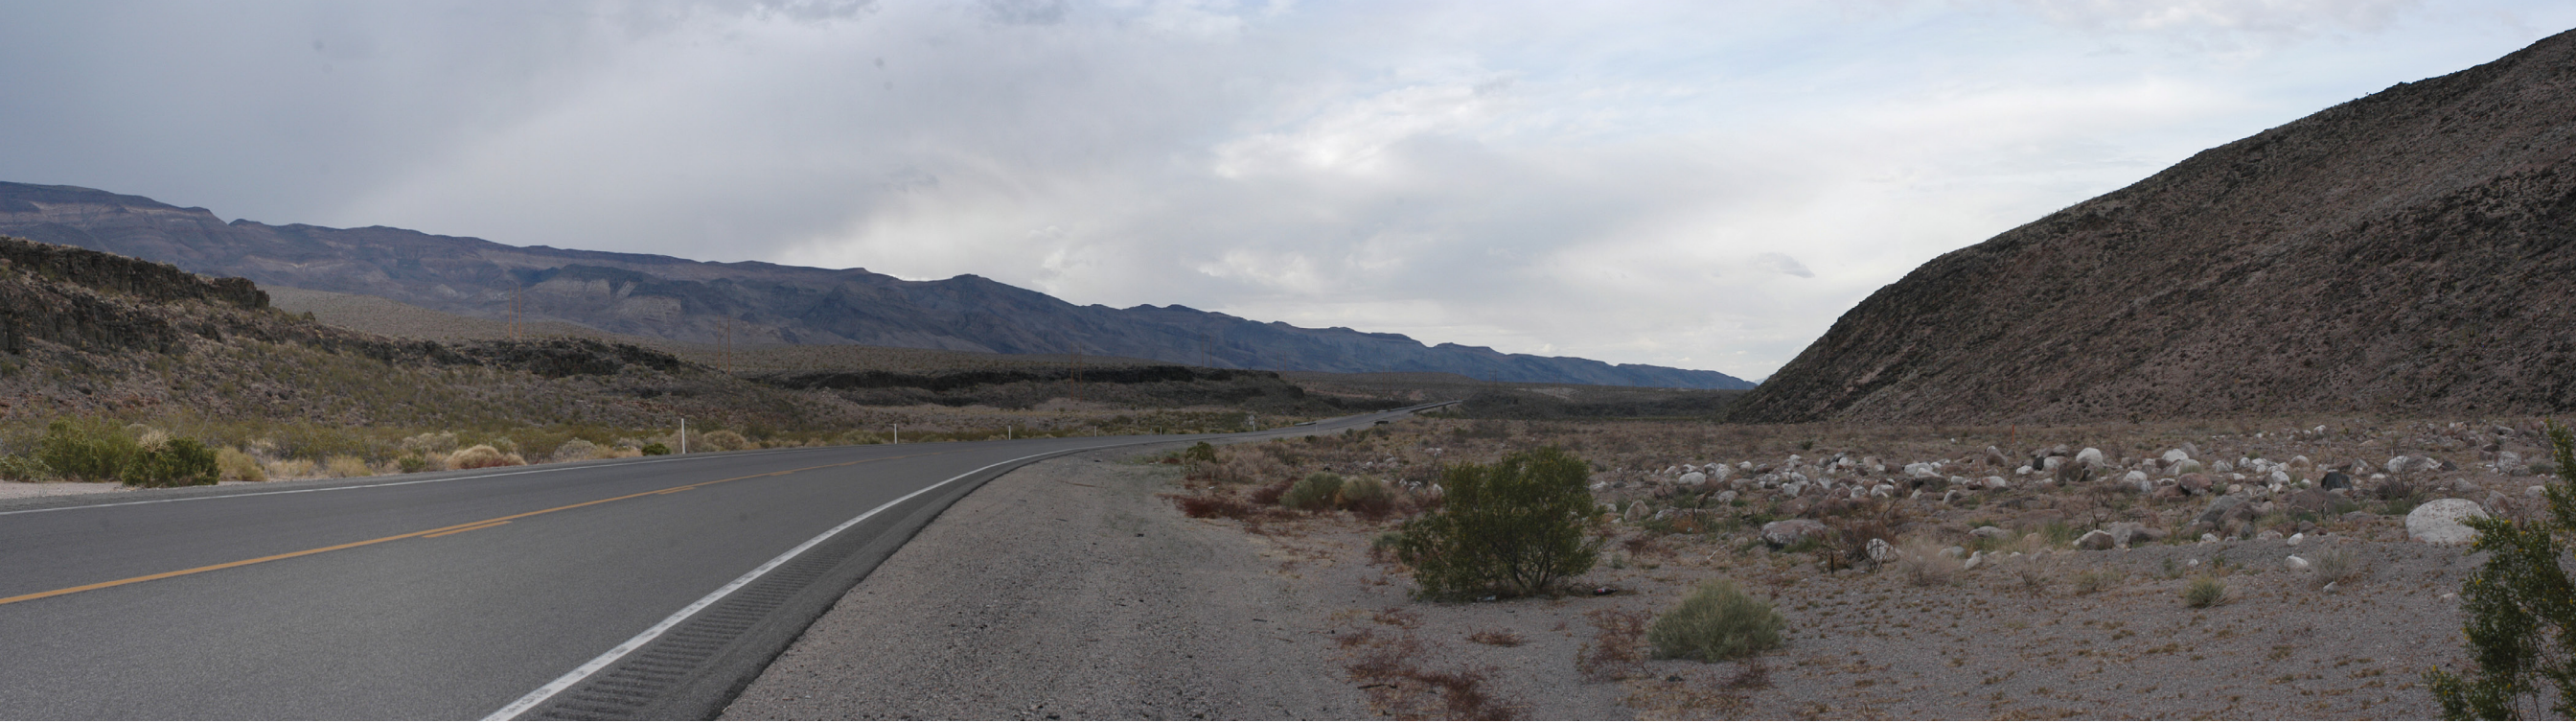
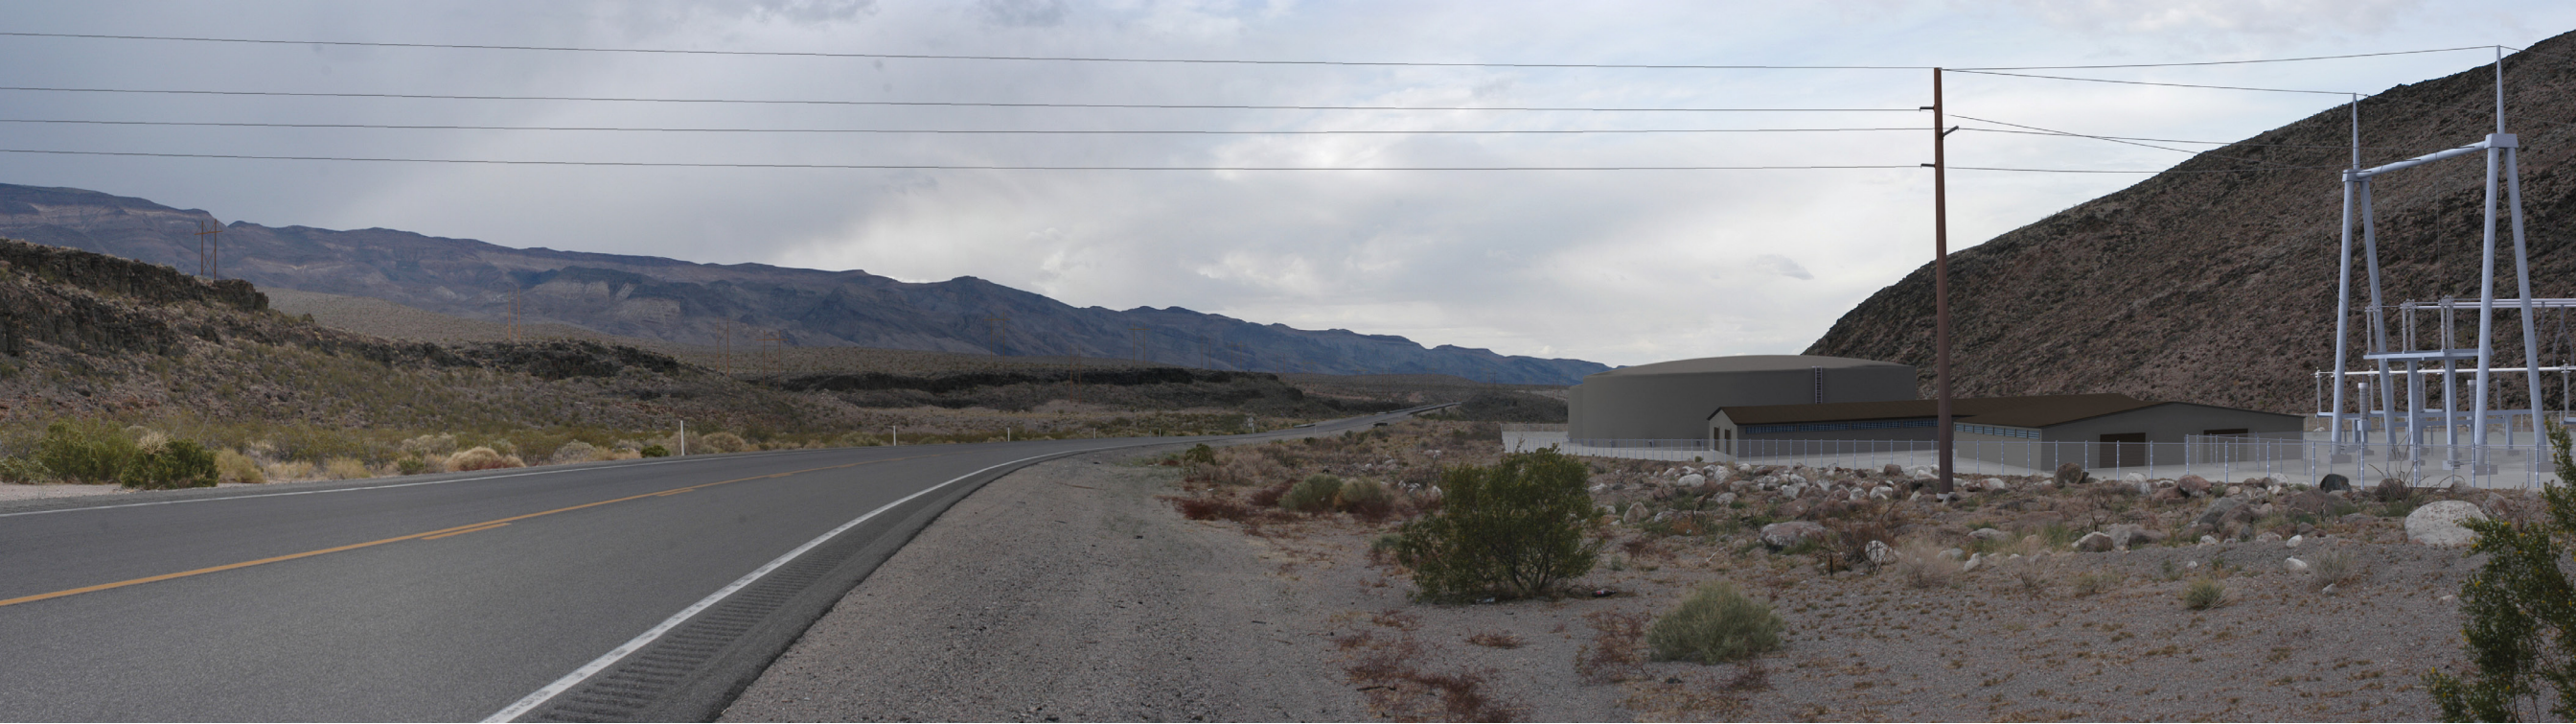
Photo taken along US Hwy 93, approximately 15 miles south of Alamo, NV - looking southeast

Simulation (Mitigation Measures Applied)

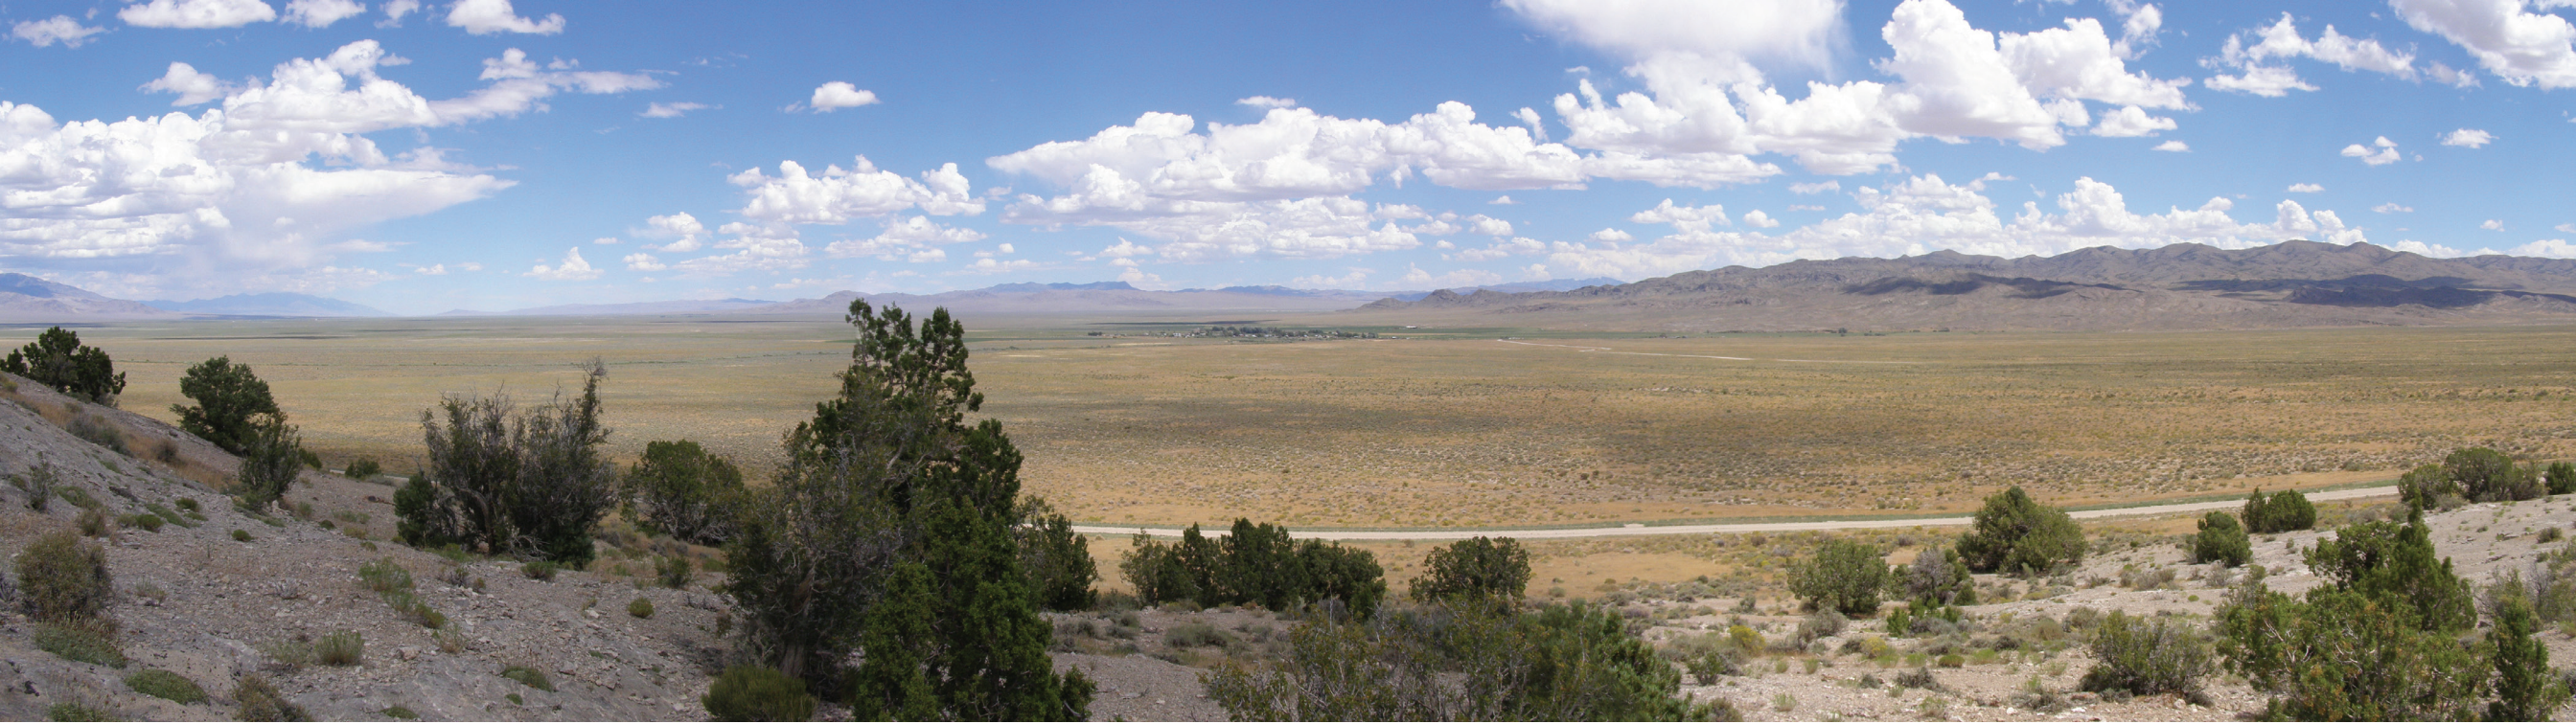
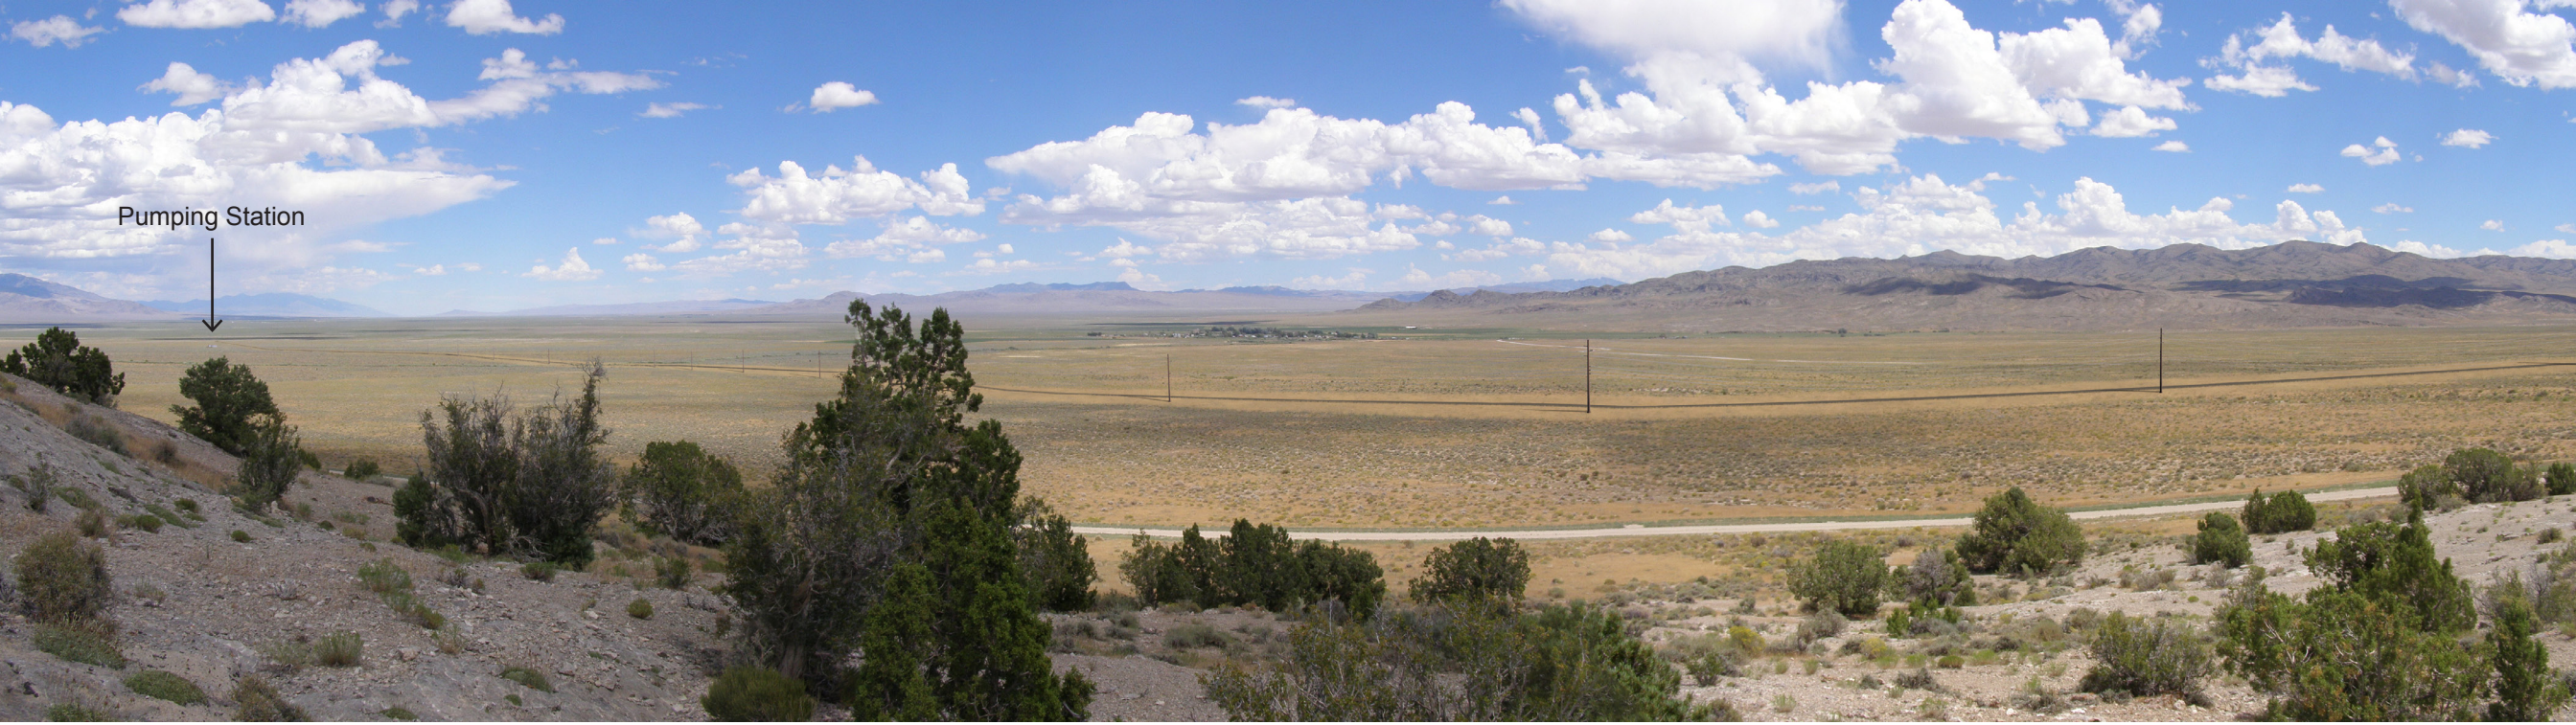
Photo taken near the Great Basin National Park boundary (3 miles to west), looking east towards Garrison, Utah (2.5 miles to east)

Simulation (Mitigation Measures Applied)
