Hydrographs Showing Deep Well Water-Level Recovery in Northeastern Illinois

Scott C. Meyer, P.G.
Illinois State Water Survey
Prairie Research Institute
University of Illinois at Urbana-Champaign

August 4, 2011

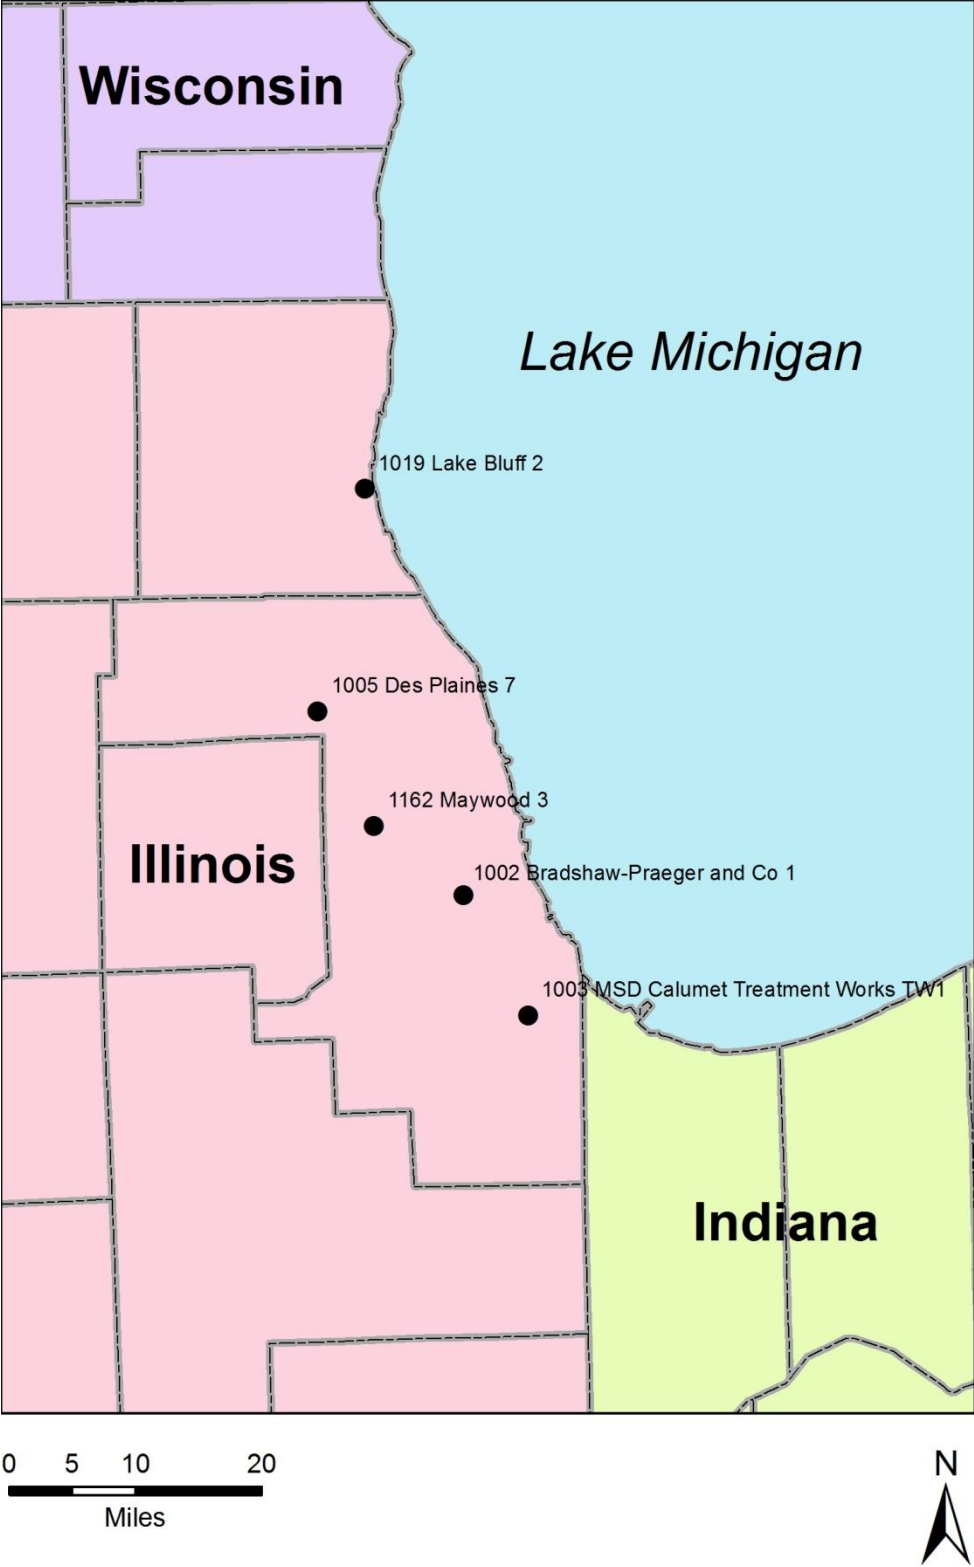
Figure 1 Hydrograph locations.

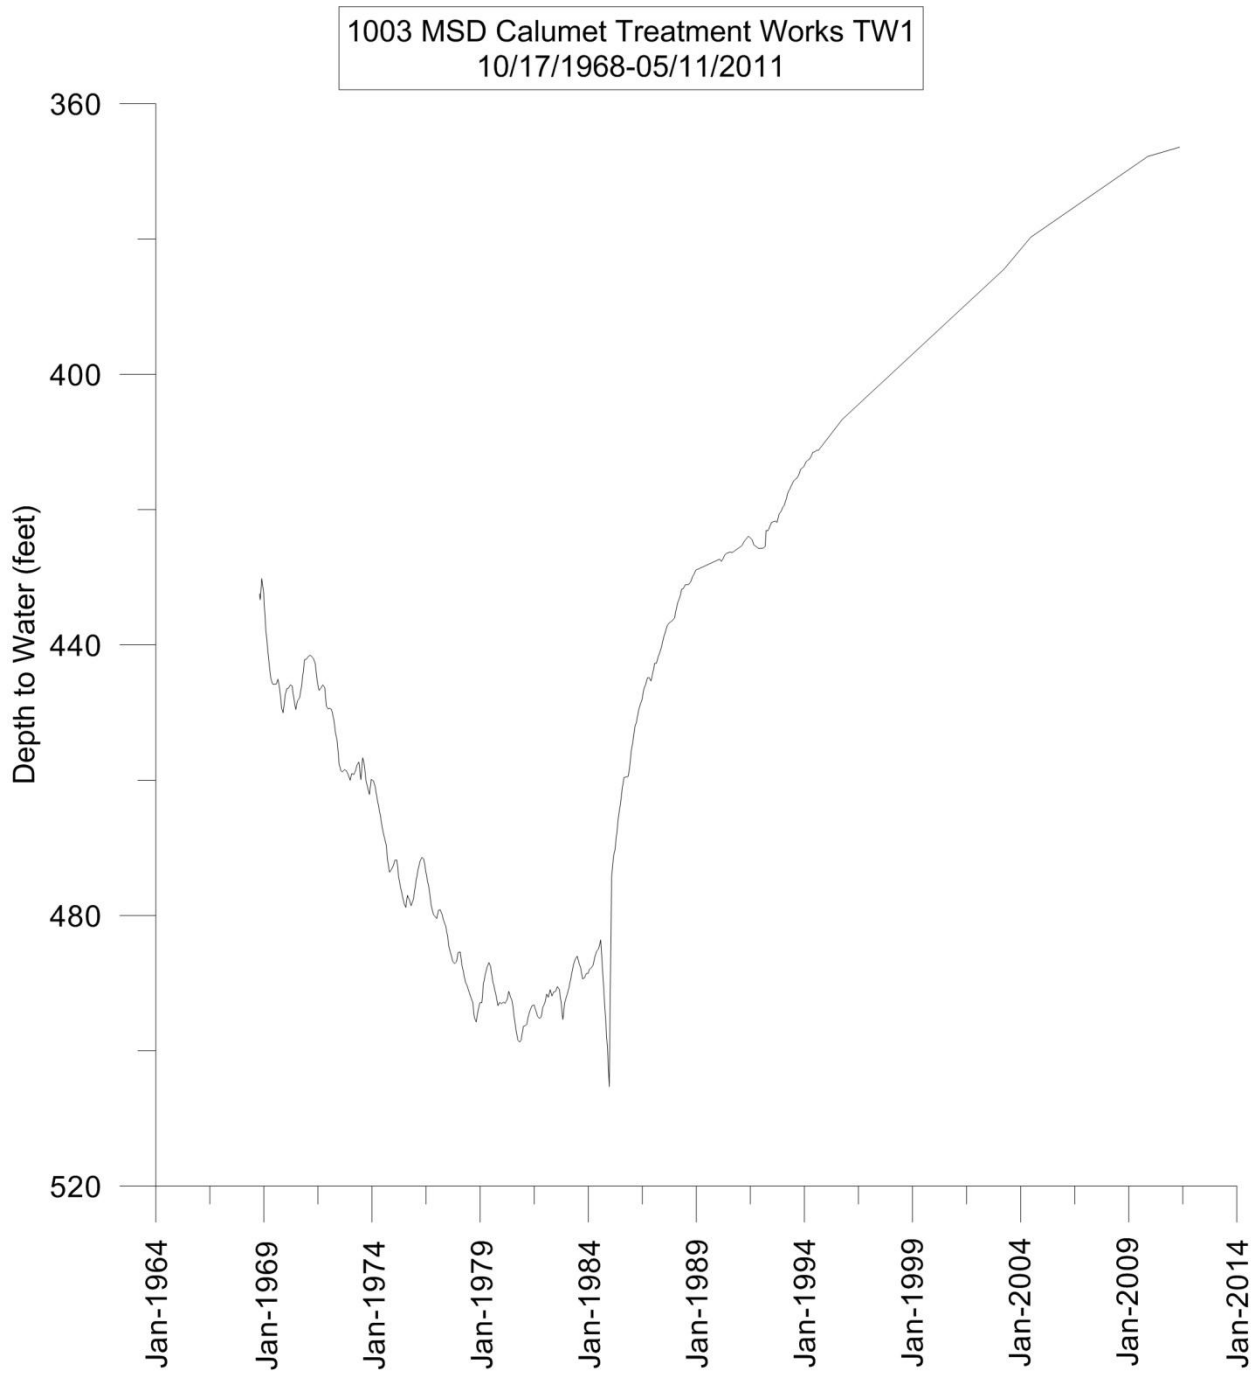
Figure 3. Depth to water in observation well 1003 (MSD Calumet Treatment Works TW1).

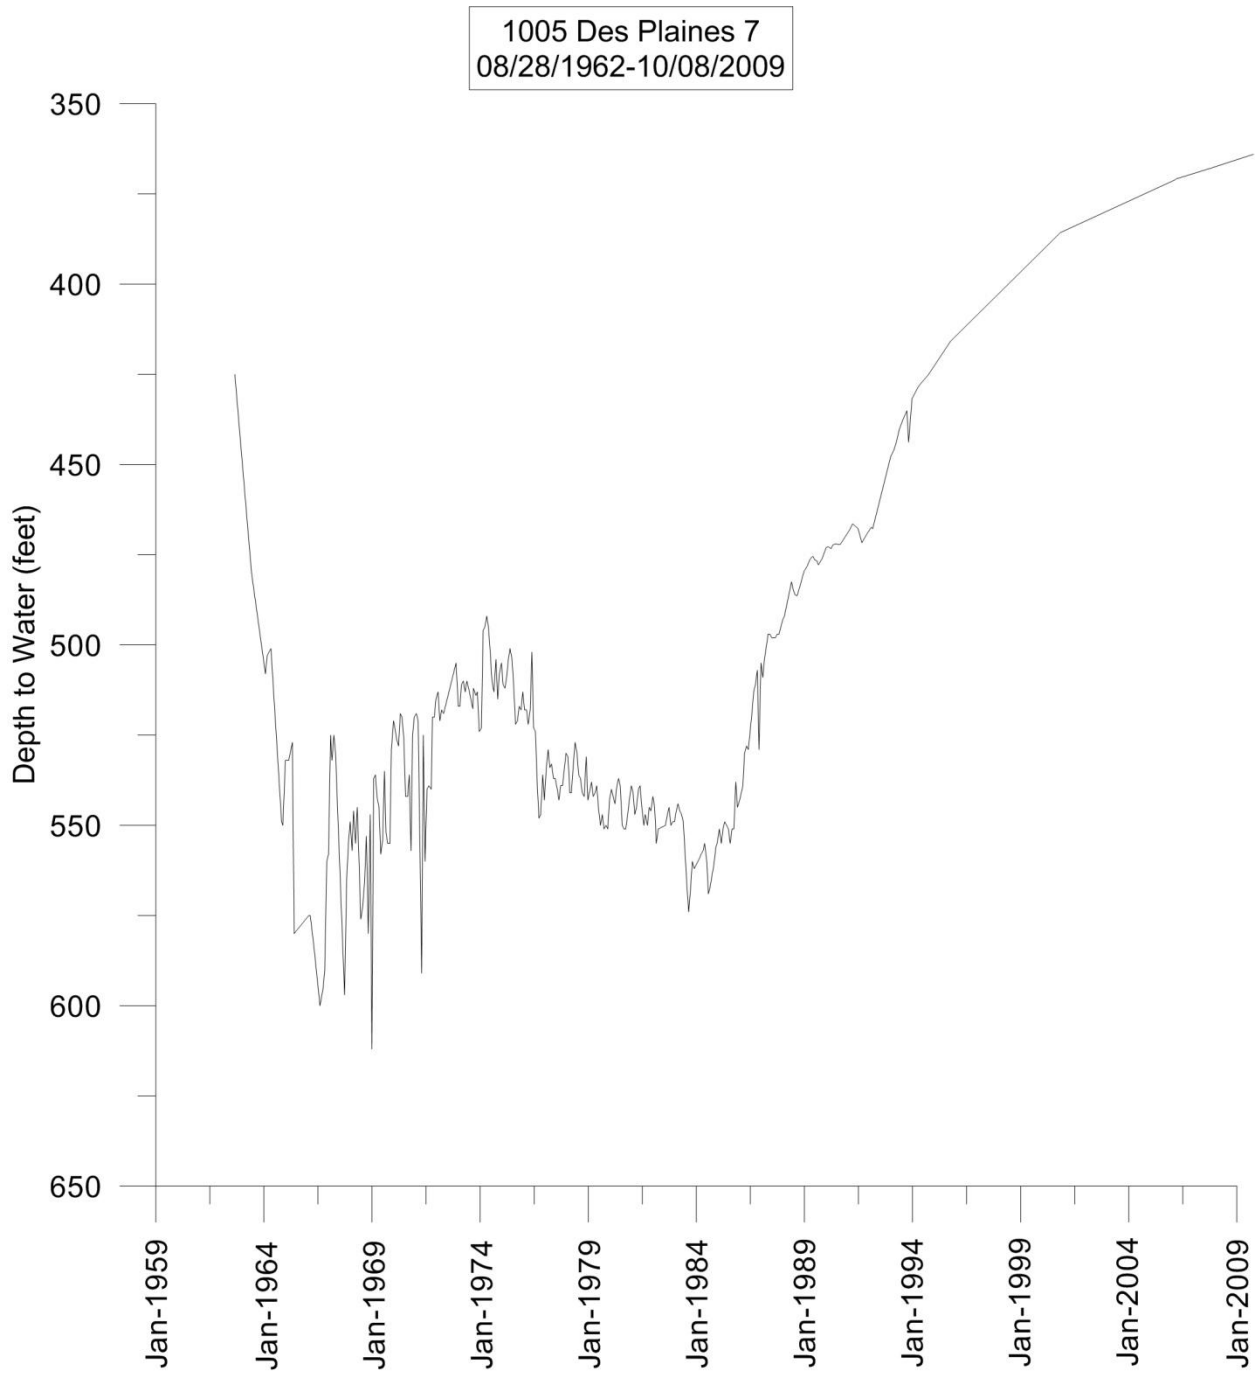
Figure 4 Depth to water in observation well 1005 (Des Plaines 7).
