Appendix F3.15

Visual Resources

- **Visual Resource Inventory Summary**
- **Compliance with Visual Resource Objectives by KOP for Proposed Action**
 - **Photographic Simulations**
 - **Contrast Rating Forms**

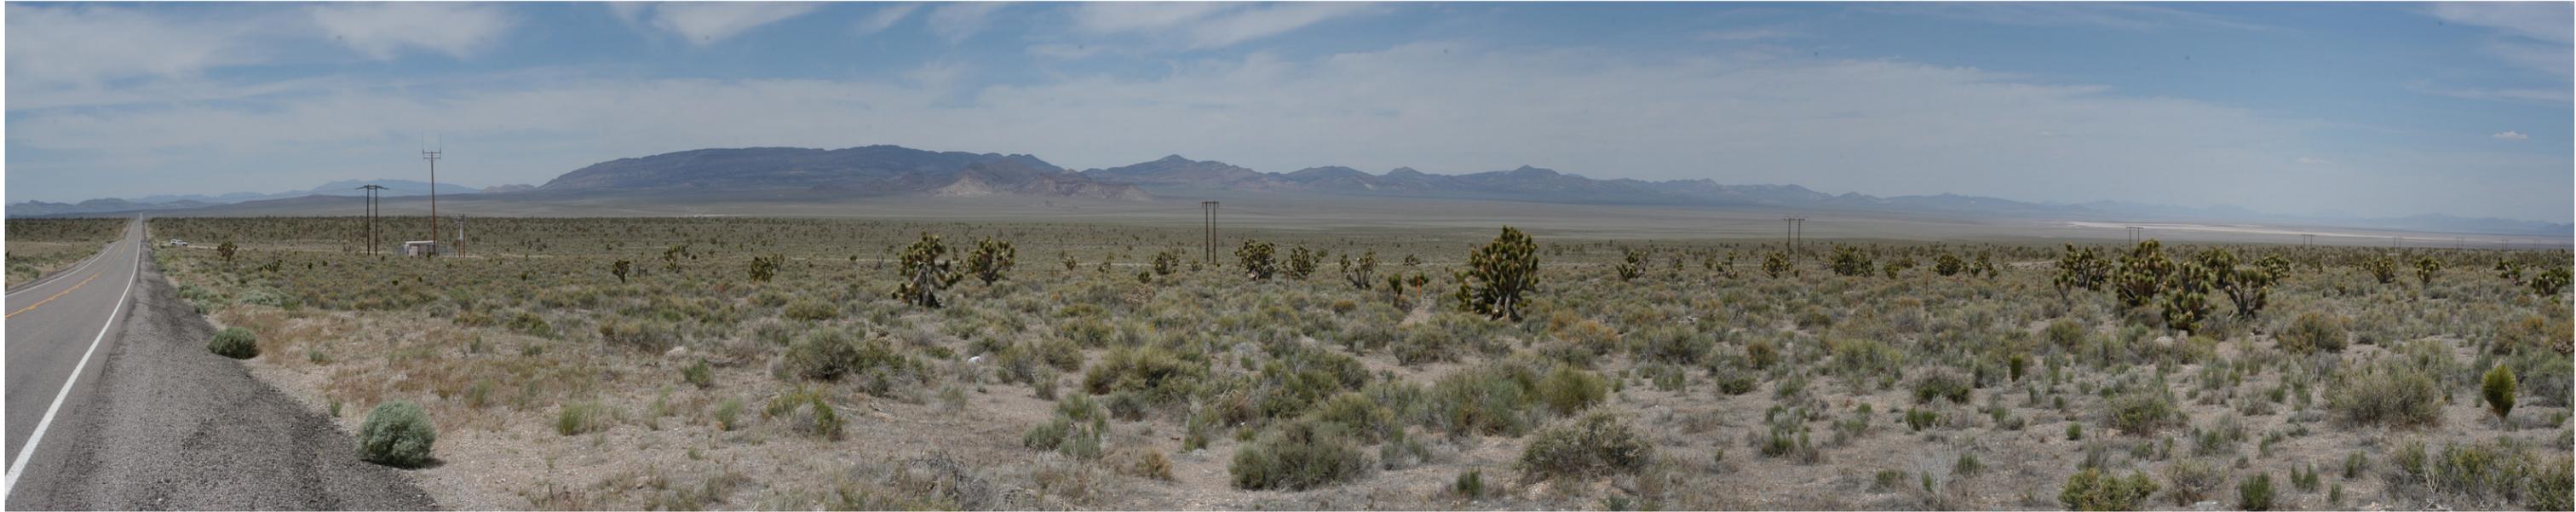
Photo taken along US 93, approximately 17 miles west of Caliente, NV - looking Northwest

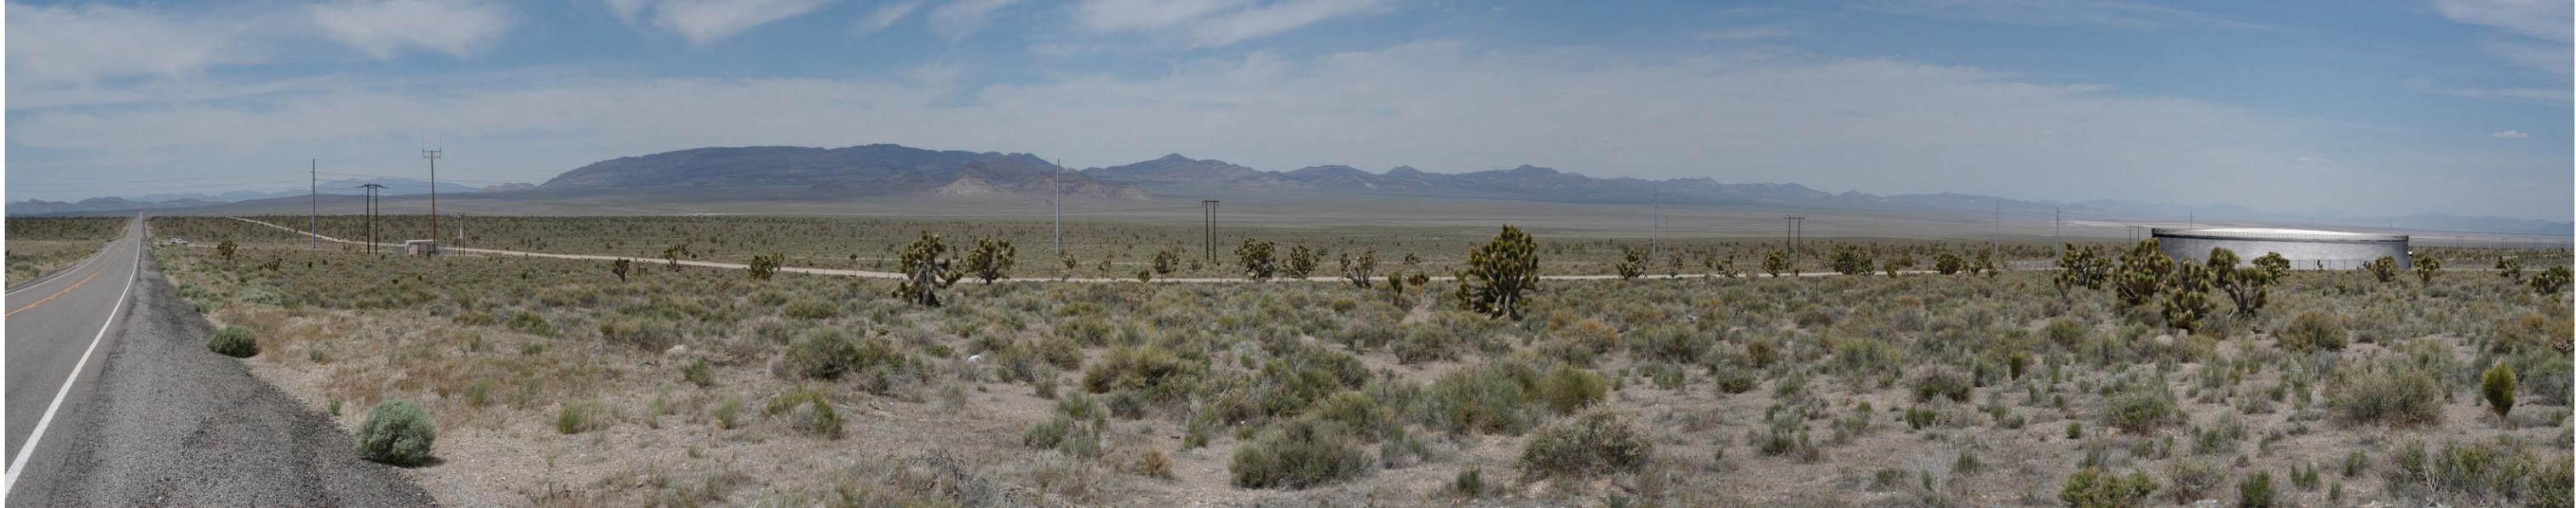
Simulation (No Mitigation Measures Applied)

Simulation Shows:

Proposed Action

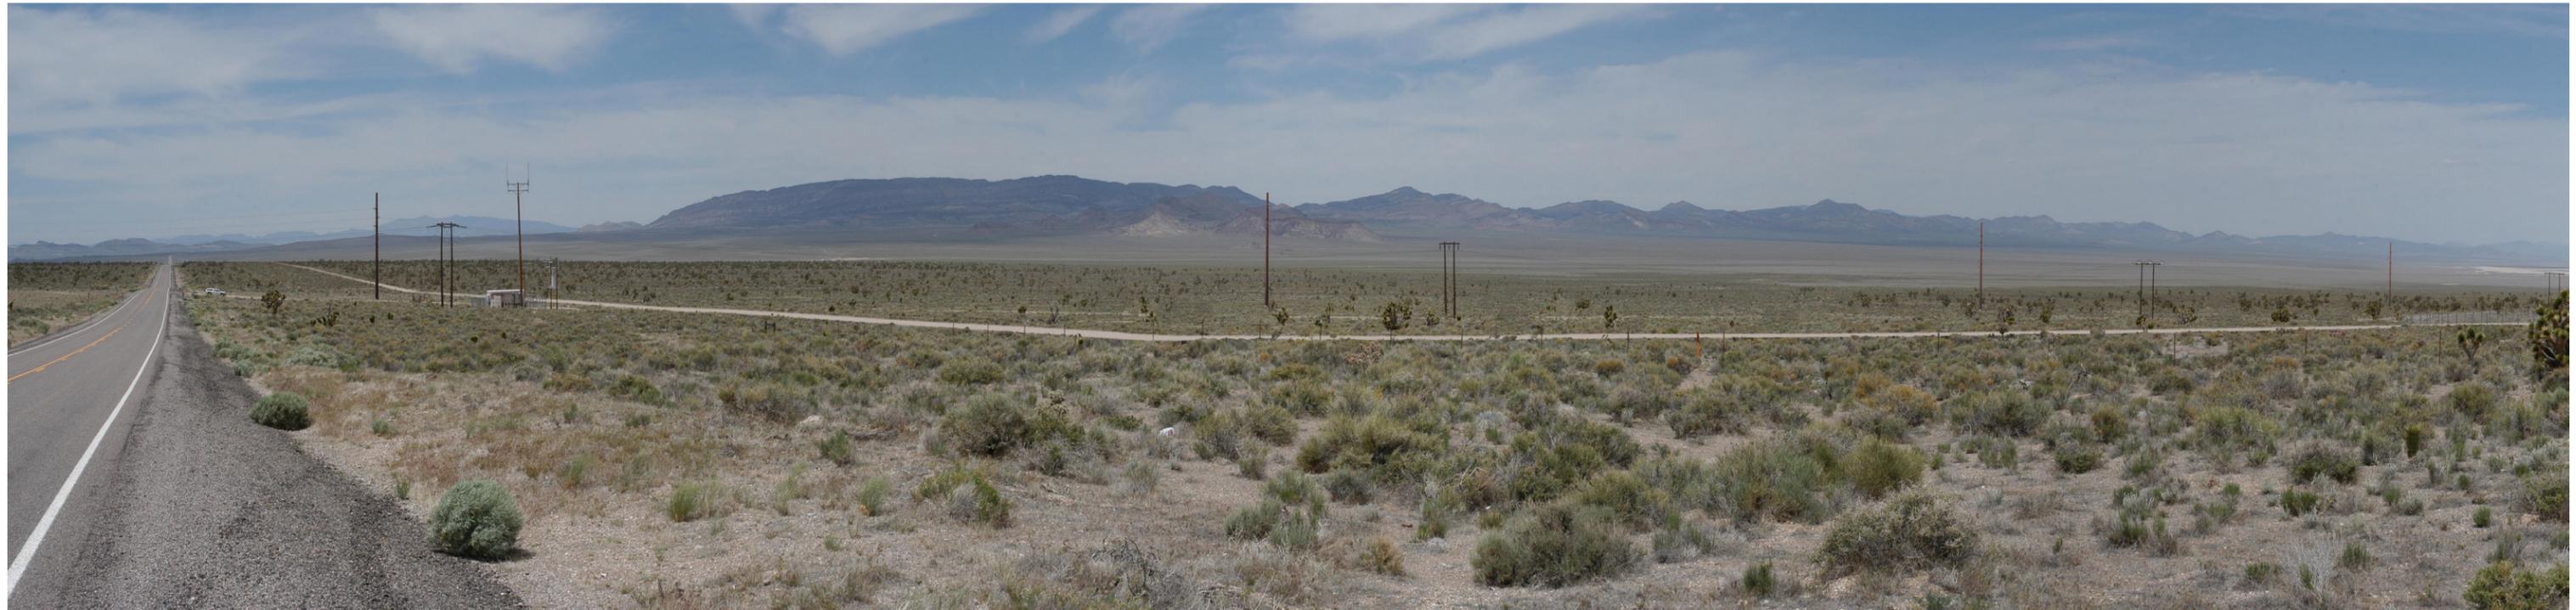
Simulation (Mitigation Measures Applied)

Simulation Shows:

Proposed Action

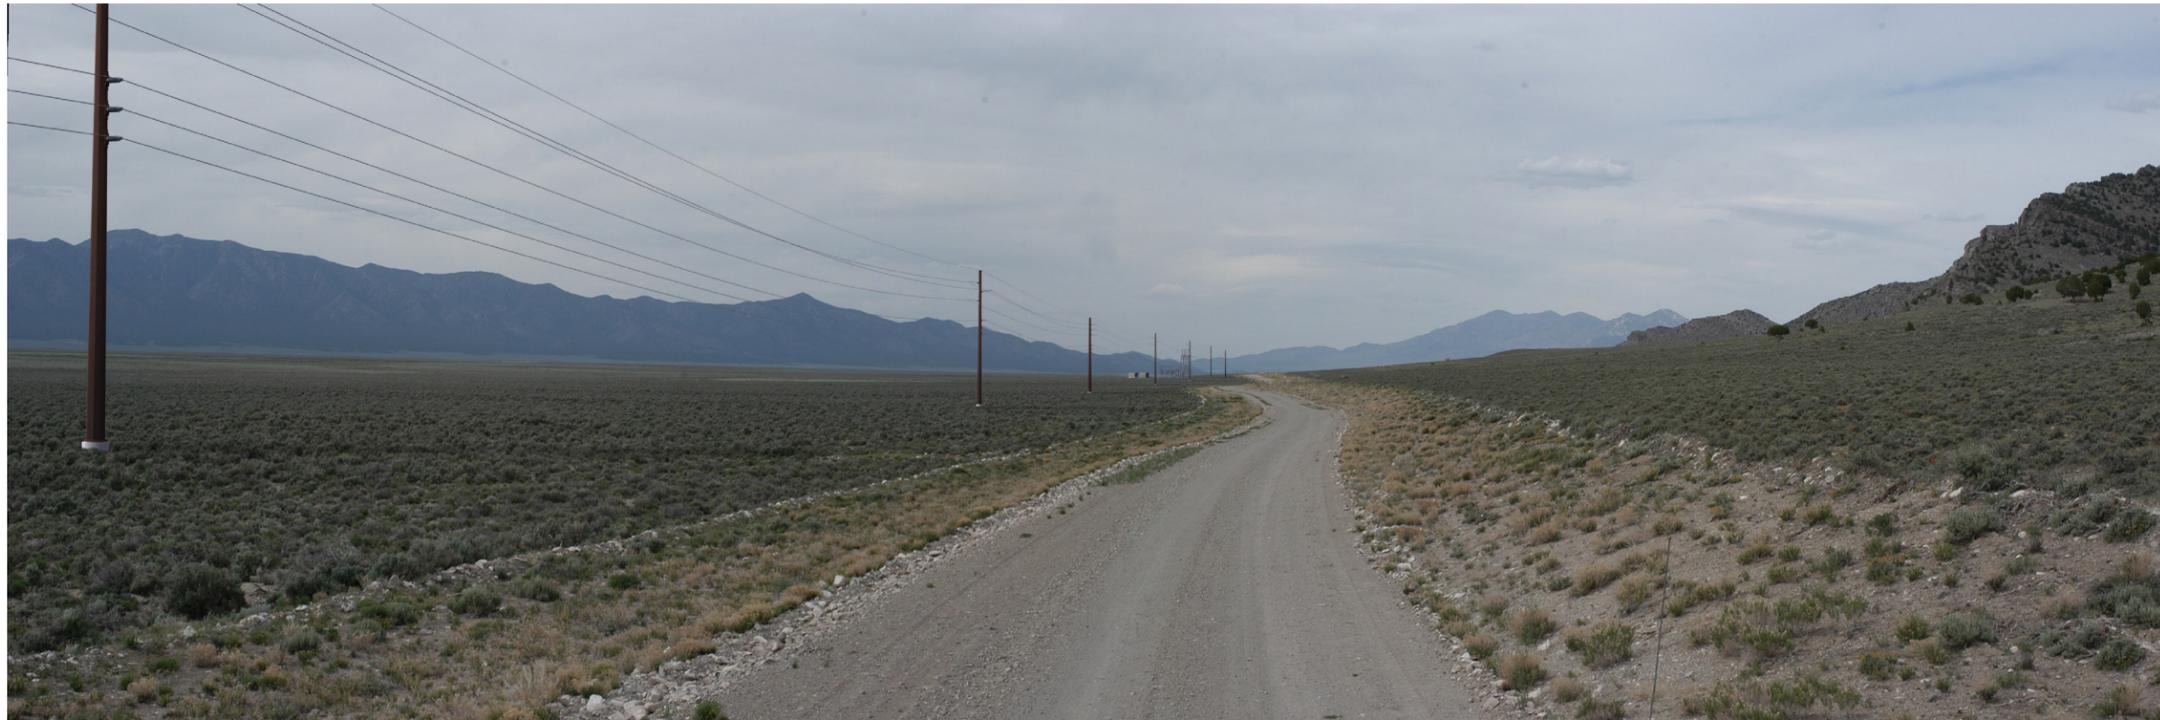
Simulation (Mitigation Measures Applied)

Simulation Shows:

Proposed Action

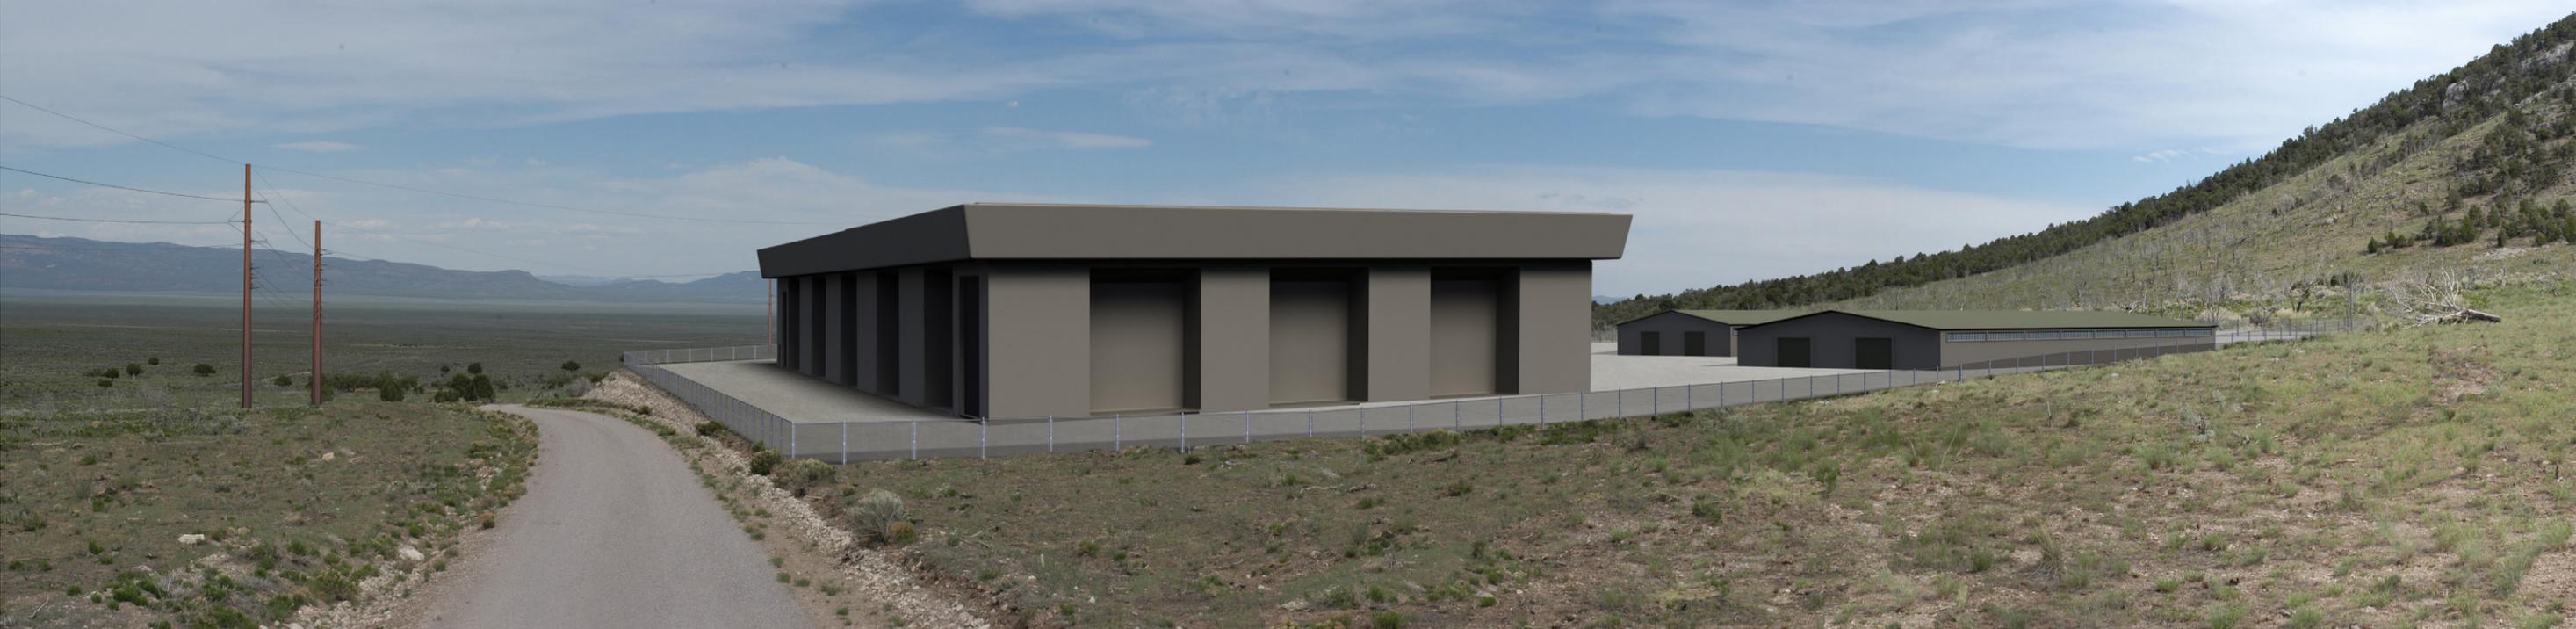
Simulation (Mitigation Measures Applied)

Simulation Shows:

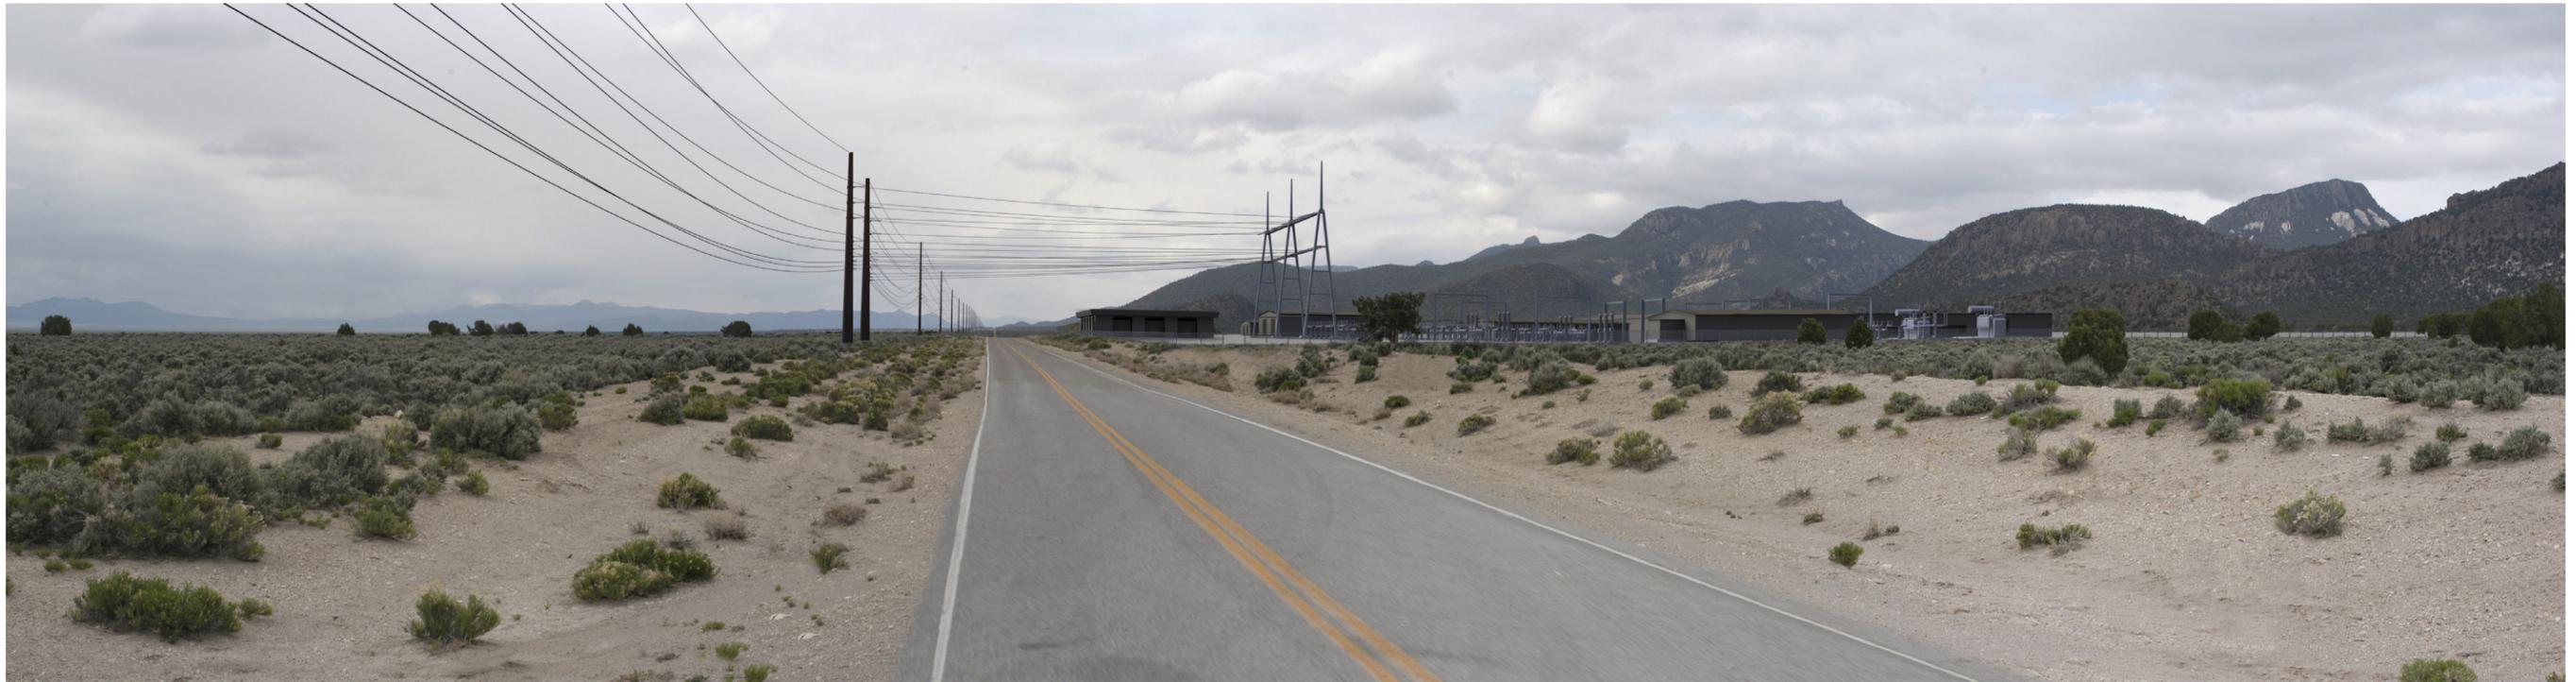
Simulation (Mitigation Measures Applied)

Simulation Shows:

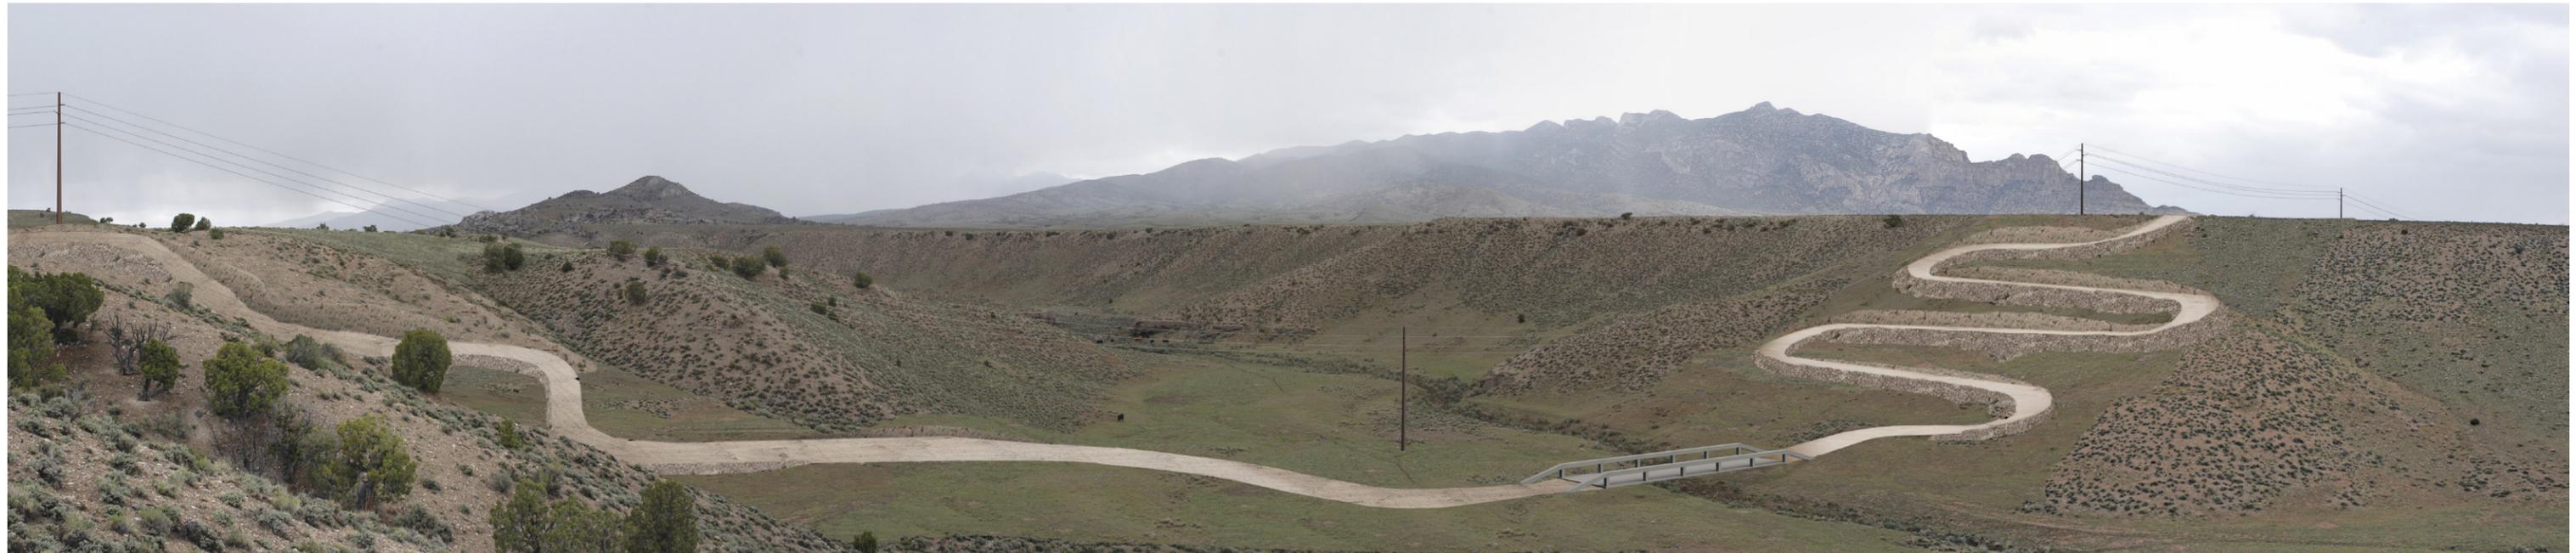
Simulation (Mitigation Measures Applied)

Simulation Shows:

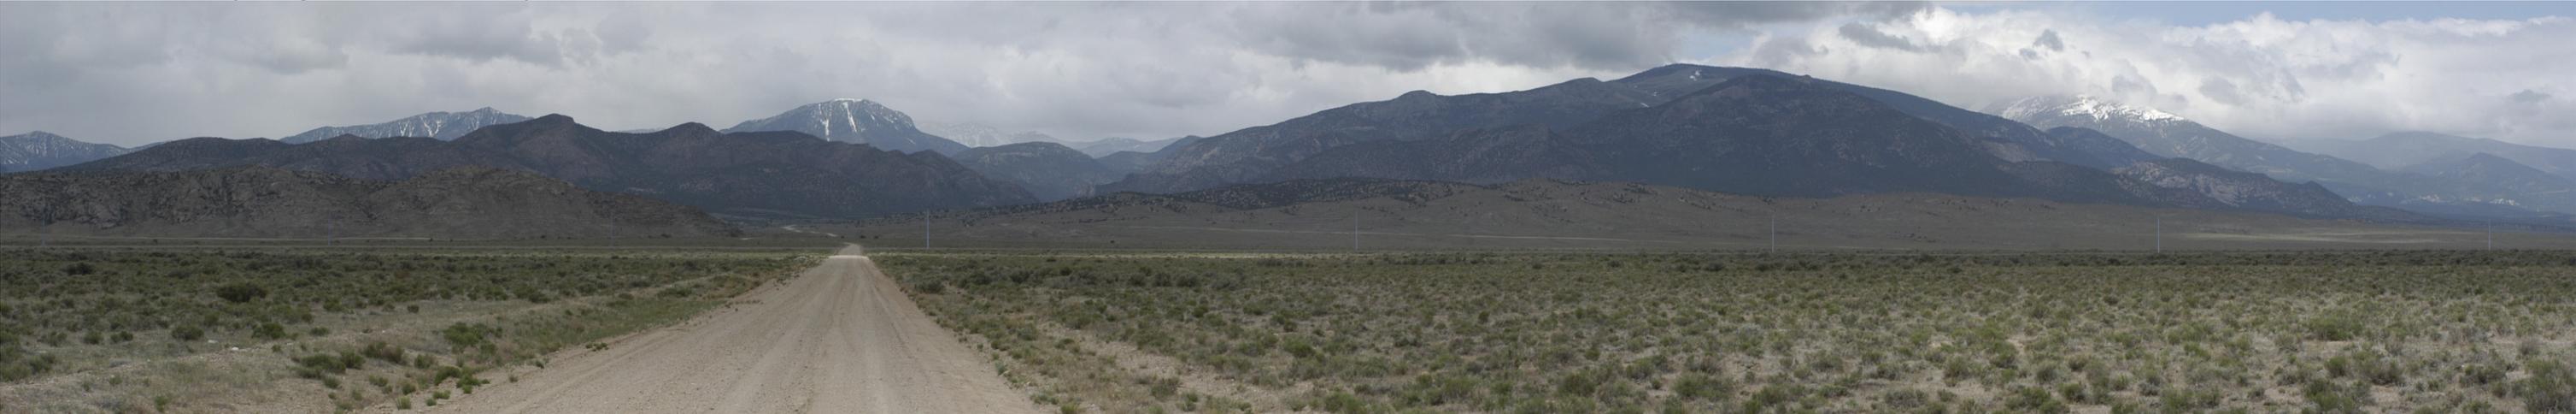
Simulation 1 (Proposed Action)

Photo taken along White Pine County Road 42, approximately 1 miles west of Garrison, Utah – looking west to Great Basin National Park (4.5 miles away).

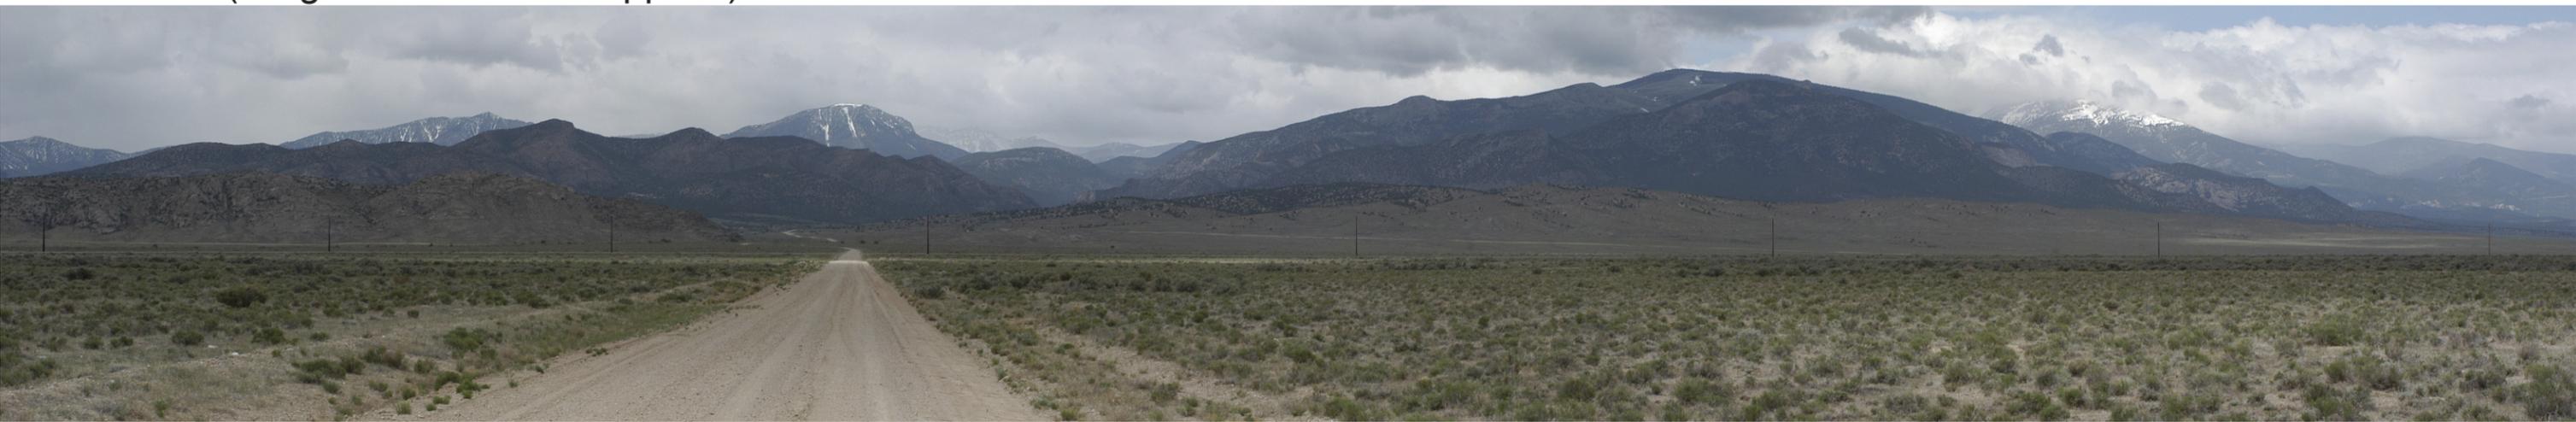
Simulation 2 (Mitigation Measures Applied)

Simulations Show:

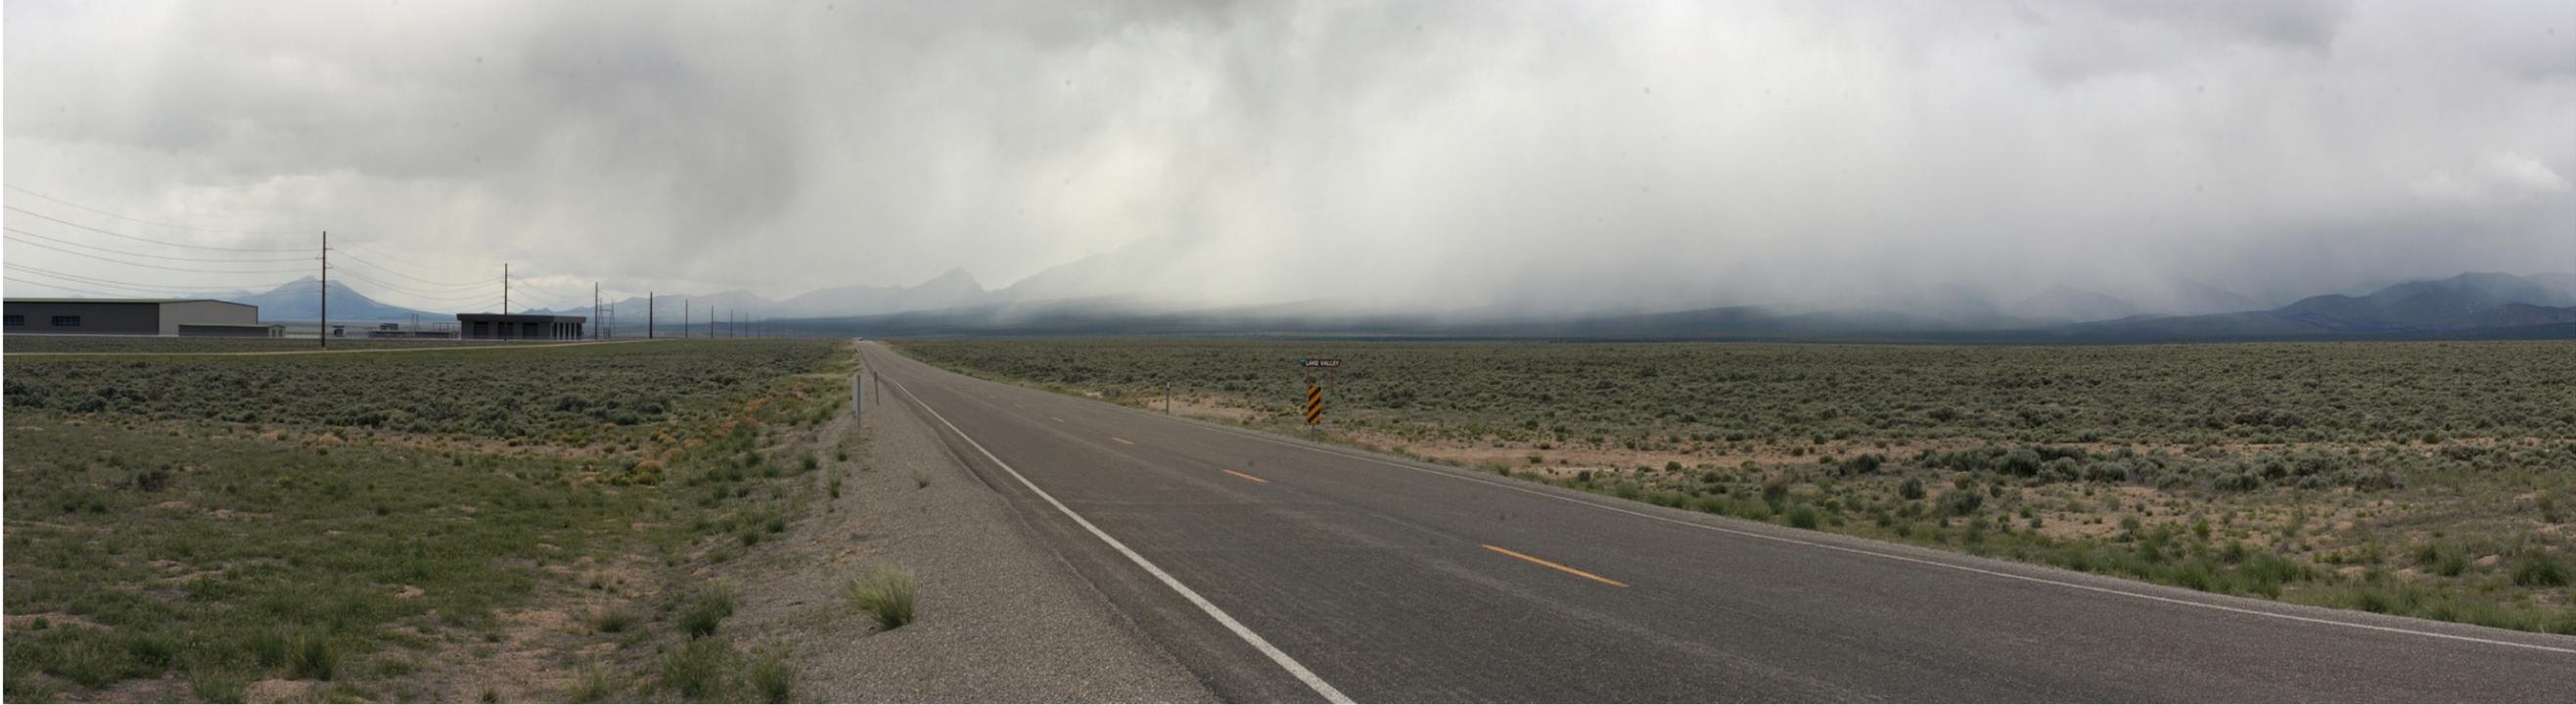
Simulation (Mitigation Measures Applied)

Simulation Shows:

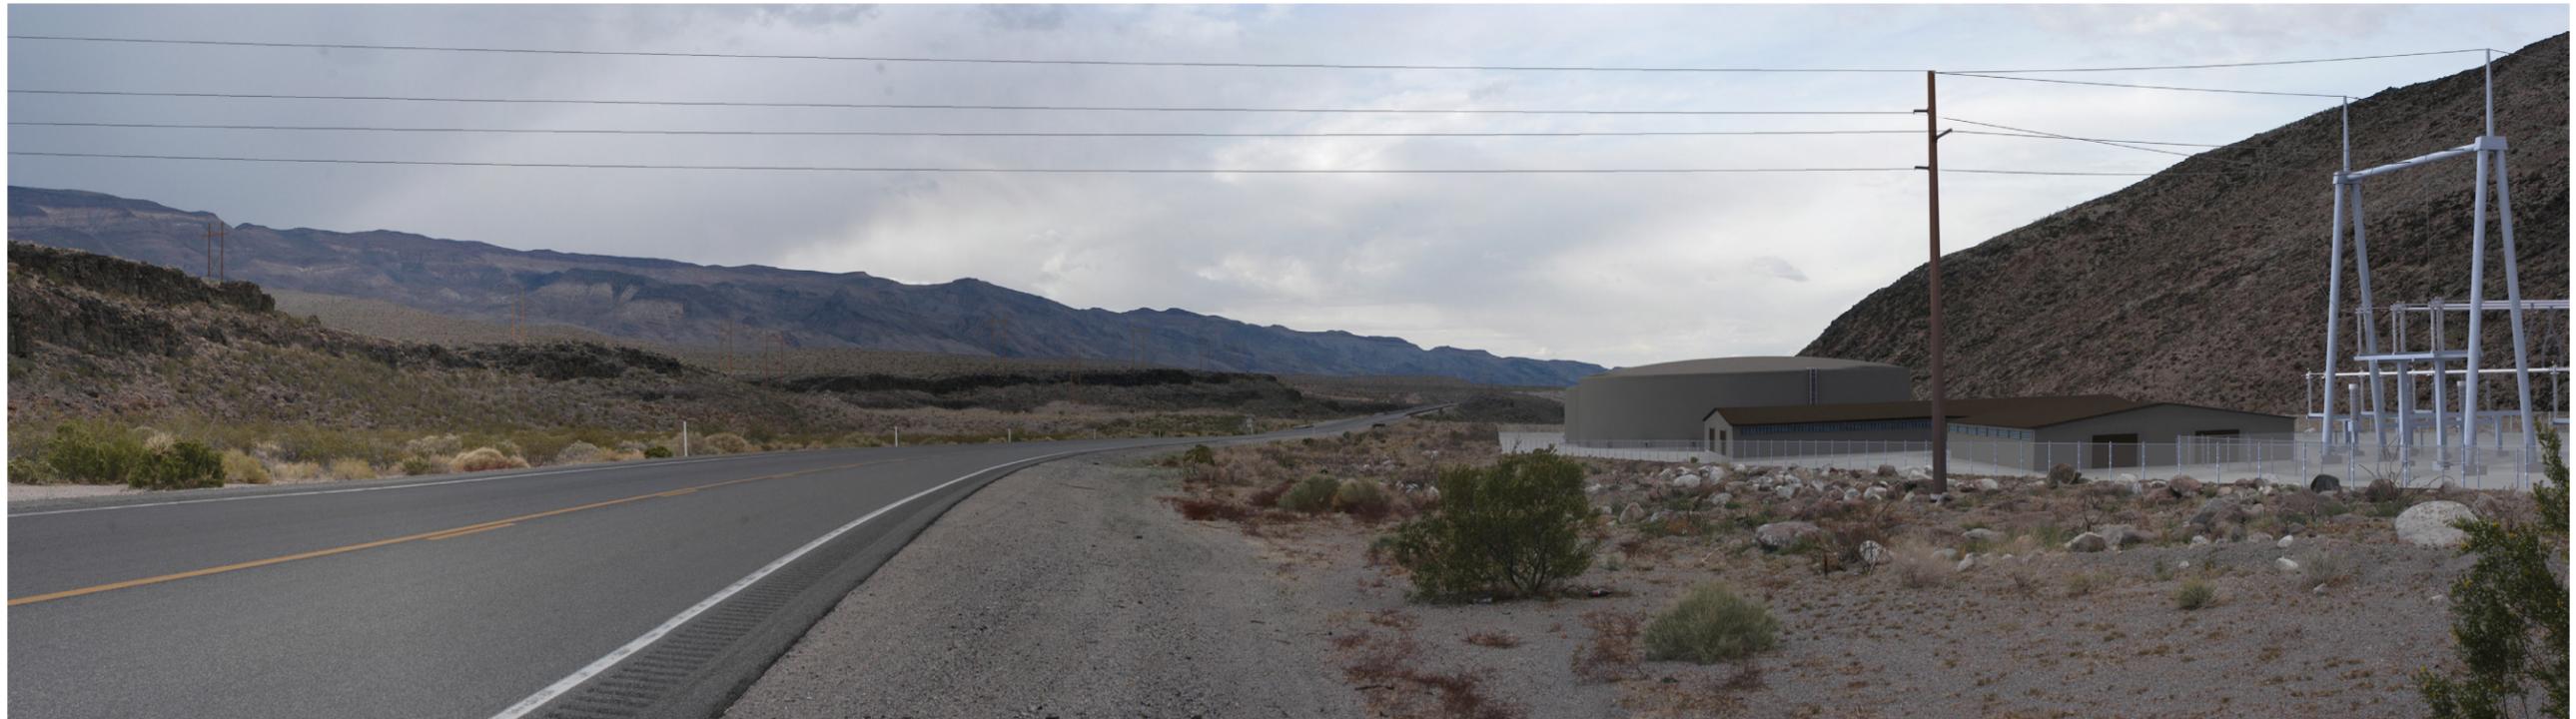
Simulation (Mitigation Measures Applied)

Simulation Shows:

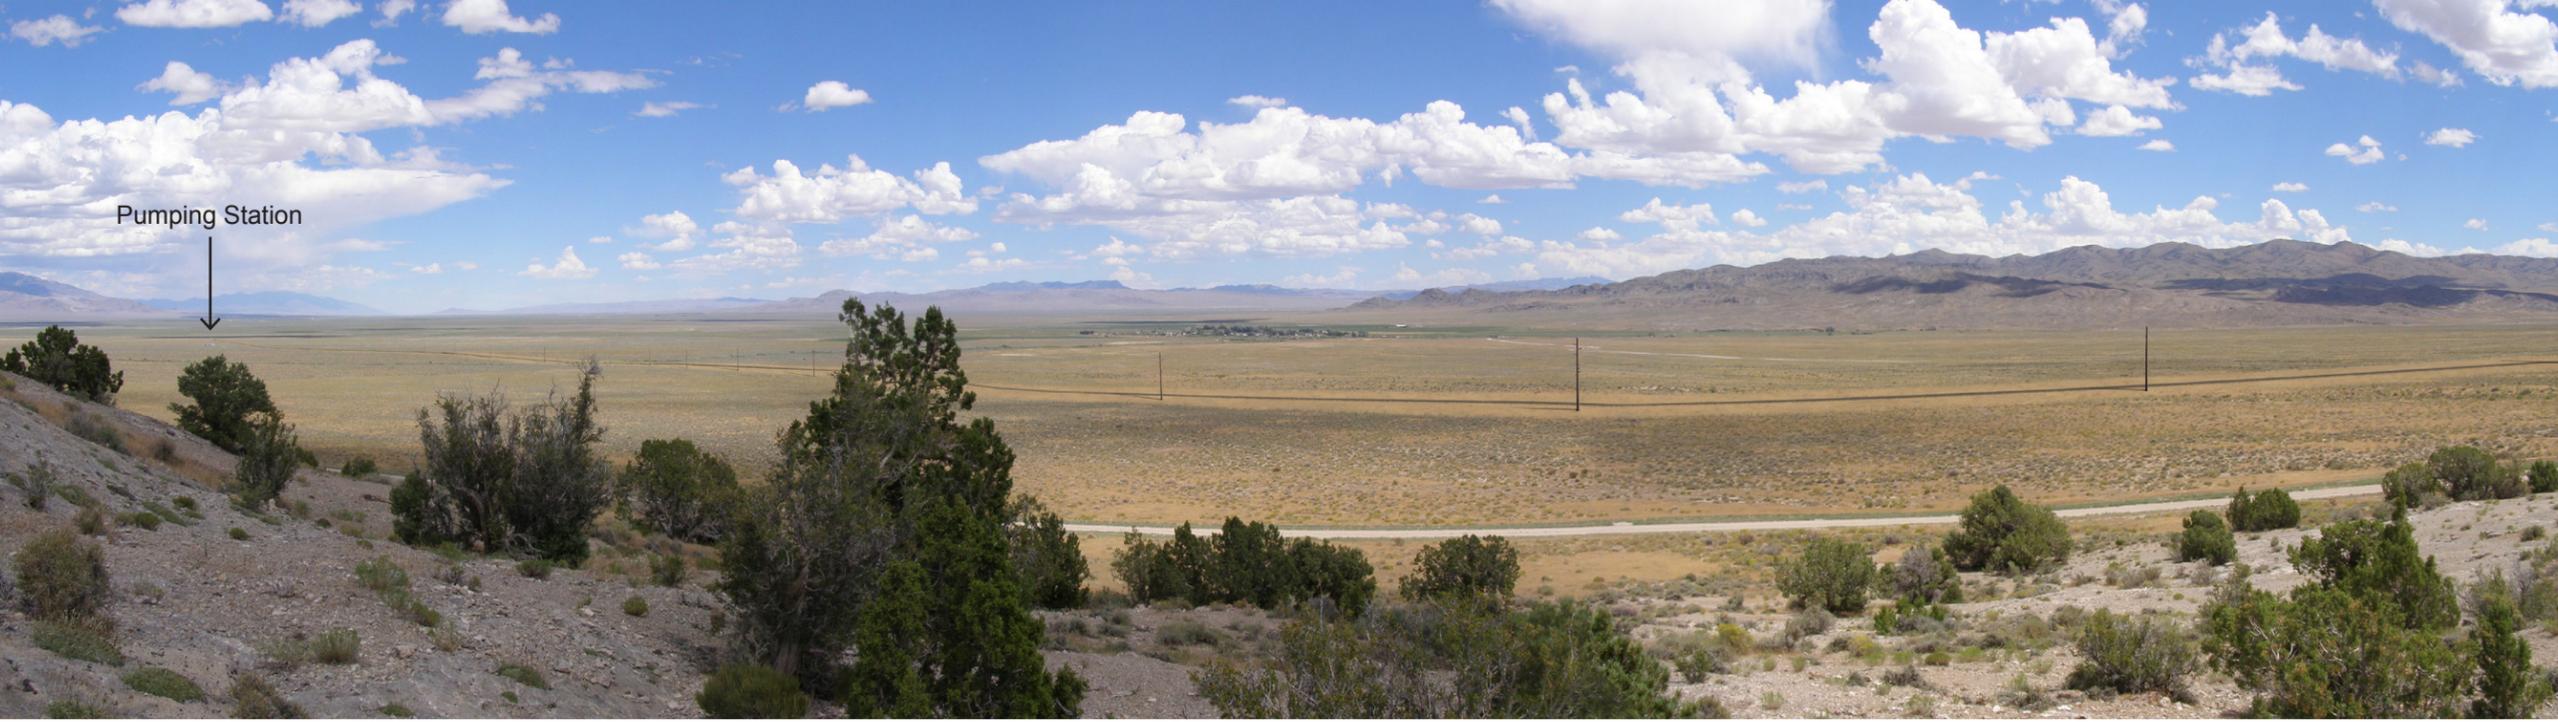
Simulation (Mitigation Measures Applied)

Simulation Shows:
